Report on the investigation of
the grounding of the passenger vessel

Waverley

South of Sanda Island

**Report No 1/2005
January 2005**

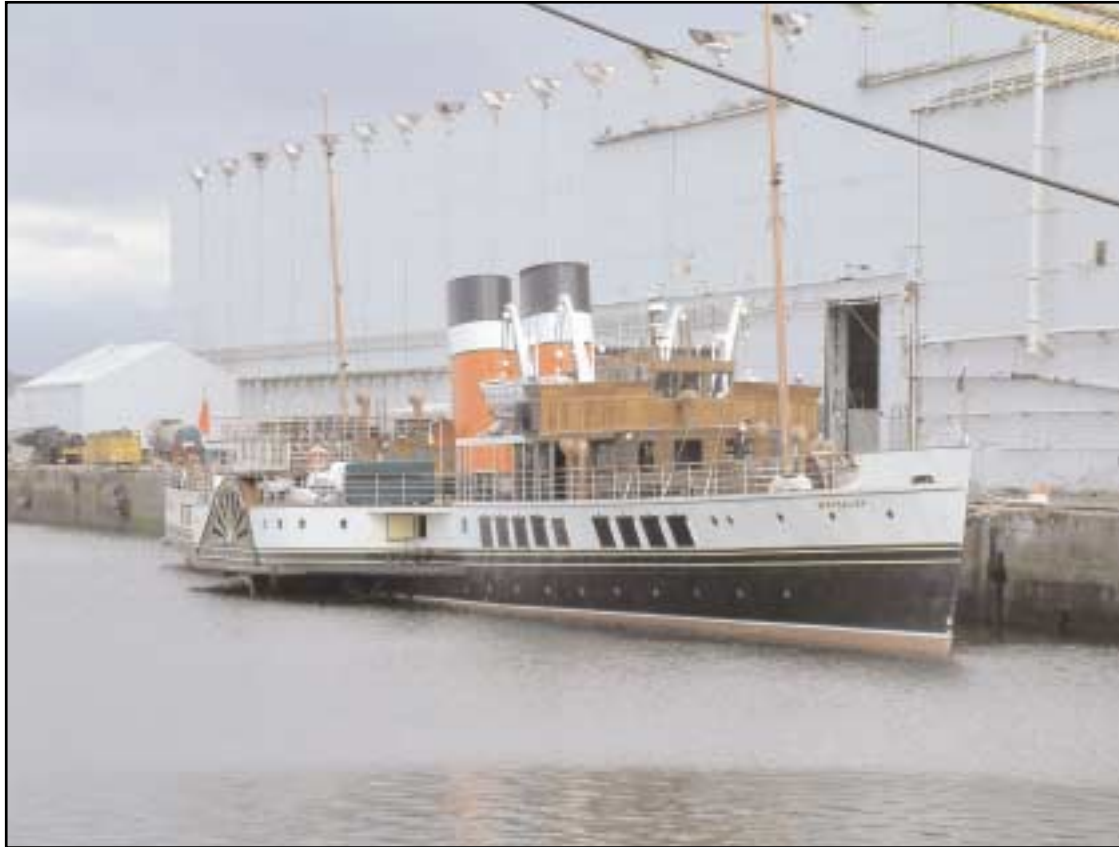
Figure 1

The paddle steamer *Waverley*

The paddle steamer *Waverley* (**Figure 1**) is the last remaining seagoing example of her kind. Built in 1947 with reparation money, she operated on the west coast of Scotland until 1973. She was then bought for £1 by the PSPS in 1974, and from 1975 has been used for pleasure excursions, enabling the general public to take day trips along the UK coast. The vessel underwent extensive refits, called the heritage rebuild, in 2000 and 2003 funded by a £7 million grant from the national lottery. During these refits, every effort was made to restore her in the style of the 1940s era. In 2003, *Waverley* was added to the historic ships register as being a vessel of pre-eminent national importance.

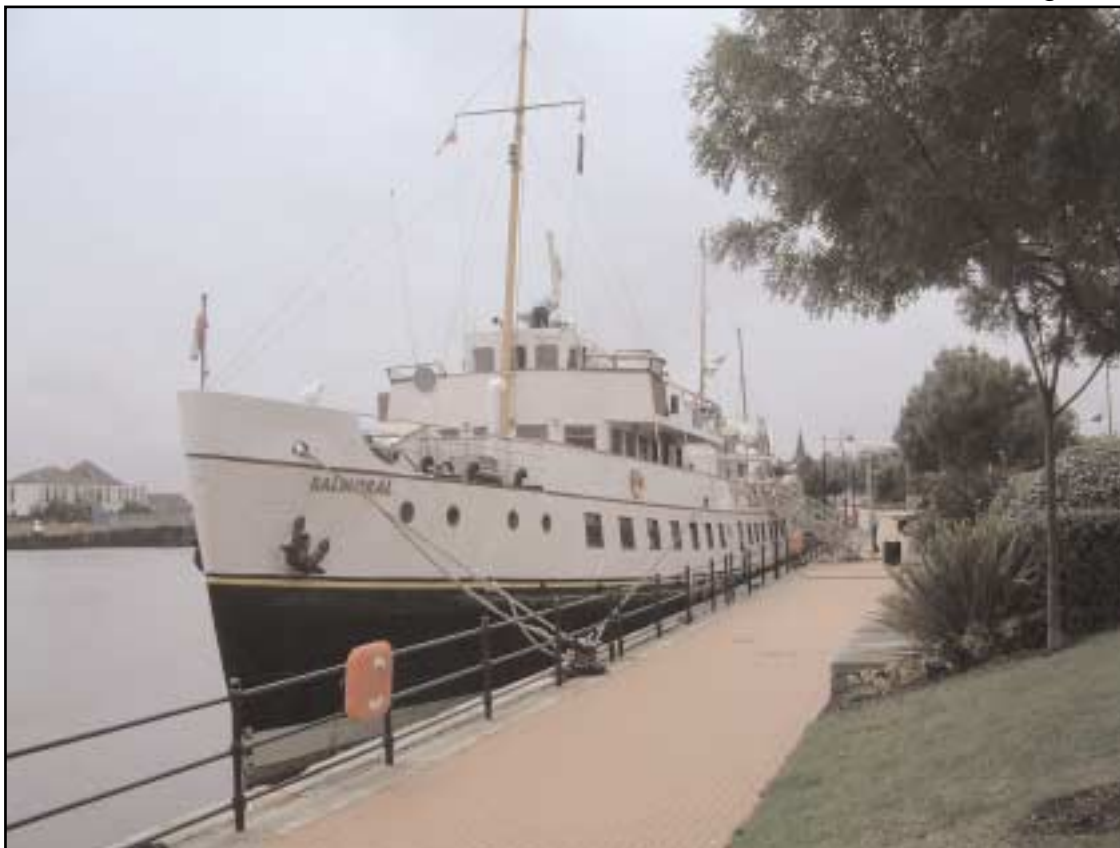
Figure 2

Motor vessel *Balmoral*

The vessel is run by Waverley Excursions Ltd, which also operates the motor vessel *Balmoral* (**Figure 2**). *Balmoral* is of a similar style and vintage to *Waverley* but is powered by two diesels through fixed pitch propellers. The two vessels run between Easter and October around the UK coast. Operating areas include: the Western Isles of Scotland, the Clyde, North Wales, the Bristol Channel, the South Coast of England, the Thames and East Anglia.

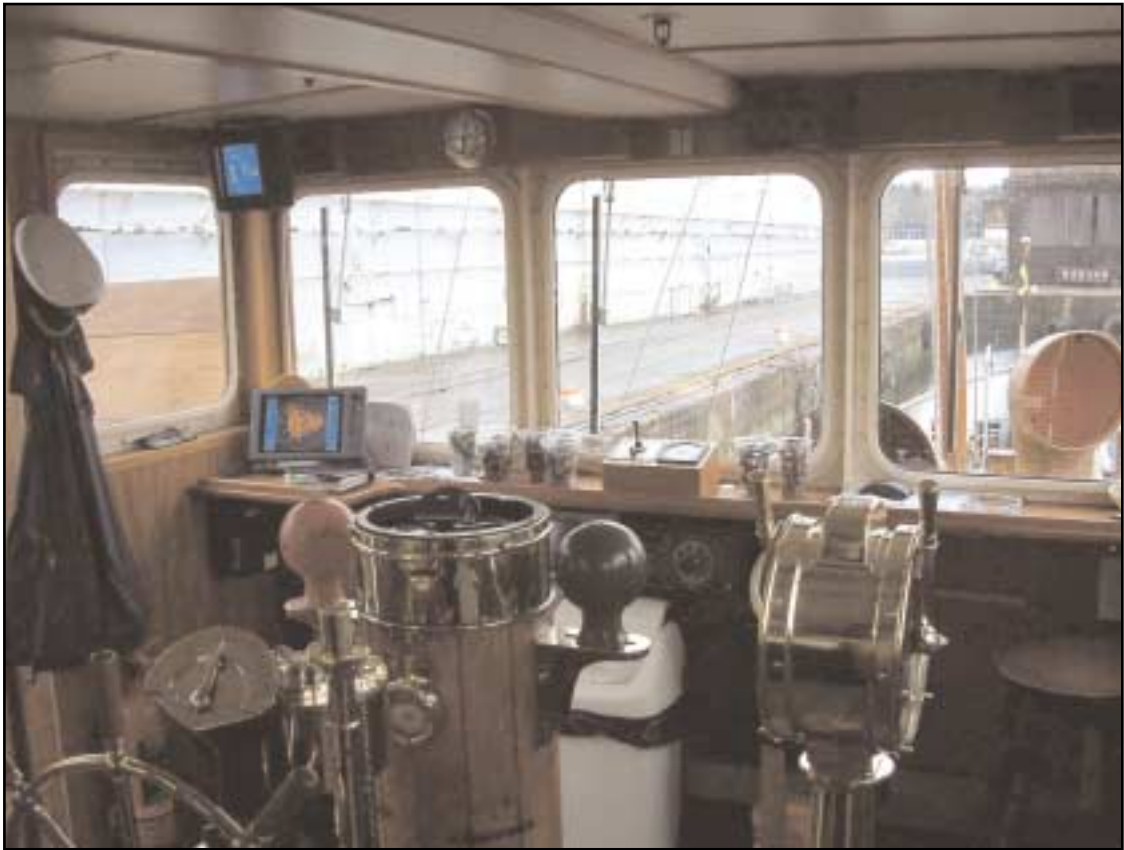
Figure 10

A photograph showing the layout of the bridge is at **Figure 10**. The main chart table was sited at the back of the bridge, with one of the GPS receivers above it. A smaller foldaway chart table was sited at the front of the bridge on the starboard side, but was not in use at the time of the accident.

Waverley's bridge layout
