Report on the investigation
of the failure of a mooring bollard from the
Class V passenger vessel
Star Clipper
resulting in a fatal accident at
St Katharine's Pier, River Thames, London
on
2 May 2004

Marine Accident Investigation Branch
Carlton House
Carlton Place
Southampton
United Kingdom
SO15 2DZ

Report No 3/2005
February 2005

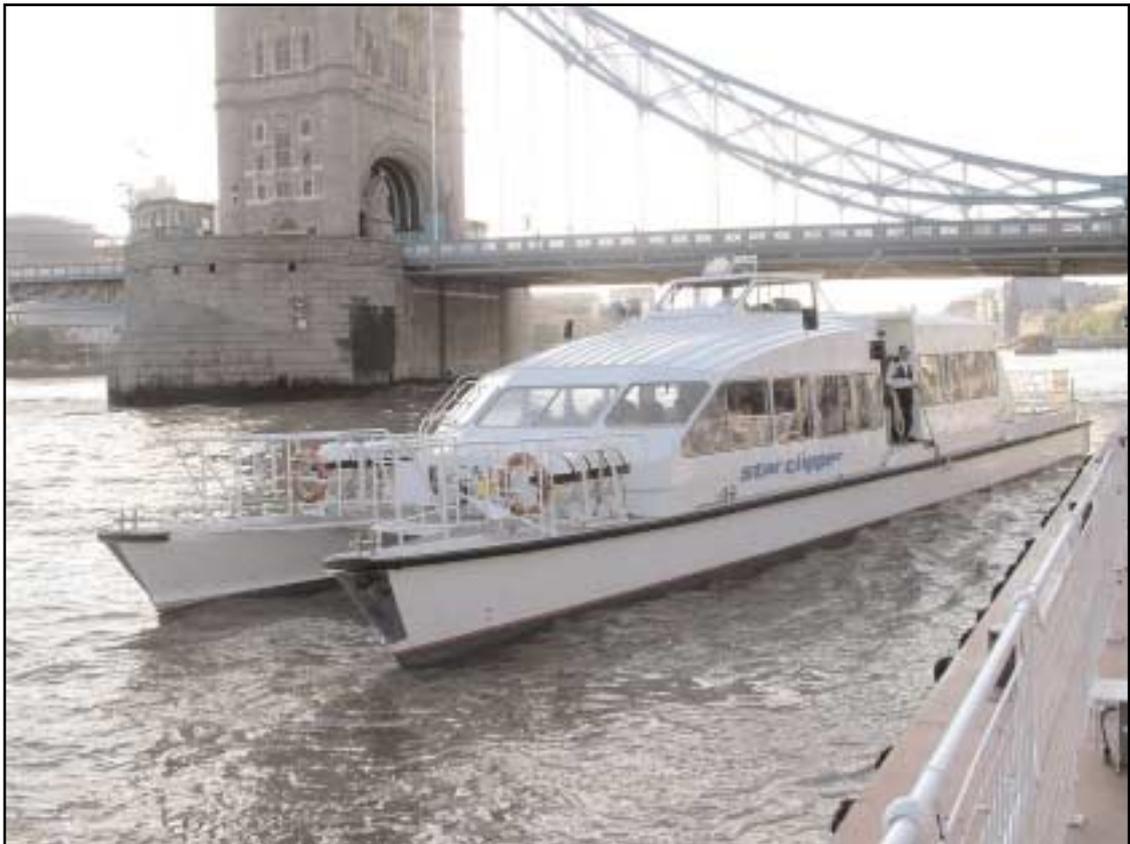
Figure 2

At 1259, having overtaken *Sarpedon*, *Star Clipper* made the final approach to St Katharine's Pier. Her mate was standing in the port passenger access with the mooring rope in his hand (**Figure 2**). The stewardess was inside the passenger cabin. Both port and starboard cabin doors, which gave access to the passenger embarkation platforms, were closed.

When *Star Clipper* was about 3 metres from the pier, her mate threw the eye of the polypropylene mooring rope over a pier bollard. Content that the eye was secure, he then took a "running turn" around the port after stainless steel mooring bollard, located in the port passenger access recess. (The arrangement at **Figure 3** shows the position of the starboard bollard, which was identical to that on the port side prior to failure.) The "turn" around the bollard allowed the mate to let rope out as the vessel aligned with the pier passenger gate.

Port passenger access - mate's position for coming alongside

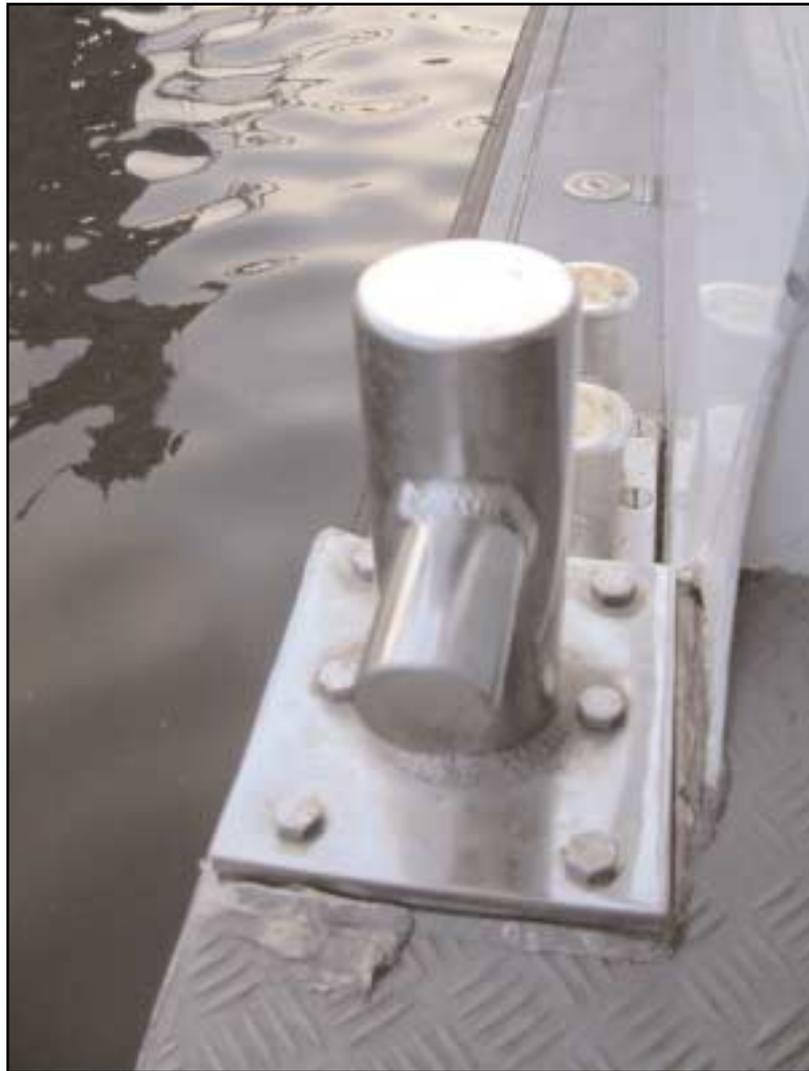
Figure 3

Passenger access - stainless steel MkIII bollard

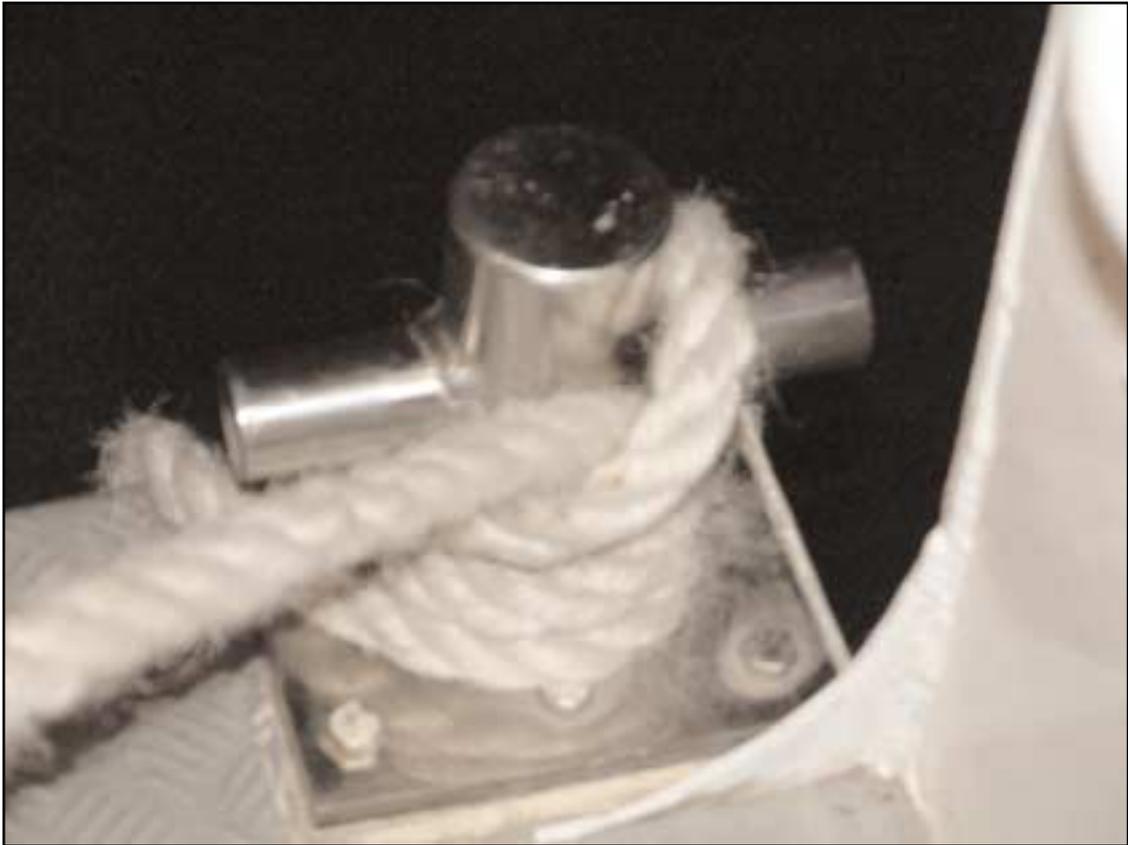
When *Star Clipper* was about 1.5m from the pier, the mate judged that about 2.6m of slack rope was required to allow her to align with the pier passenger gate. He secured the rope onto the vessel's bollard with a "pin hitch" (**Figure 5**). This action is known as the "fetch up".

Mooring rope 'pin hitch' arrangement

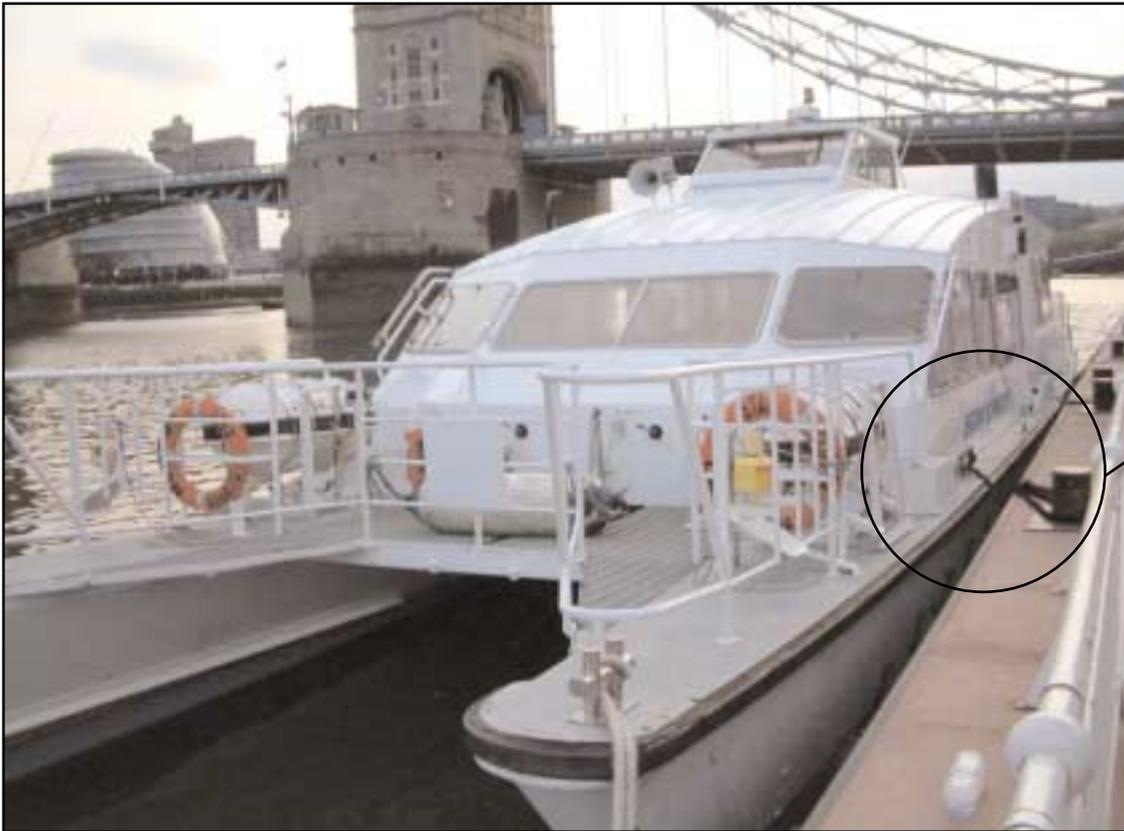
Figure 15

While under Serco Denholm Ltd charter (paragraph 1.7.3), the crews found access from the passenger platform of the three *Clipper* vessels to the forward bollards extremely difficult, particularly during inclement weather (**Figure 15**). To overcome this, four **Mk I** bollards were fitted in the passenger access areas (**Figure 16**). No changes were made to the 3mm aluminium supporting structure. During this time, the bollards were only used during passenger movements. The original fit bollards continued to be used for overnight mooring.

Showing the difficult access to forward bollards

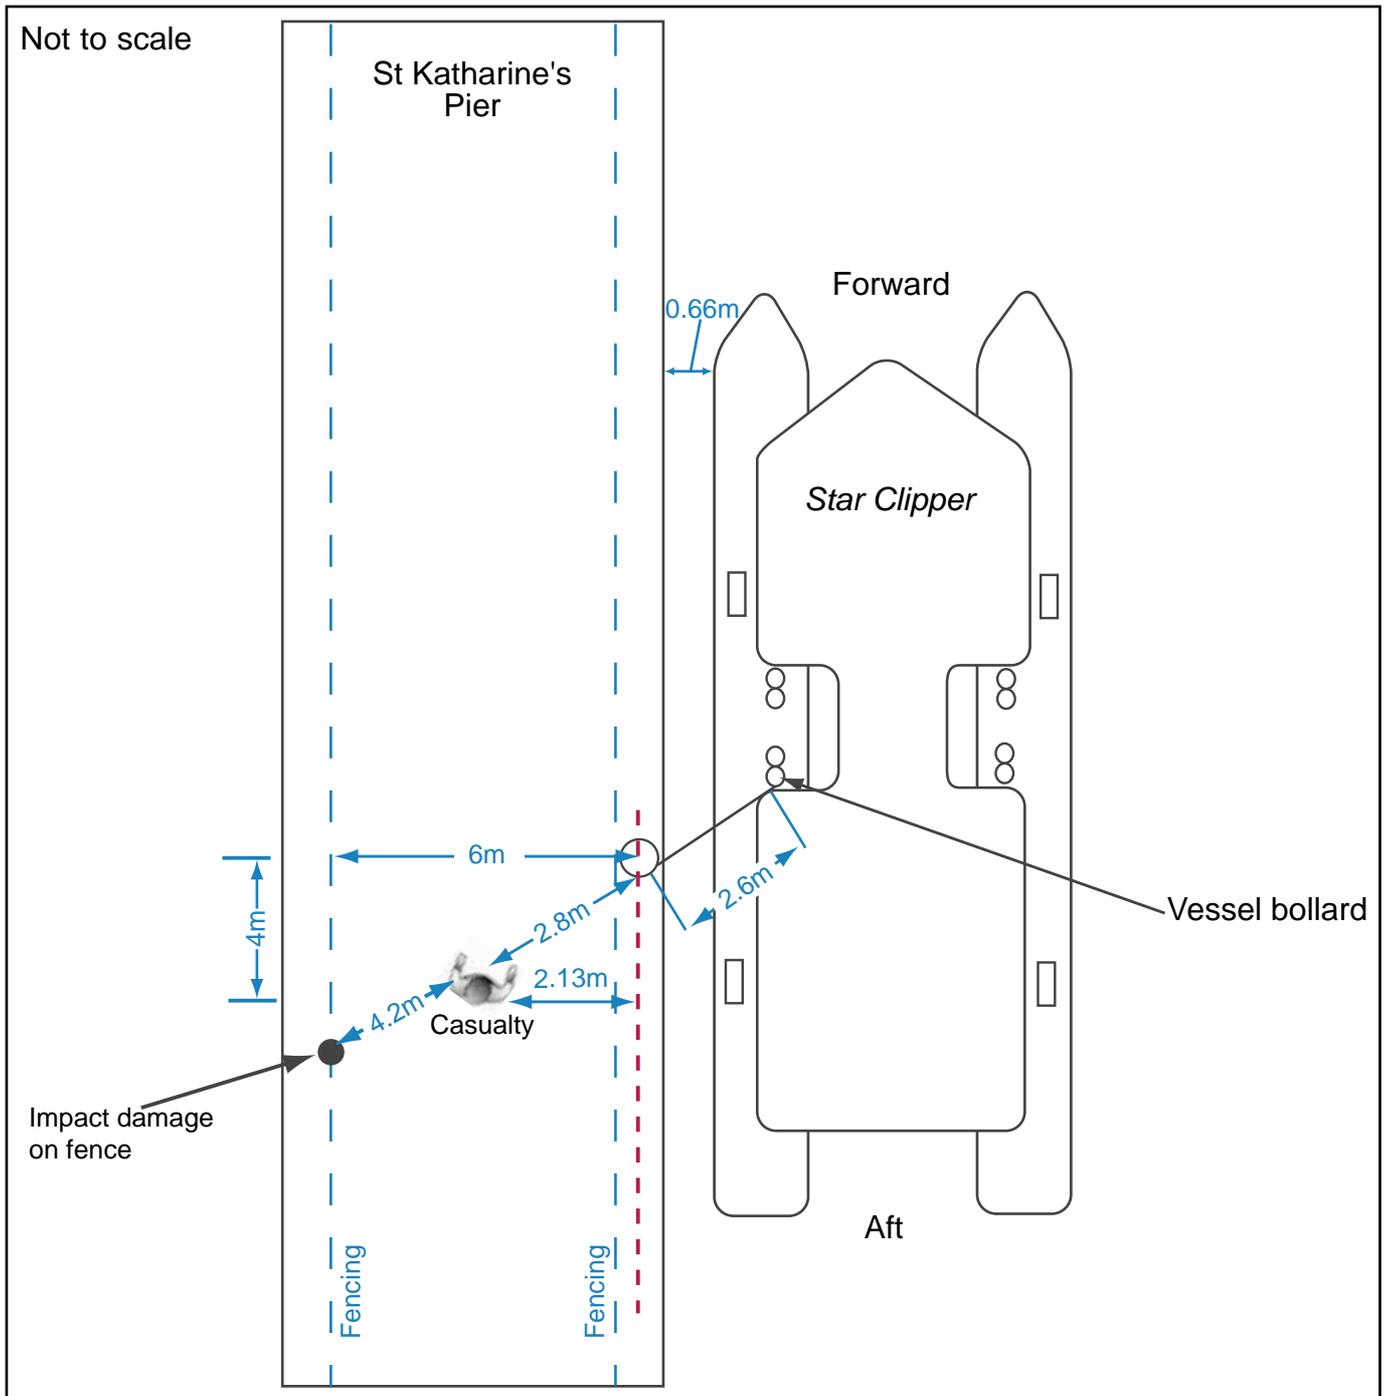
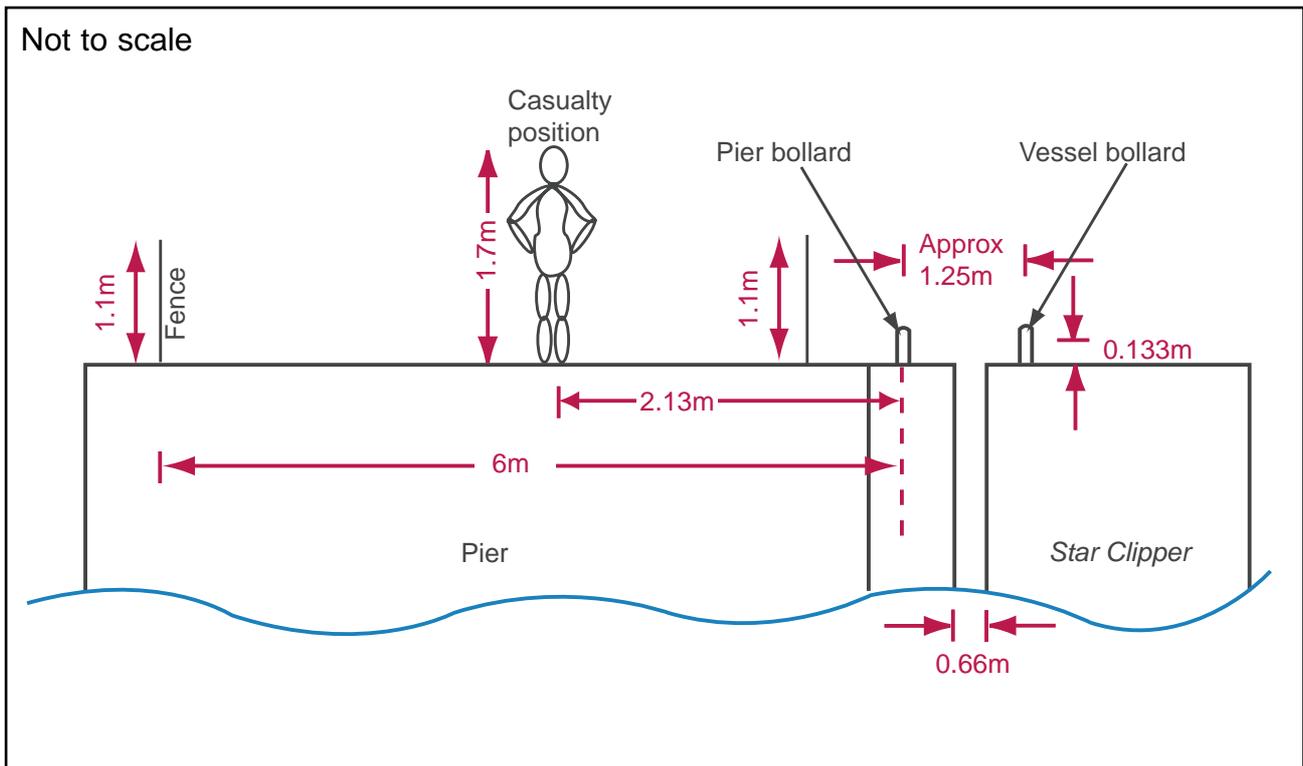
Figure 21

As a result of the re-enactment, it was possible to accurately ascertain the position of the casualty relative to the pier and vessel's bollards (**Figures 21 and 22**).

Casualty's position immediately prior to accident
