MCA Prohibition Notice dated 2 May 2004 and Prohibition  
Notice Addendum dated 3 May 2004

The Test House Report – T40821 dated 3 June 2004. Laboratory Report  
Examination of a Fractured Bollard Mounting Plate Weld and Associated  
Material from the Thames River Craft *Star Clipper*

**LABORATORY REPORT  
EXAMINATION OF A FRACTURED  
BOLLARD MOUNTING PLATE WELD  
AND ASSOCIATED MATERIAL FROM  
THE THAMES RIVER CRAFT  
*STAR CLIPPER***

Tension Technology International Ltd – Report TTI-NOH-2004-274  
dated 4 August 2004 – “Final Report on the Examination and  
Tensile Testing of a Polypropylene Rope Strop, and Calculations  
to Establish the Likely Rope Stored Energy Involved in the Vessel  
Bollard Failure of the *Star Clipper*”

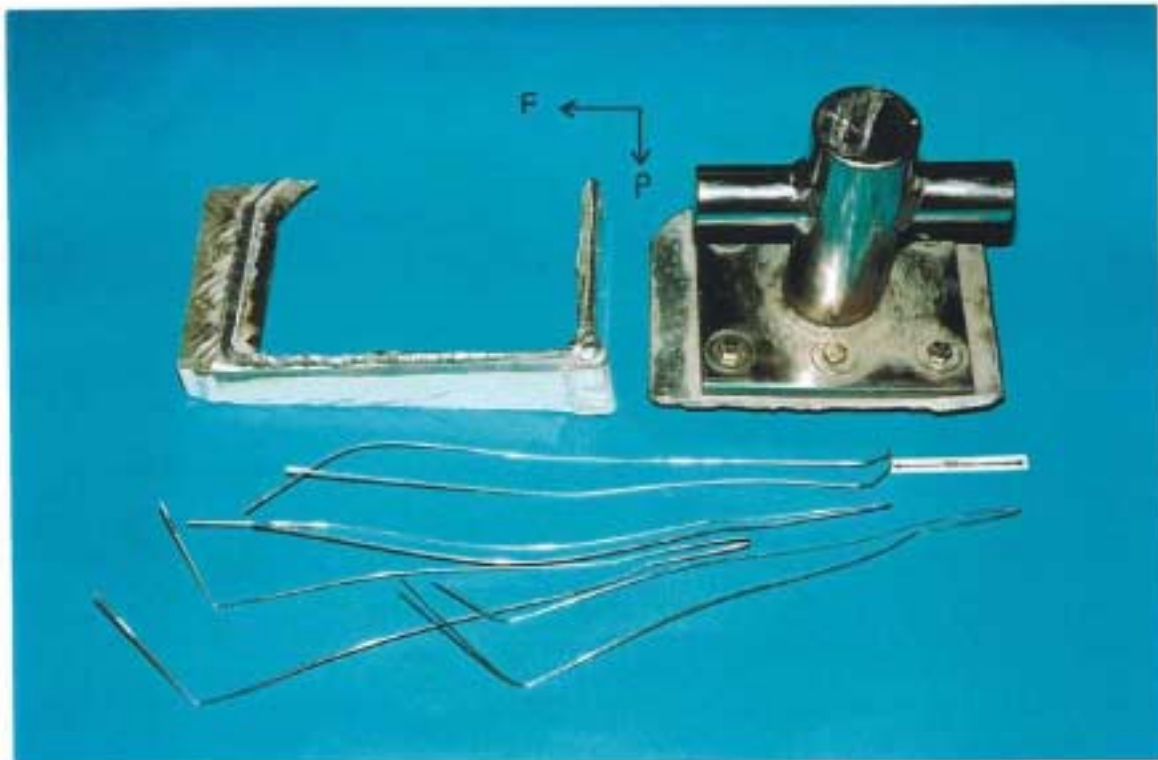
To complete its laboratory based failure analysis, TTH was provided with the detached aft port side bollard, both halves of the fractured insert plate weld and four lengths of TIG welding consumable, all of which are shown in figures 1 and 2.

Figure 2: Sample material, shown after unpacking and oriented in respect of vessel installation (F = forward, P = port).

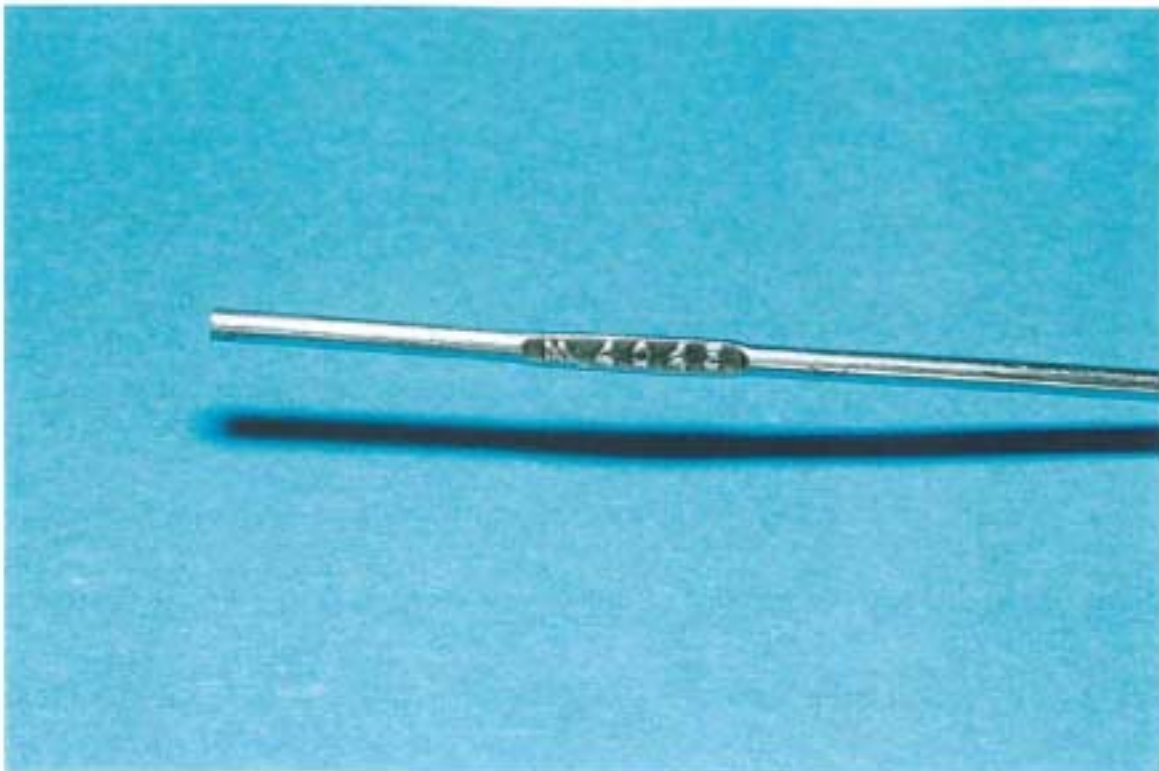
The four lengths of welding consumable were of standard 2.4mm diameter by 1 metre length. One end of each length was embossed with a monogram and the alloy grade reference number 4043 (figure 3), which positively identified the consumable as a relatively low strength Aluminium 5% Silicon alloy type. The opposite wire ends were embossed with the number sequence 3.2245 (figure 4), the significance of which is not currently fully recognised.

Figure 3: Alloy grade (4043) embossed at one end of the welding consumable lengths supplied.

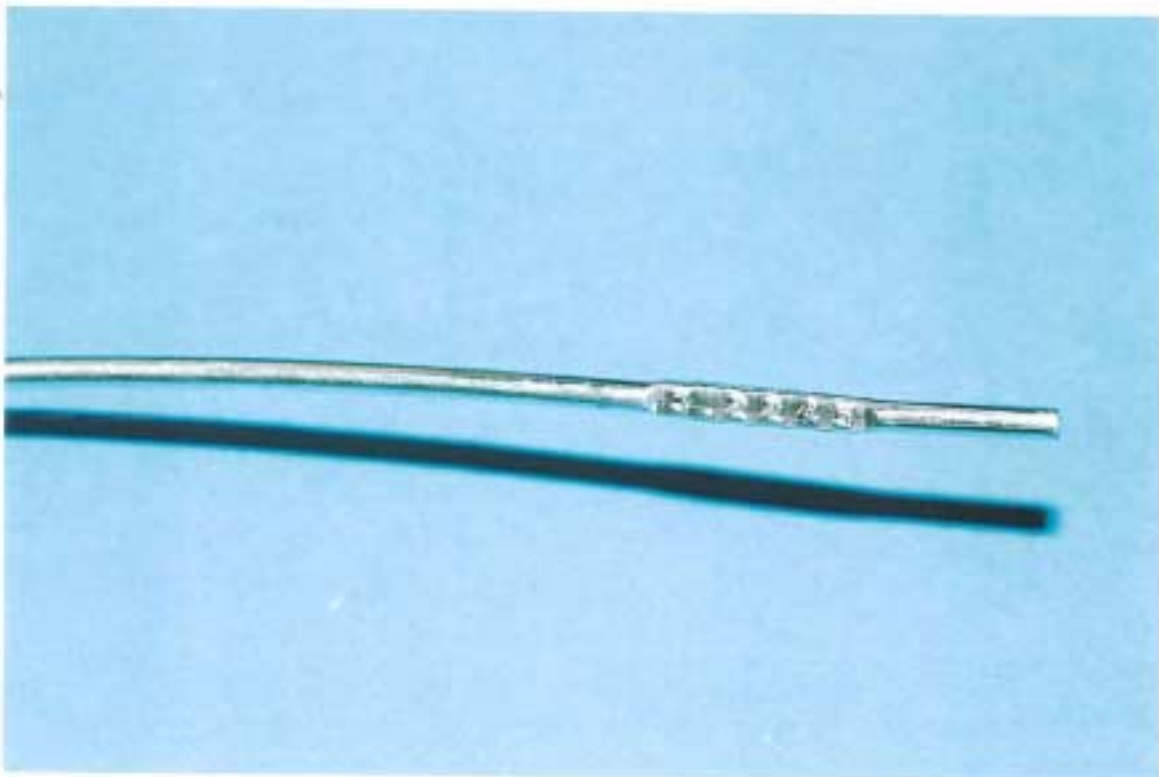
Figure 4: Embossed number sequence apparent at the opposite welding consumable wire ends.

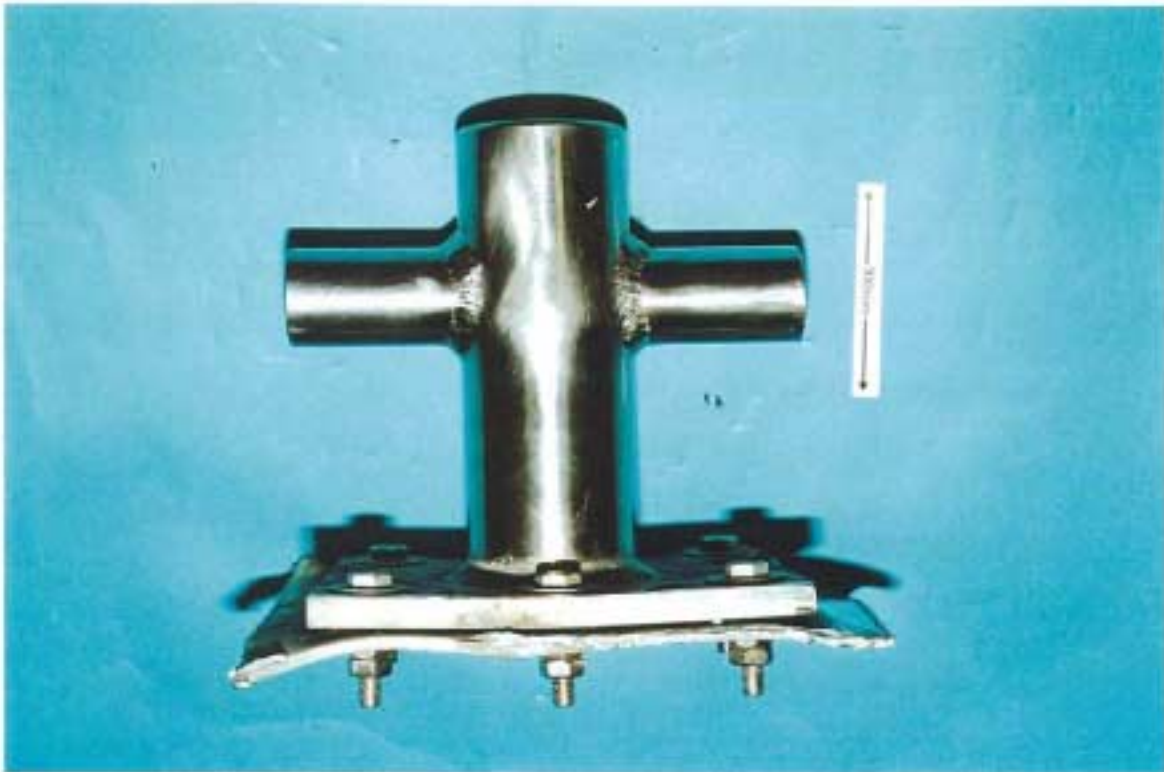
The inboard insert plate edge appeared to have only been welded at the forward end. Fracture had occurred through the throat (the shortest distance from the weld root to the weld face or cap) of the weld length present, and though the plate had been restrained at both inboard corners, significant upwards deformation was apparent (figures 9 and 10). The outboard edge was fully welded and fracture had occurred through the throat of the full weld length. In the case of this edge, fracture was accompanied by upward deformation around the forward bolt hole and severe downwards indenting of the bollard base into the insert plates aft outboard corner (figures 11, 12 and 13). The forward edge exhibited evidence of welding along its full length, and fracture had again occurred through the throat of the full weld length. The weld fracture at this plate edge was accompanied by upward deformation of the plate around both bolt holes (figures 14 and 15). The aft plate edge exhibited evidence of a weld along its full length, and fracture yet again had propagated through the throat of the full weld length. The deformation at this plate edge was upwardly directed at the inboard corner bolt hole, in contrast with the outboard corner, which exhibited downwards indenting of the bollard base into the insert plates outboard corner (figures 16 and 17).

Figure 9: Bollard and insert plate viewed from inboard side.

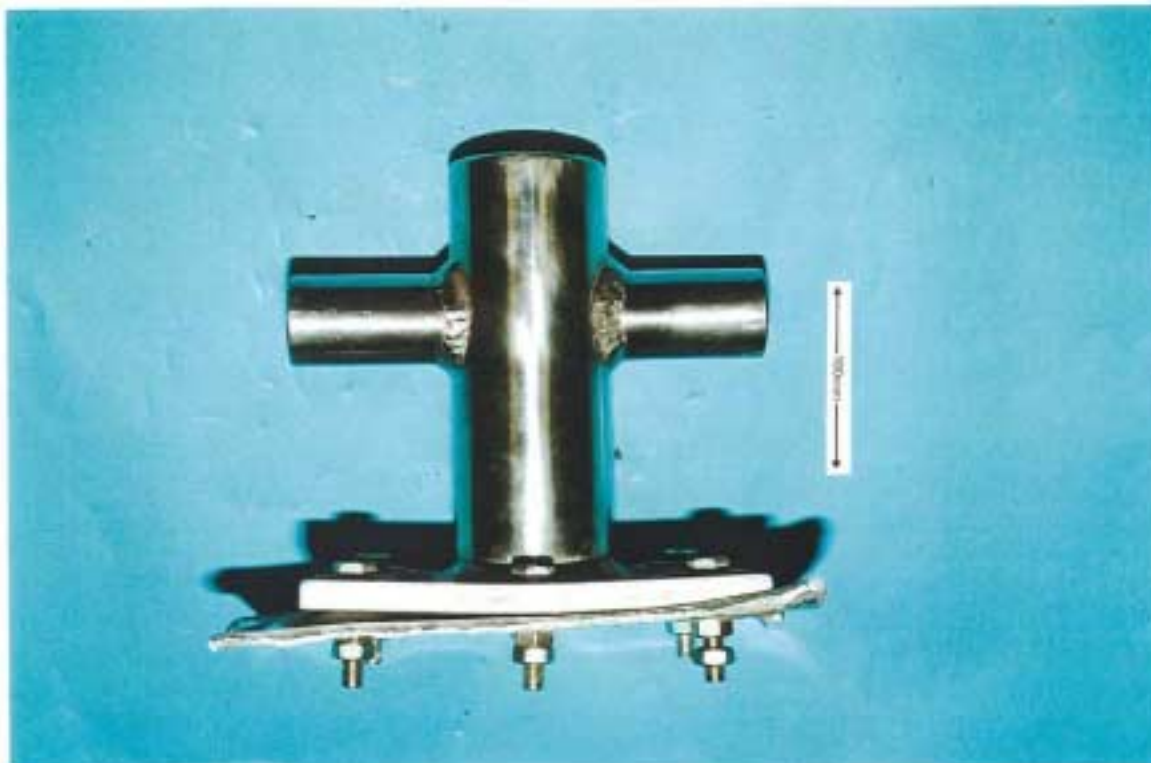
Figure 11: Bollard and insert plate viewed from outboard side.

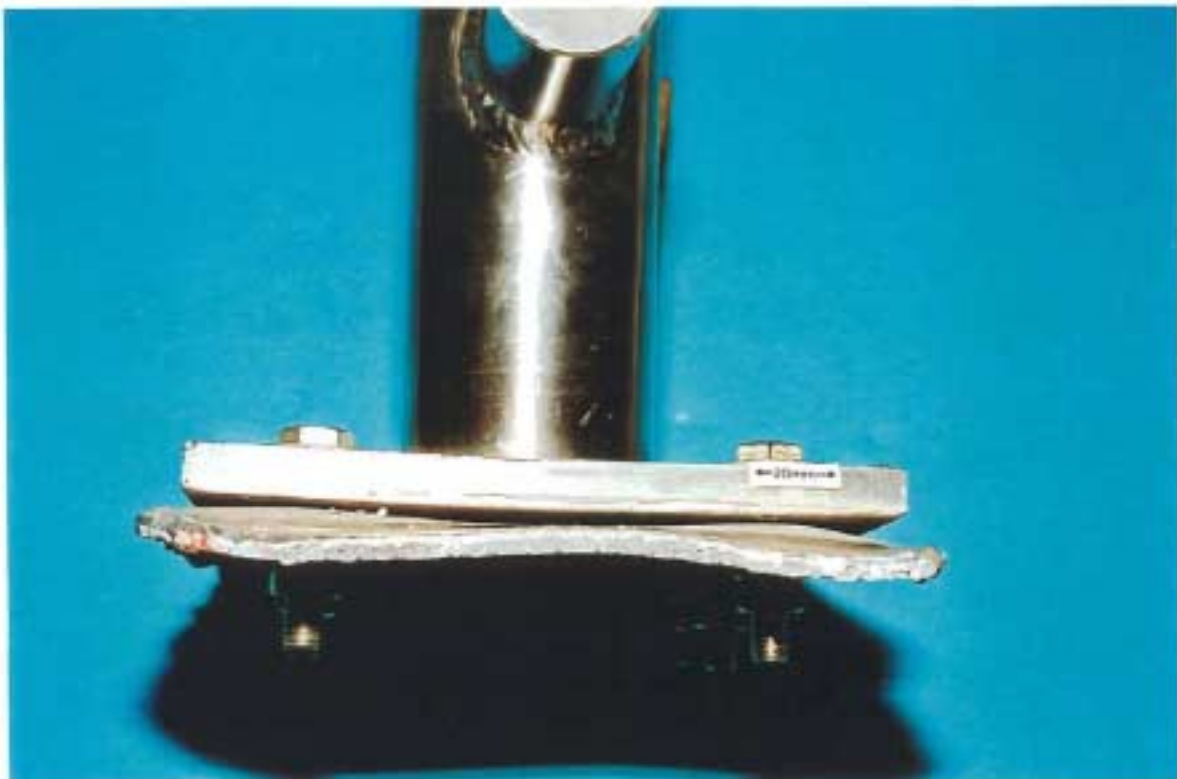
Figure 14: Bollard and insert plate viewed from forward end.

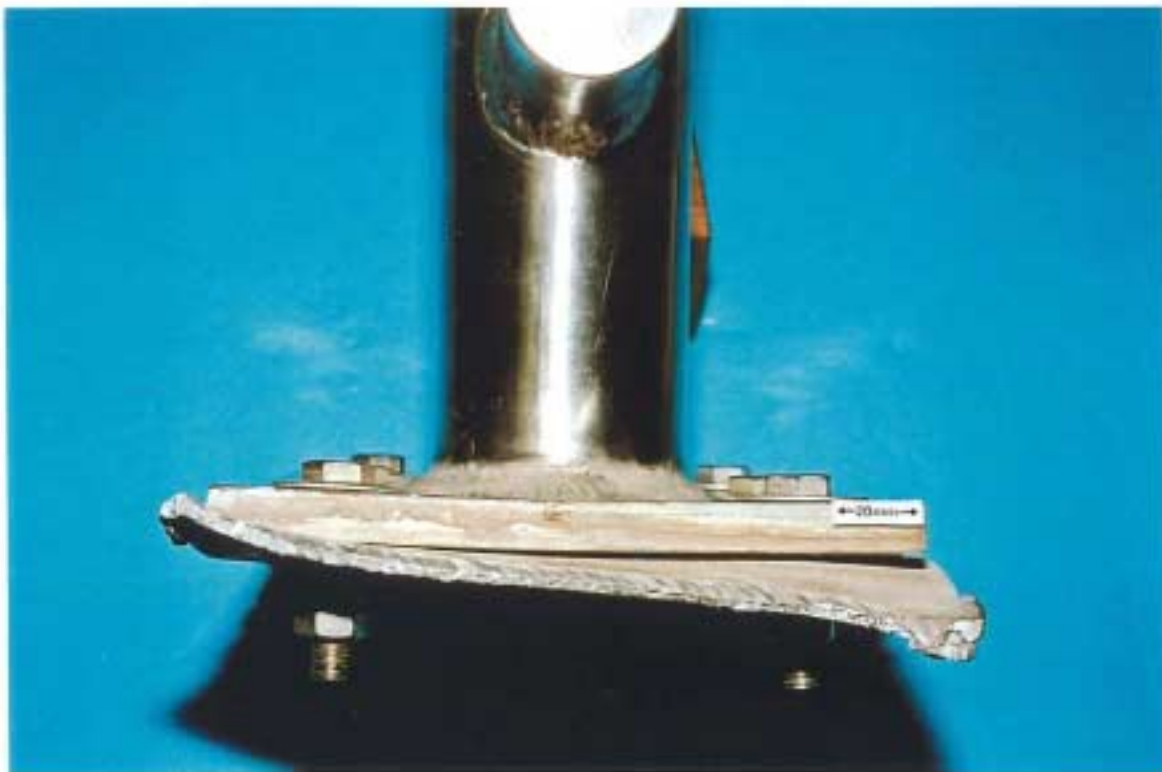
Figure 16: Bollard and insert plate viewed from aft end.

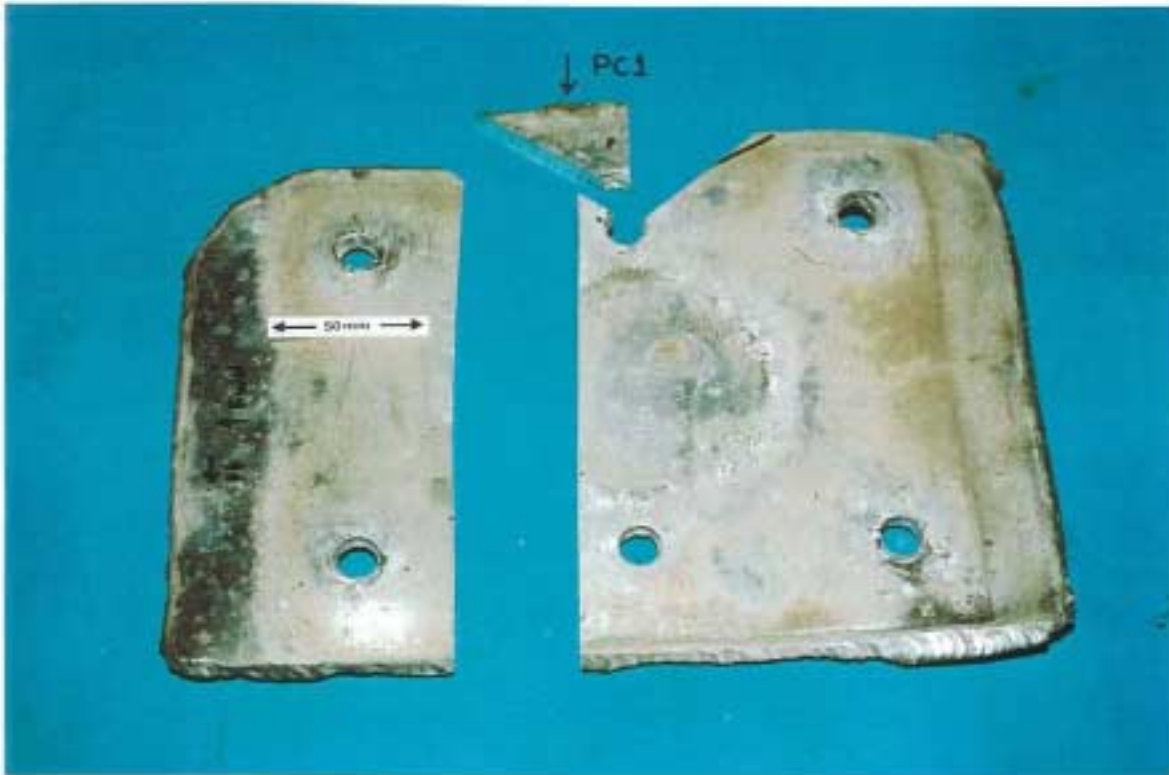
A section of the fractured inboard weld side (PC1) was removed from the insert plate edge (figure 27). Three similar samples (PC2, PC3 and PC4) were removed from the forward, outboard and aft weld sections of the underside fracture half respectively (figure 28). The sample set was ultrasonically cleaned in acetone and subsequently examined via a Scanning Electron Microscope (SEM). Characteristic features and defects identified during the examination were as follows.

Figure 27: Sample (PC1) removed from inboard weld side and which was subjected to detailed examination.

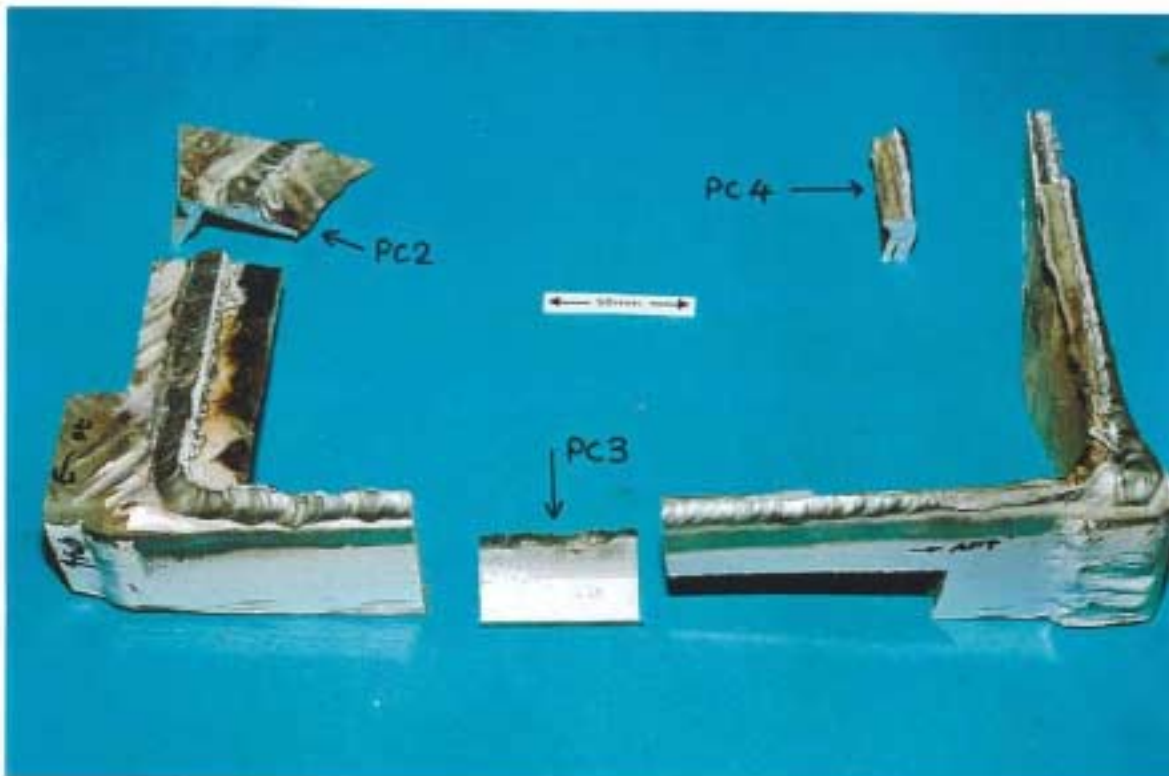
Figure 28: Samples (PC2, PC3 and PC4) from the forward, outboard and aft weld sides, and which were subjected to detailed examination.

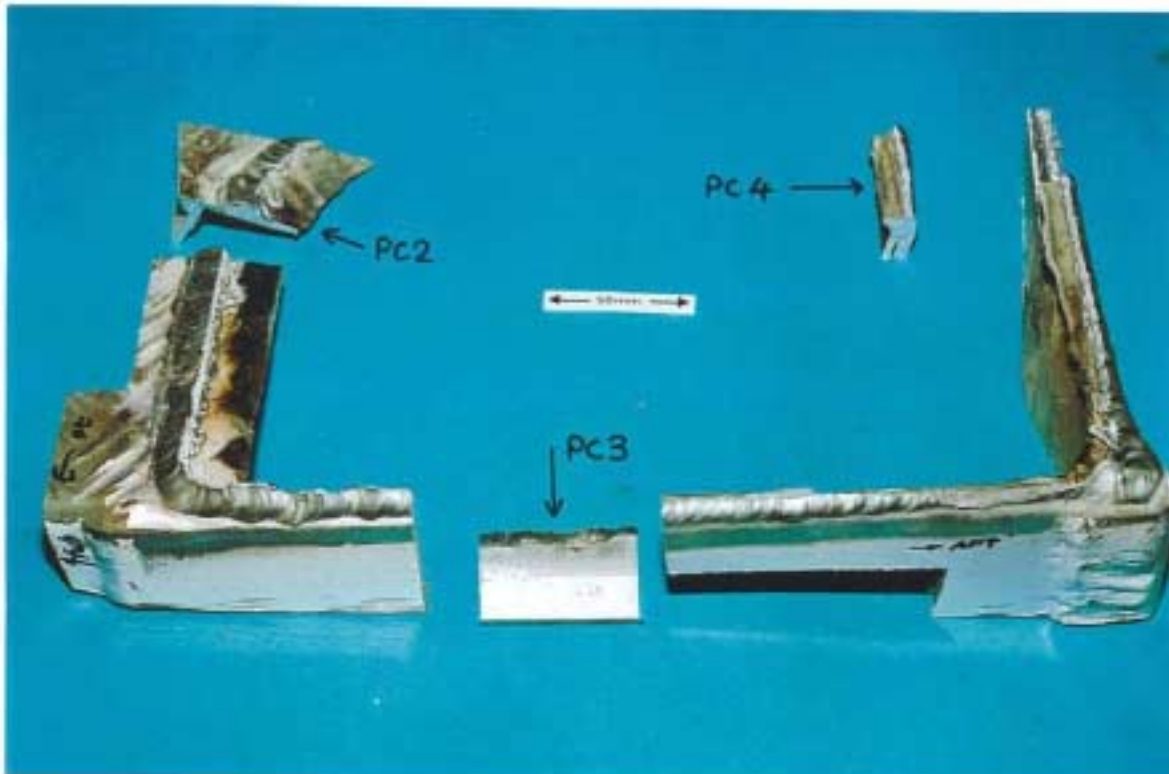
Figure 28: Samples (PC2, PC3 and PC4) from the forward, outboard and aft weld sides, and which were subjected to detailed examination.

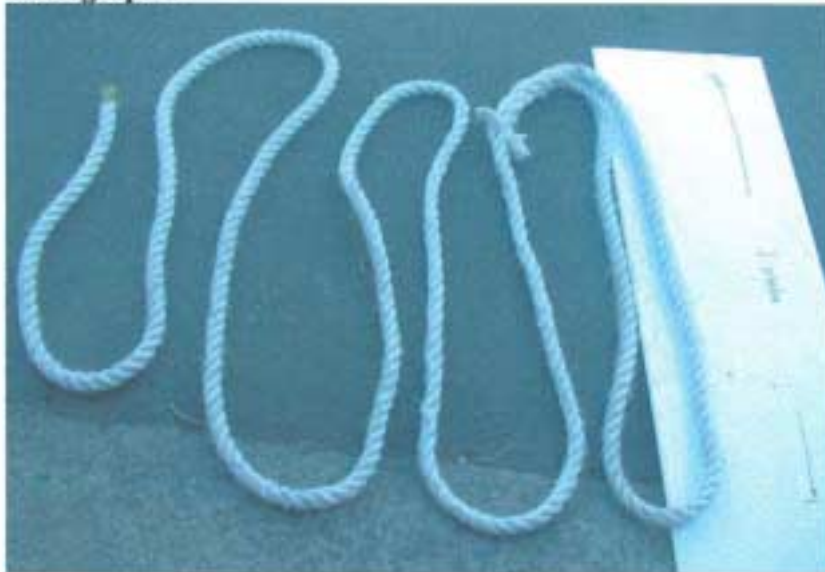
**Photograph 1**

Photograph 1 shows the rope as received at TTI premises in Arbroath. The rope specification was provided by MAIB[ Annexe 1], being stated to be a 24 mm diameter 3-strand construction, of polypropylene spun staple fibre yarns.

According to BS EN 699:1995 '*Fibre ropes for general service-Polypropylene*' this rope is defined as a '3-strand hawser laid polypropylene rope [Type A]'.

From Table 1 of the Standard, a 24 mm diameter rope will have a Minimum Breaking Force of 7970 daN, 8.12 tonnef.

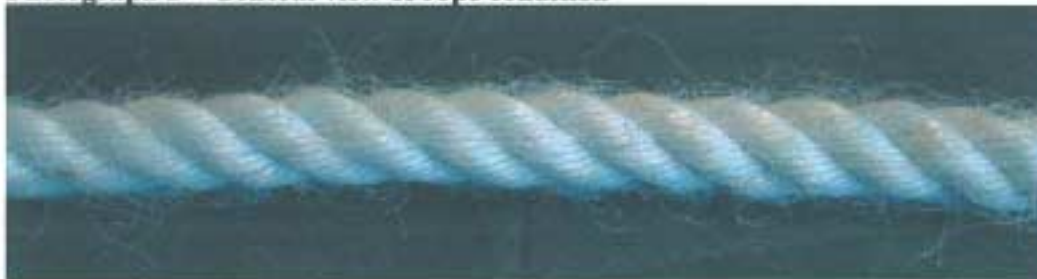
The assembly appeared in good condition, Photograph 2 showing a view of the rope used in the assembly. Photograph 3 is a view of the eye, showing minor abrasion to its inner face, where it has been in contact with bollards or other mooring devices.

**Photograph 2 General view of rope condition**

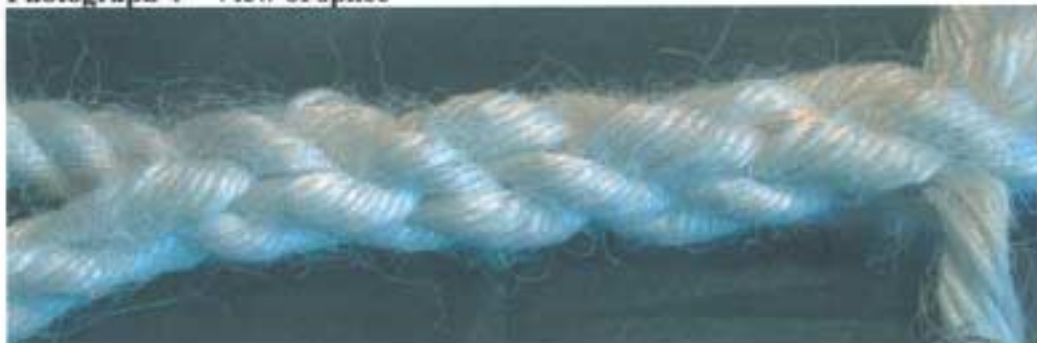
Photograph 4 shows the splice used to create the single eye, and Photograph 5 shows the one minor problem seen in the 'rope part' of the assembly, a raised loop, maybe caused by the rope catching on an object.

**Photograph 4 View of splice**

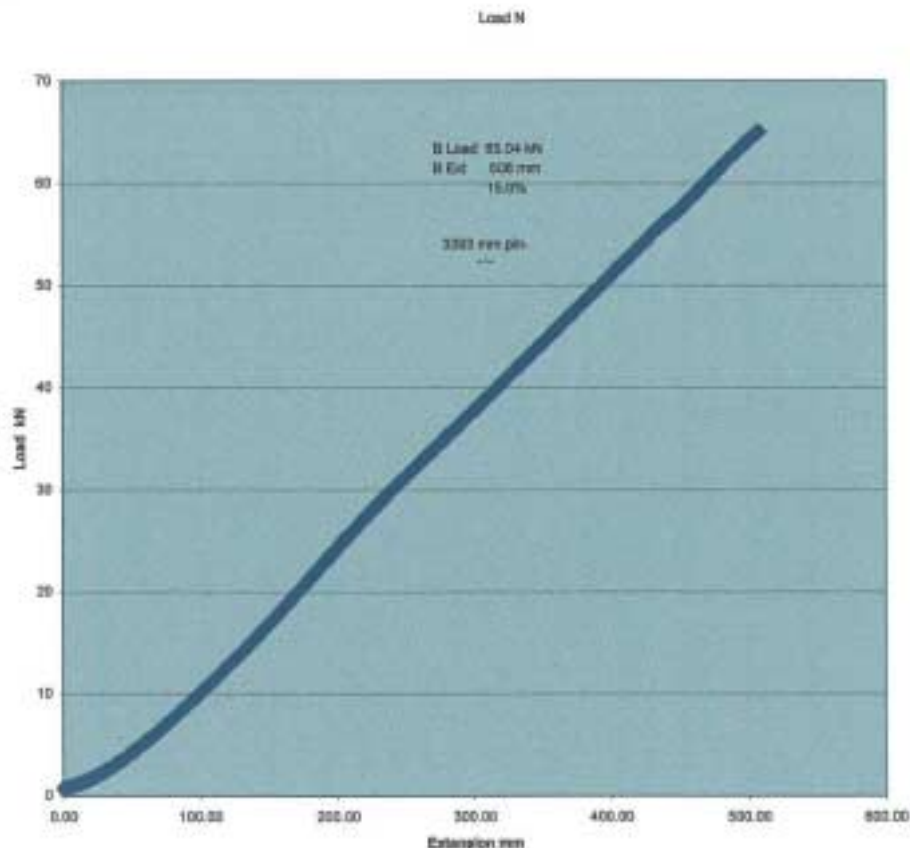
The breaking strength was found to be 65kN, and with an elongation to break of 15%. This is less than the new strength which should have been in circa 80 kN, representing a loss of 18%.

**Figure 2 Load/ mm extension curve for final pull to destruction of strop**

The Breaking Load was 65.04 kN, 6.63 tonnef.  
 The Breaking Extension was 508 mm, 14.97%

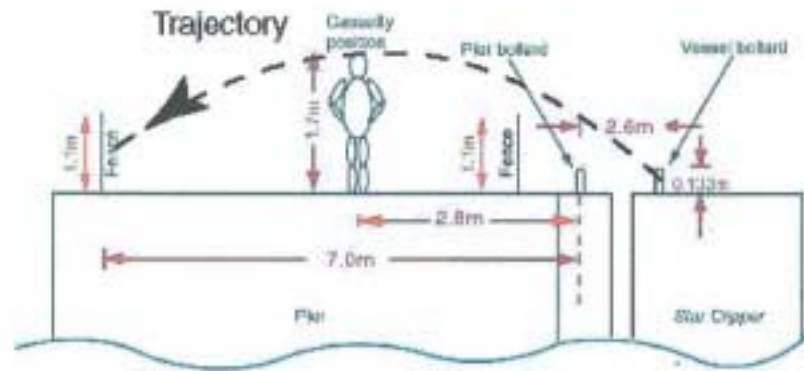
Figure 3 General view of accident scene, in plane of flight of bollard

The trajectory of the bollard is broadly known, as illustrated by Figure 3. The bollard was ripped out from the vessel deck and flew upwards to strike the victim's head. The bollard continued and is believed to have hit the far fence. Since the fence is 1.1 m high and the victim was struck at a height of 1.7m, the bollard descended after striking the victim.

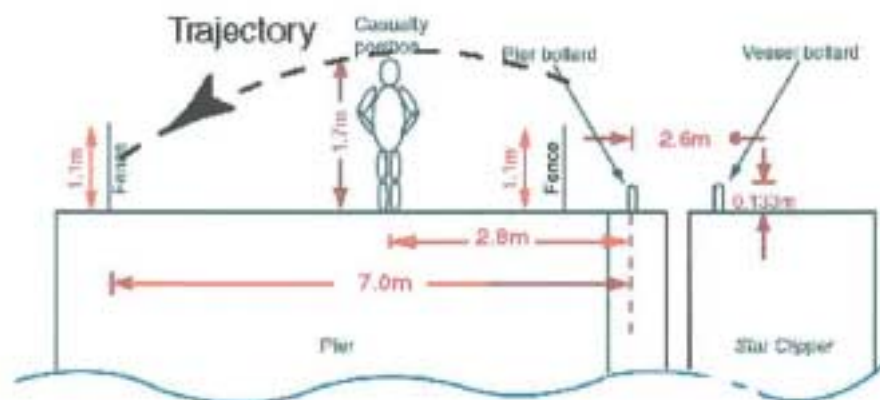
There are many alternatives that give very different input energies. For example if the bollard had hit the first fence on a diagonal strut and then bounced up, with the rope wrapping around the first fence the action would have been similar to the bowling of a cricket ball. This straighter trajectory would have caused the bollard to hit both the victim and the far fence with a significantly higher velocity. This is illustrated in Figure 7.

Figure 7 Trajectory Starting above Second Bollard

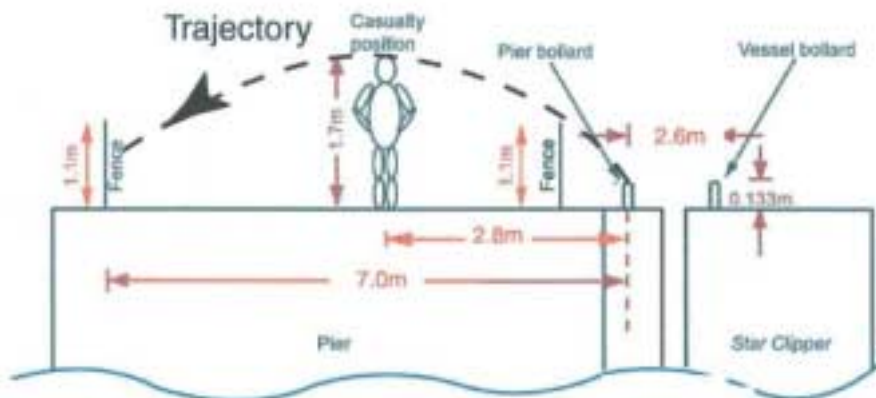
Figure 8 - Trajectory Starting at Second Bollard

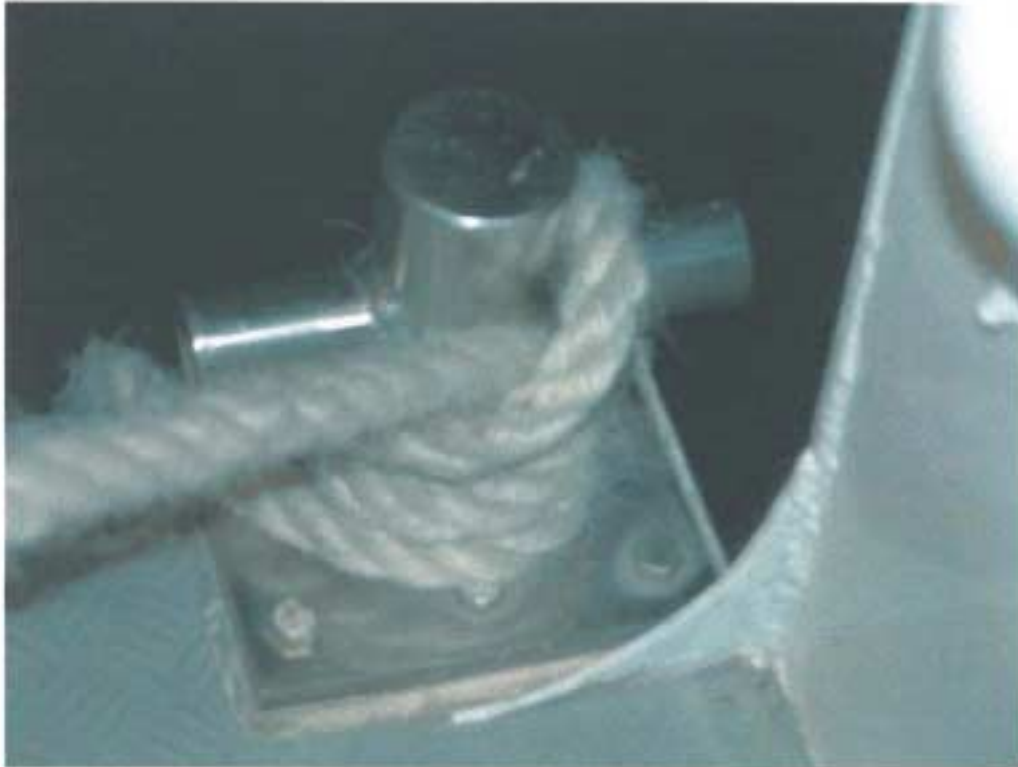
After the accident, the rope was found detached but near the final position of the ship's bollard. An explanation as to the mechanism that allowed it to become detached is as follows. The rope will remain tight on the bollard so long as it is under tension. When the tension is released the pressure on the tuck is relieved and the rope becomes loose and able to slip off the bollard. Photograph 10 shows an example of a bollard and the rope attachment method used.

The mooring rope used is quite light in relation to the forces that could be imposed on it. Clearly the bollard should have been able to withstand the mooring force, but had it been stronger, the installed rope could have become overloaded and broken. The energy of lash back is extremely high and, even without the mass of the ship's bollard, breaking ropes alone can cause fatal injuries.

Photograph 10 – Rope Reeved to Bollard [ courtesy of MAIB]
