Report of the investigation

***KINGFISHER II***

5 miles east of North Uist

**Report No 15/2004  
November 2004**

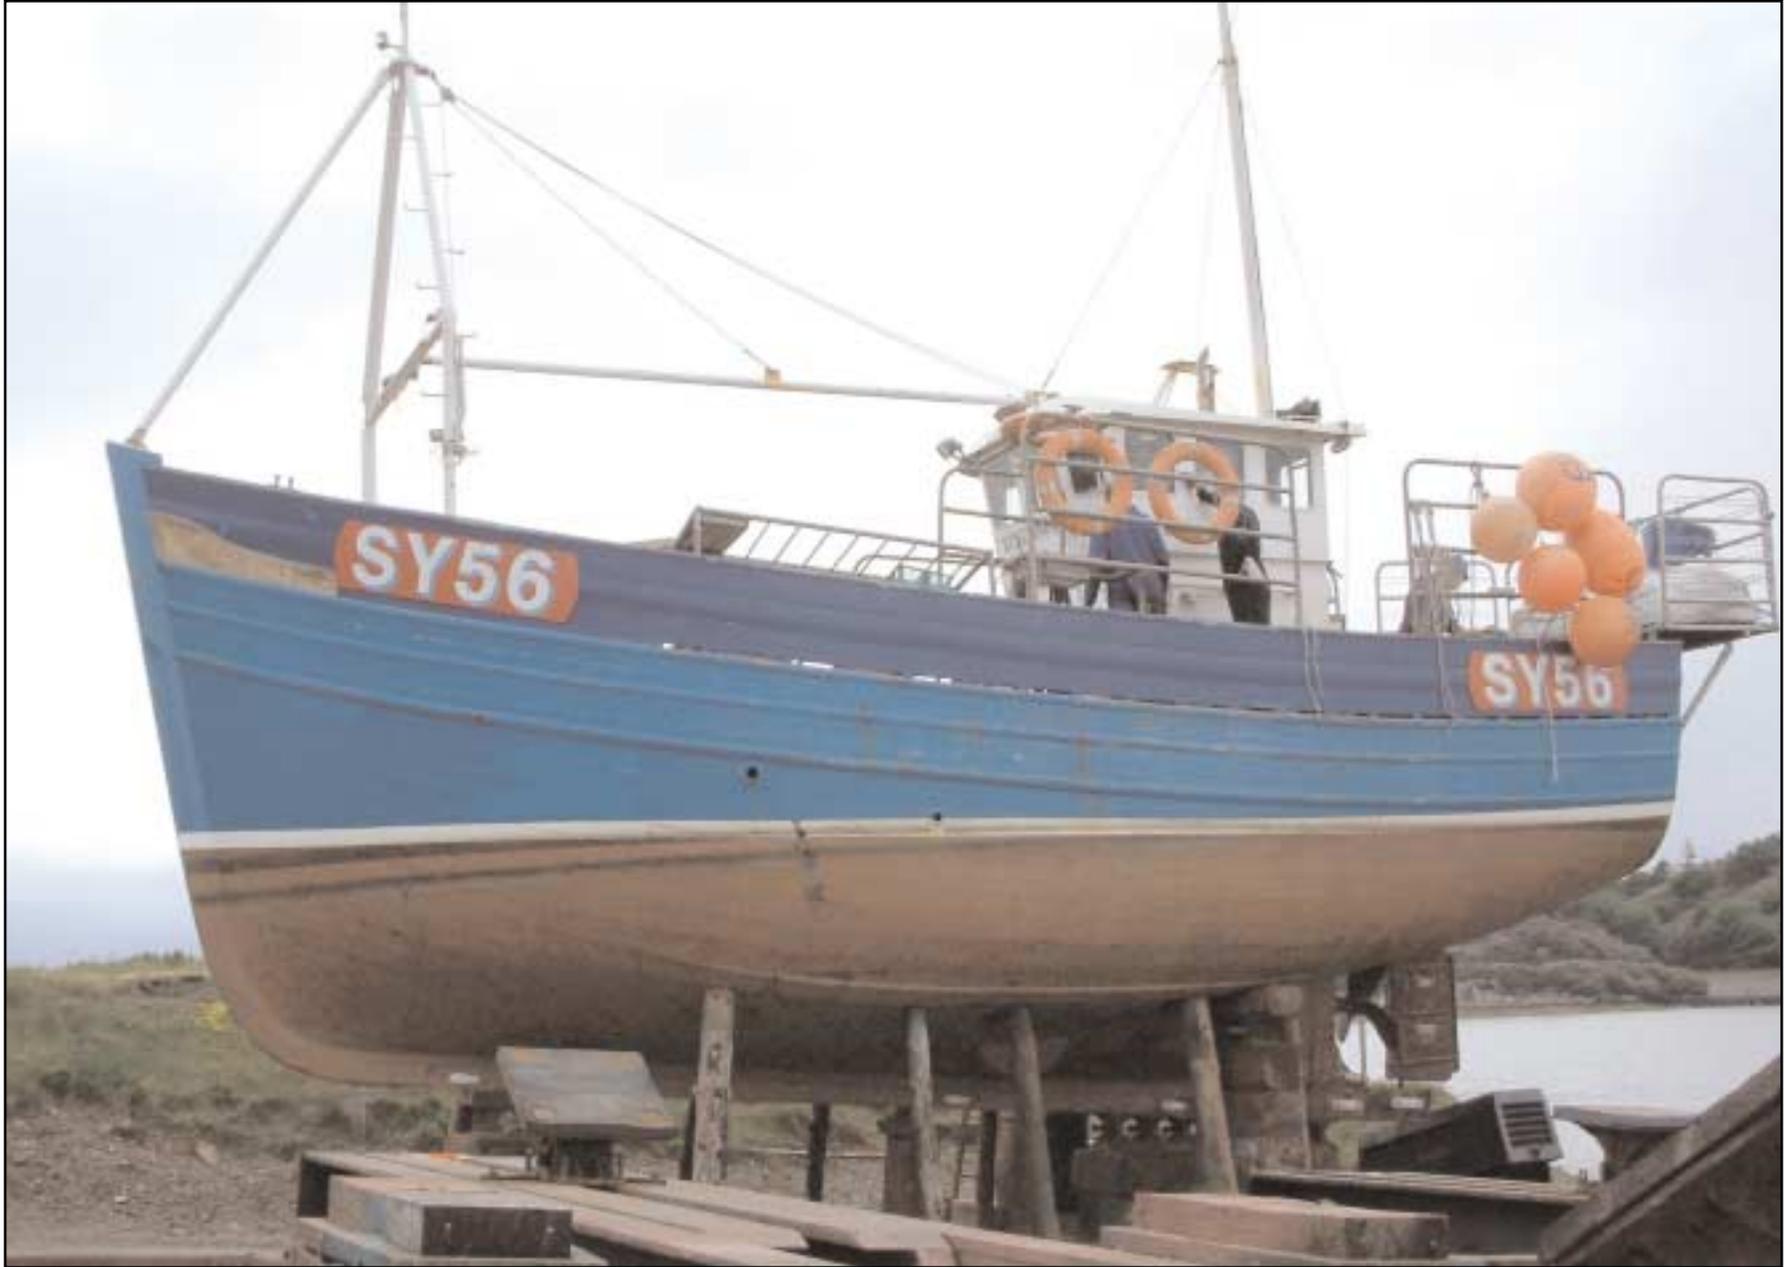
Port side view of the vessel on the slipway at Stornoway

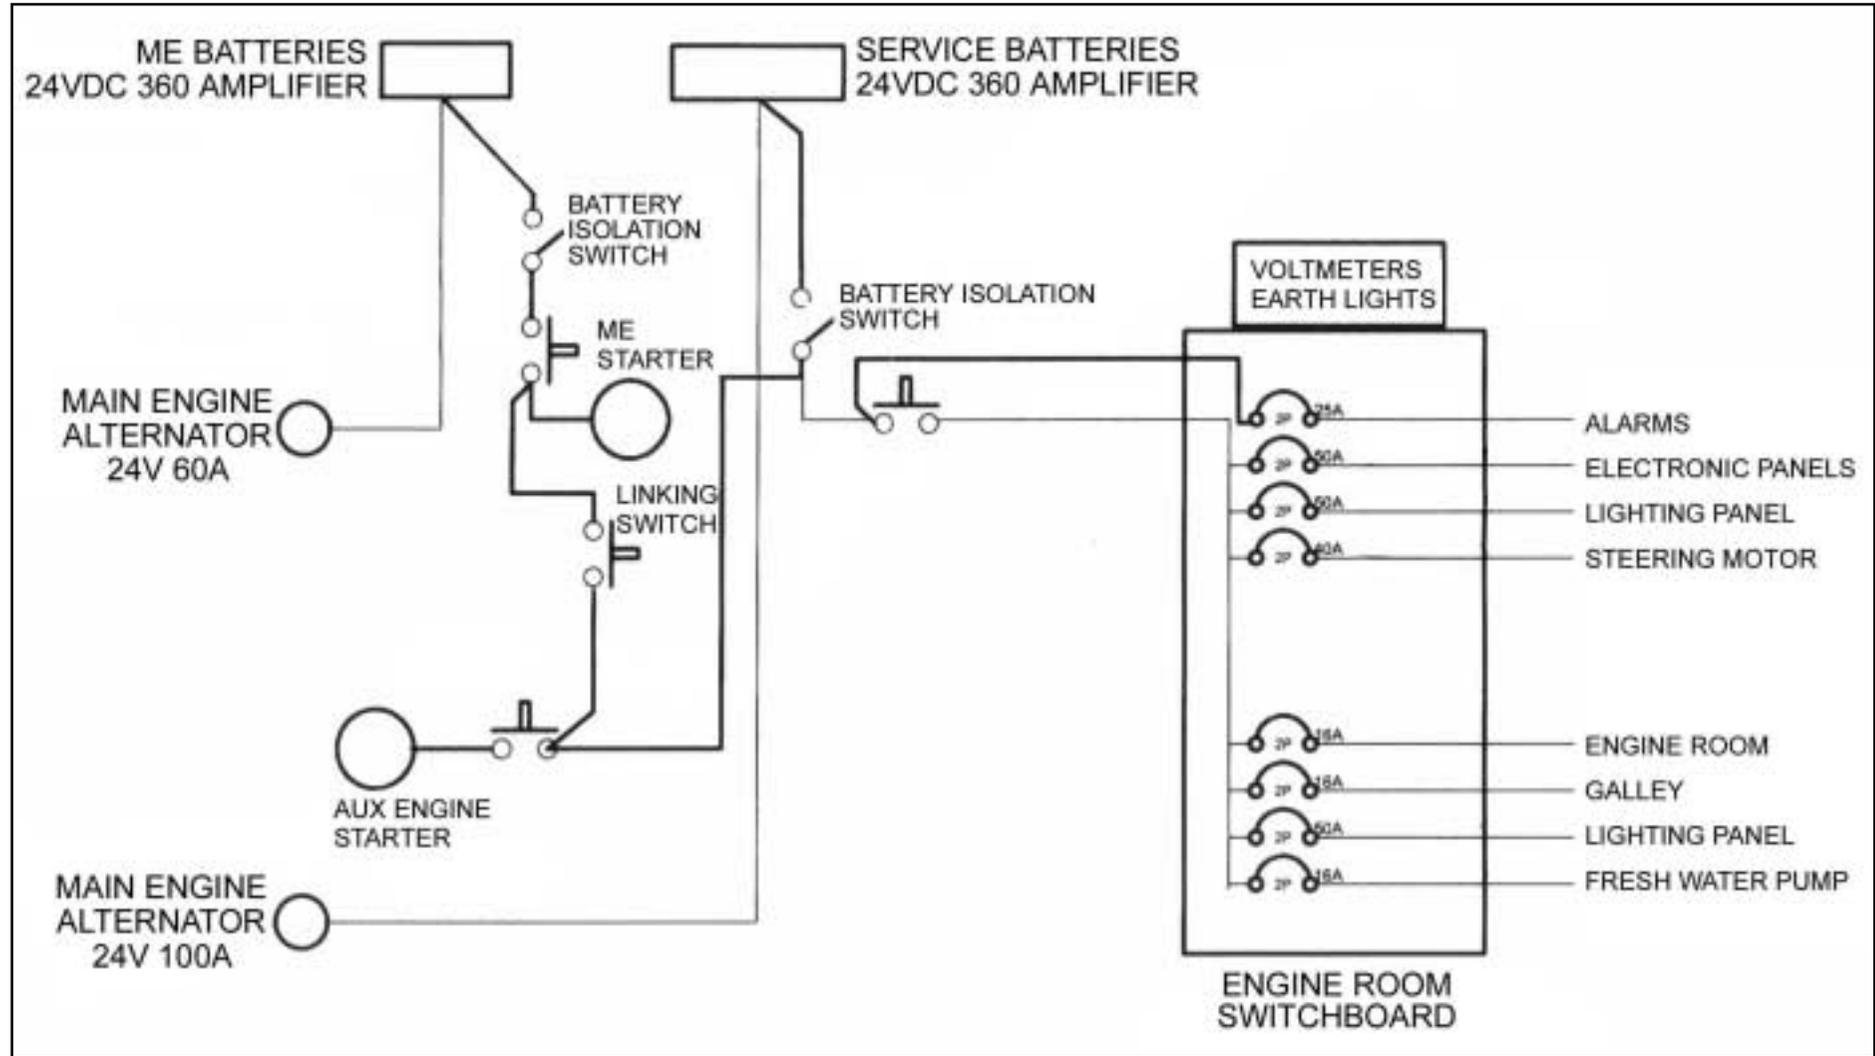
No original electrical circuit drawings are available from either the owner or from any of the electrical contractors who had completed work prior to the fire. A drawing of the replacement system, which is considered to be very similar to the original configuration, is at **Figure 11**.

*Kingfisher II* is fitted with a main engine-driven alternator, and a main engine belt-driven “transmotor”. The output from these units is 24 volts, 100 amps and 24 volts, 60 amps respectively. The alternator is configured to charge the service batteries which then provide power to the vessel’s services through a battery isolation switch and fused distribution panel situated on the after bulkhead of the engine room. A further set of switches is located in the wheelhouse. These control individual services. The service batteries are also used to start the auxiliary engine under normal circumstances.

Electrical charging and distribution system

The “transmotor” is used to charge the main engine batteries, which are configured to start the main engine through a battery isolation switch.
