Report of the investigation

KINGFISHER II

on 26 April 2004

**Report No 15/2004
November 2004**

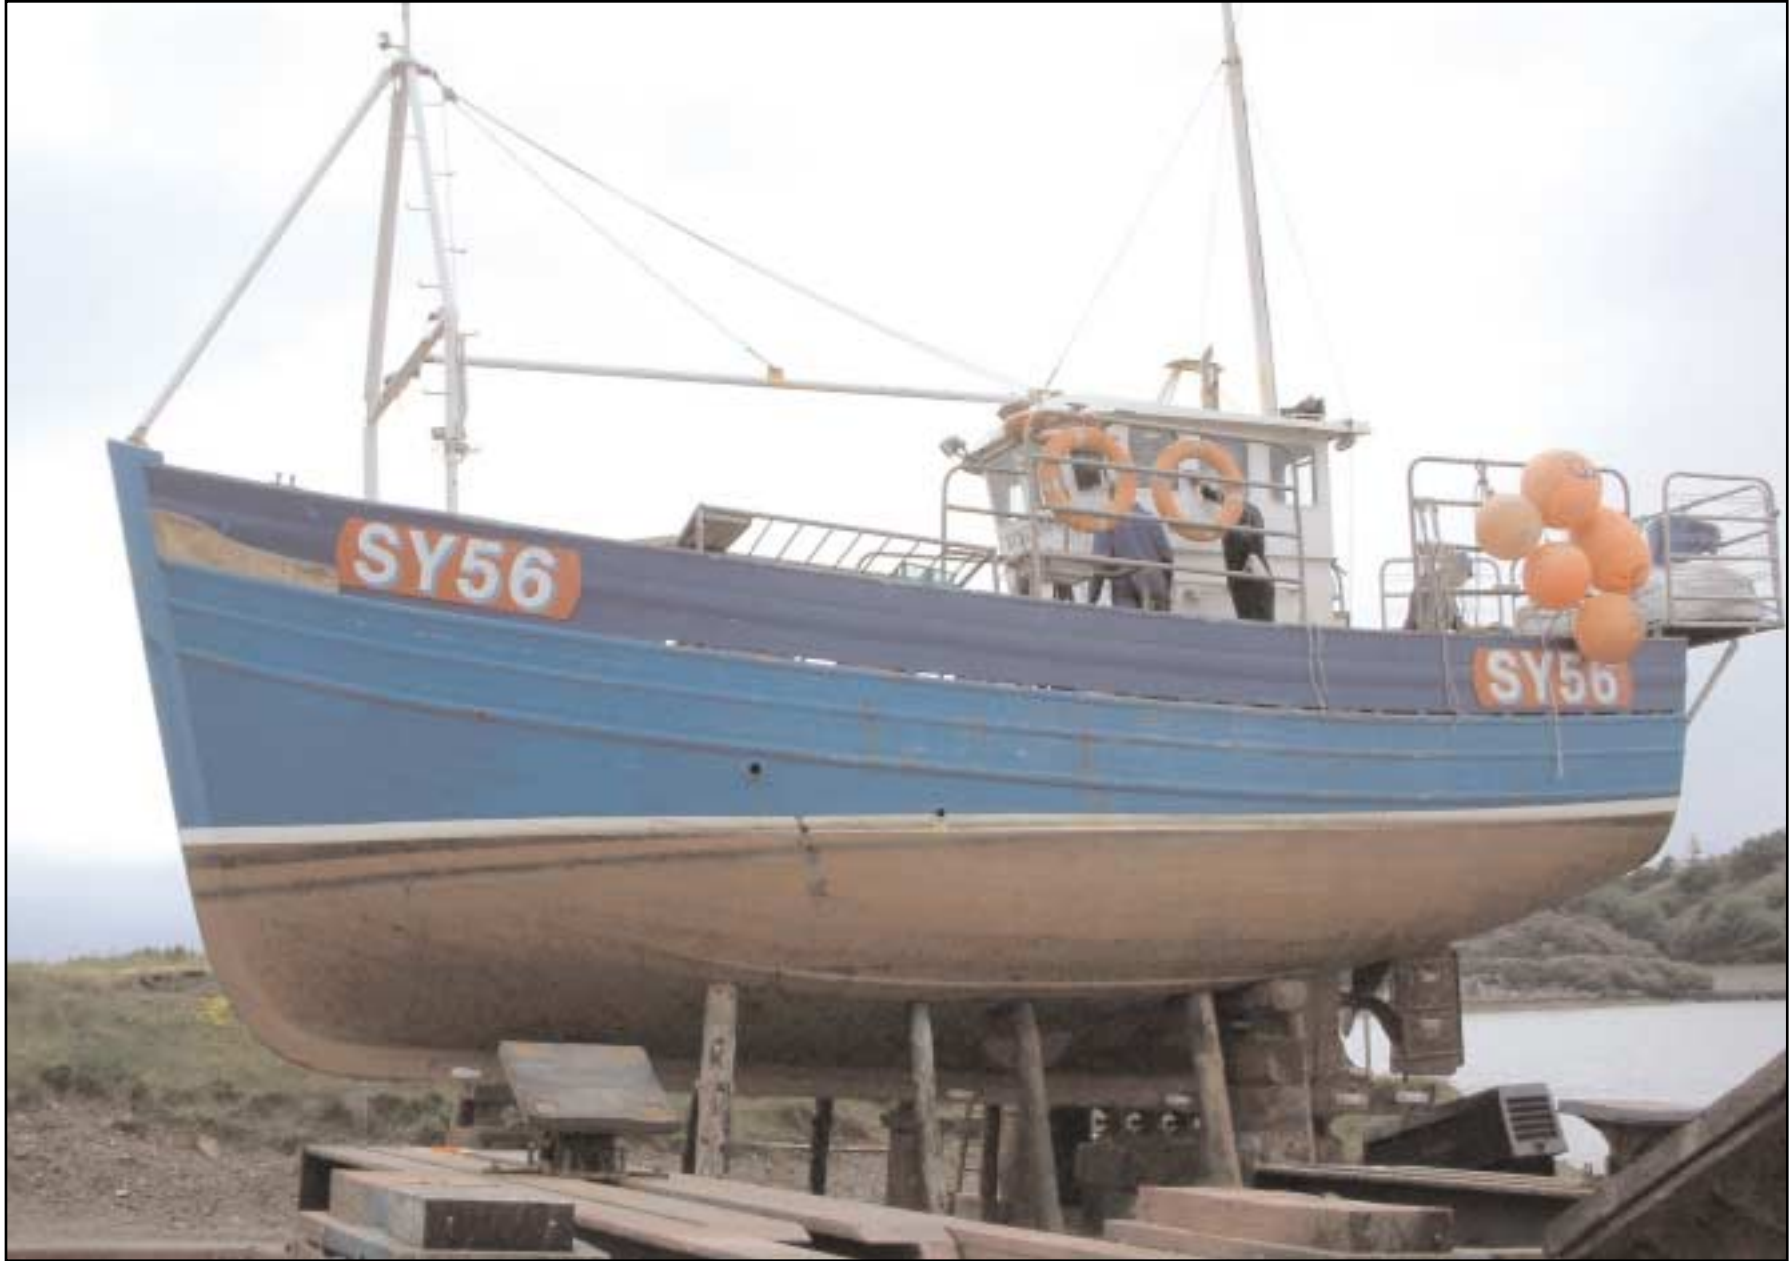
Port side view of the vessel on the slipway at Stornoway

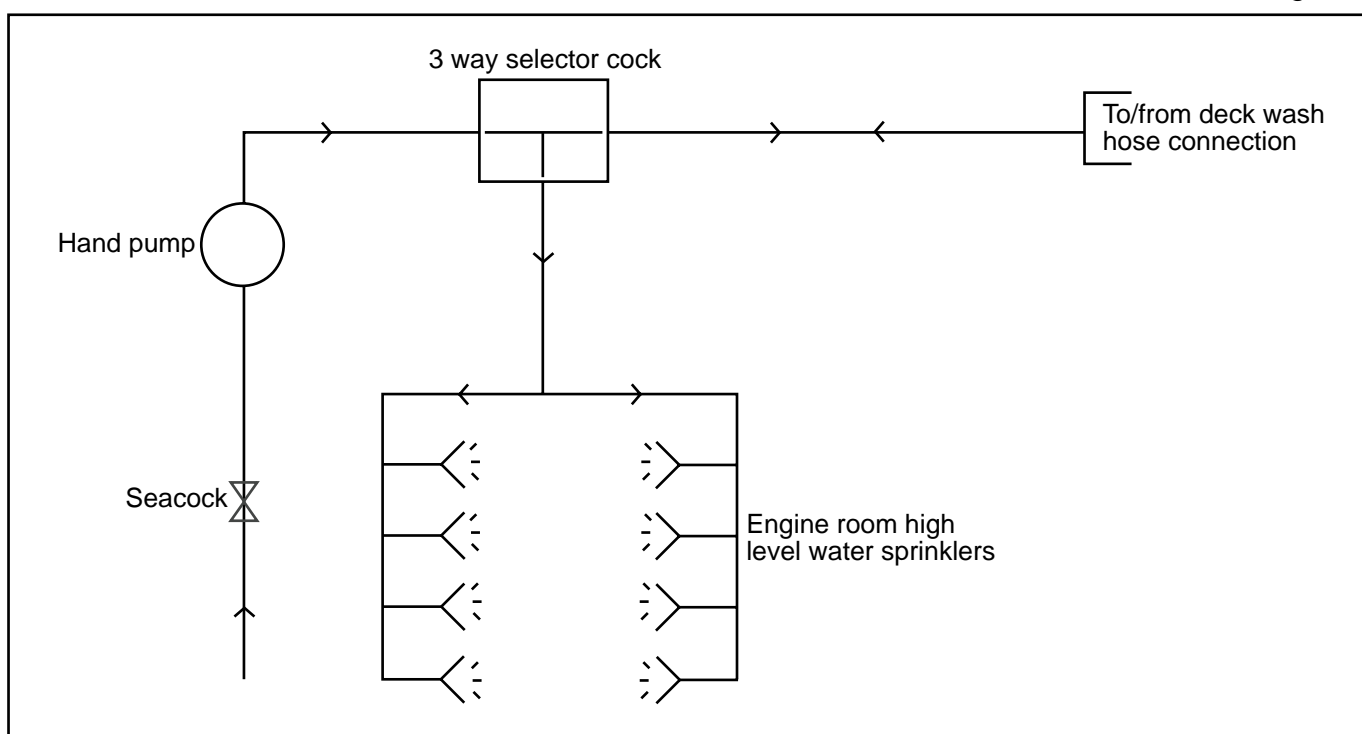
Figure 9

A water sprinkler system is fitted throughout the engine room. The deck wash hand-pump, situated externally on the wheelhouse after bulkhead, provides sea water to the system. The pump takes its suction through a section of flexible corrugated pipe and a sea cock situated in the dry provisions store of the steering gear compartment. A selector cock at the pump discharge allows water to be discharged to the deck wash outlet, or to the engine room sprinkler system. Water can also be provided from the deck wash outlet to the engine room sprinklers. The system and selector cock arrangement is shown at **Figures 9 and 10** respectively.

Deck wash and engine room high level sprinkler arrangement

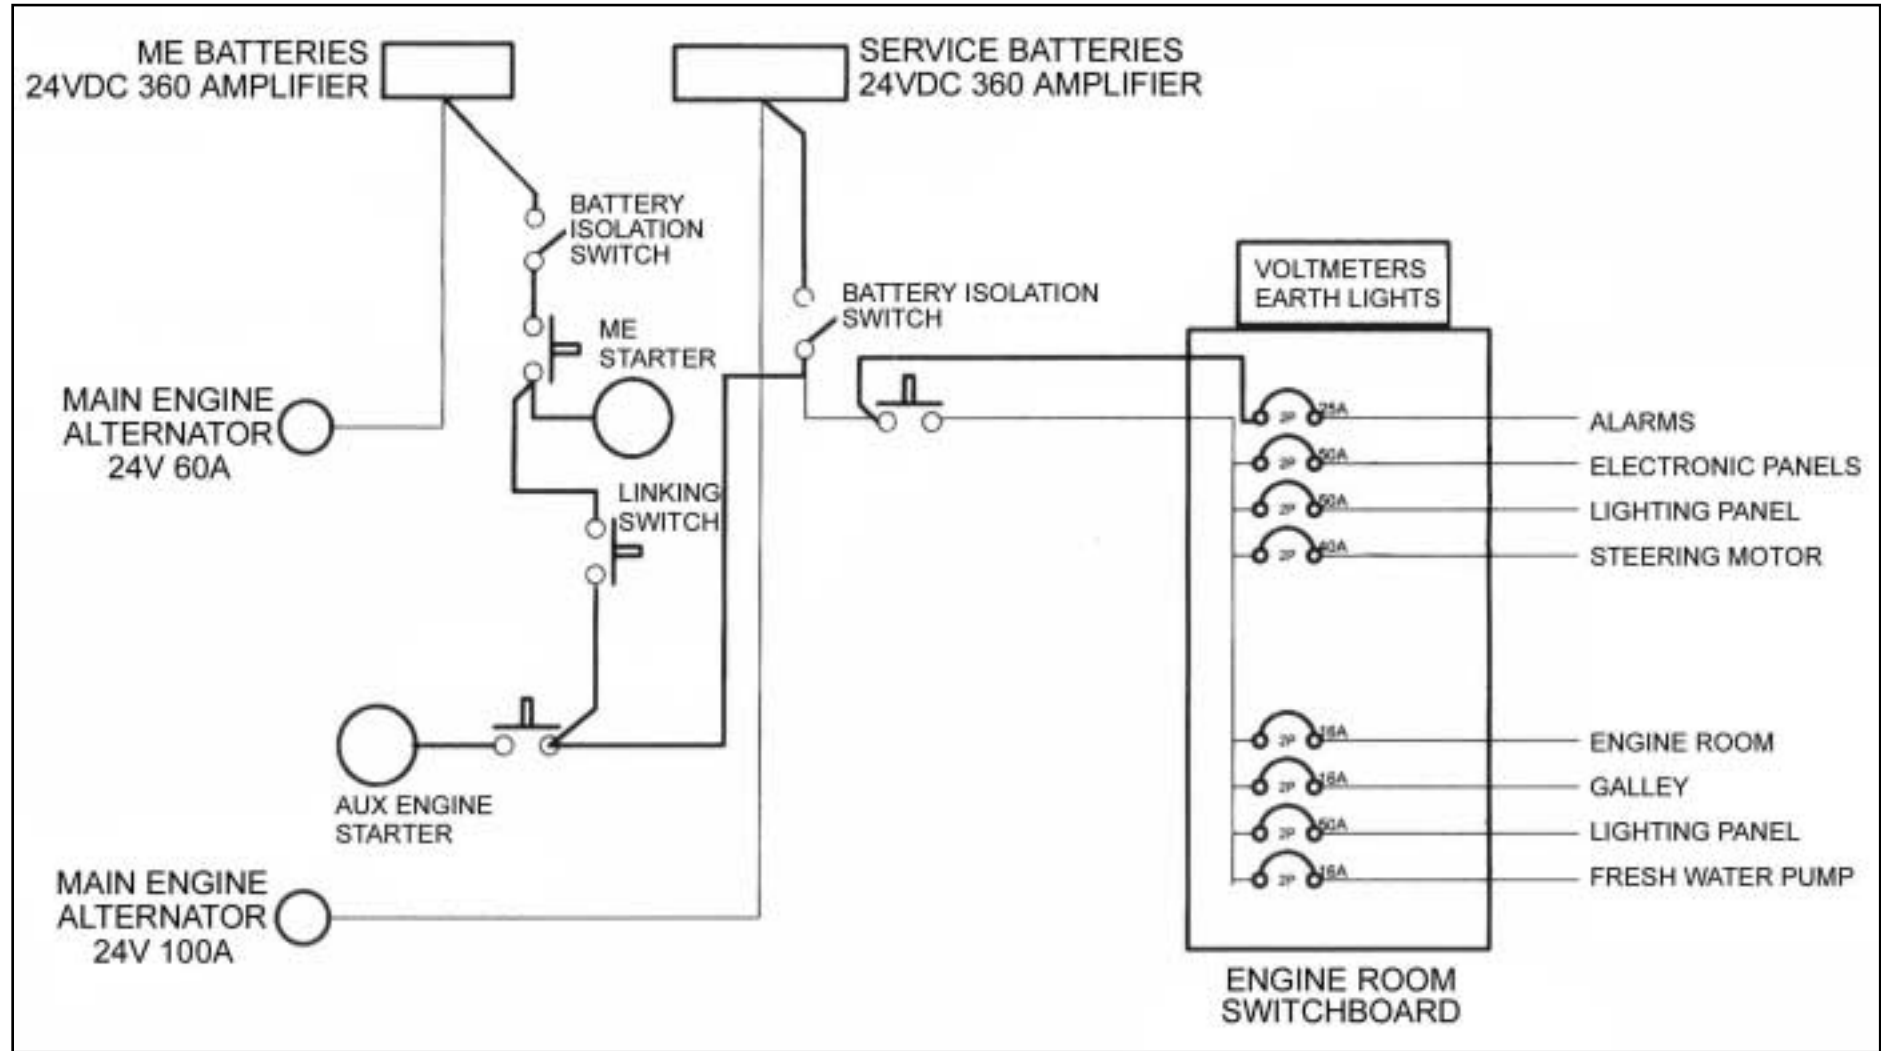
No original electrical circuit drawings are available from either the owner or from any of the electrical contractors who had completed work prior to the fire. A drawing of the replacement system, which is considered to be very similar to the original configuration, is at **Figure 11**.

Kingfisher II is fitted with a main engine-driven alternator, and a main engine belt-driven “transmotor”. The output from these units is 24 volts, 100 amps and 24 volts, 60 amps respectively. The alternator is configured to charge the service batteries which then provide power to the vessel’s services through a battery isolation switch and fused distribution panel situated on the after bulkhead of the engine room. A further set of switches is located in the wheelhouse. These control individual services. The service batteries are also used to start the auxiliary engine under normal circumstances.

Electrical charging and distribution system
