Report on the investigation of
the injury to person on
Dart 8
while berthing at Europort Terminal, River Thames
on
21 March 2004

Marine Accident Investigation Branch
First Floor
Carlton House
Carlton Place
Southampton
United Kingdom
SO15 2DZ

**Report No 12/2004
September 2004**

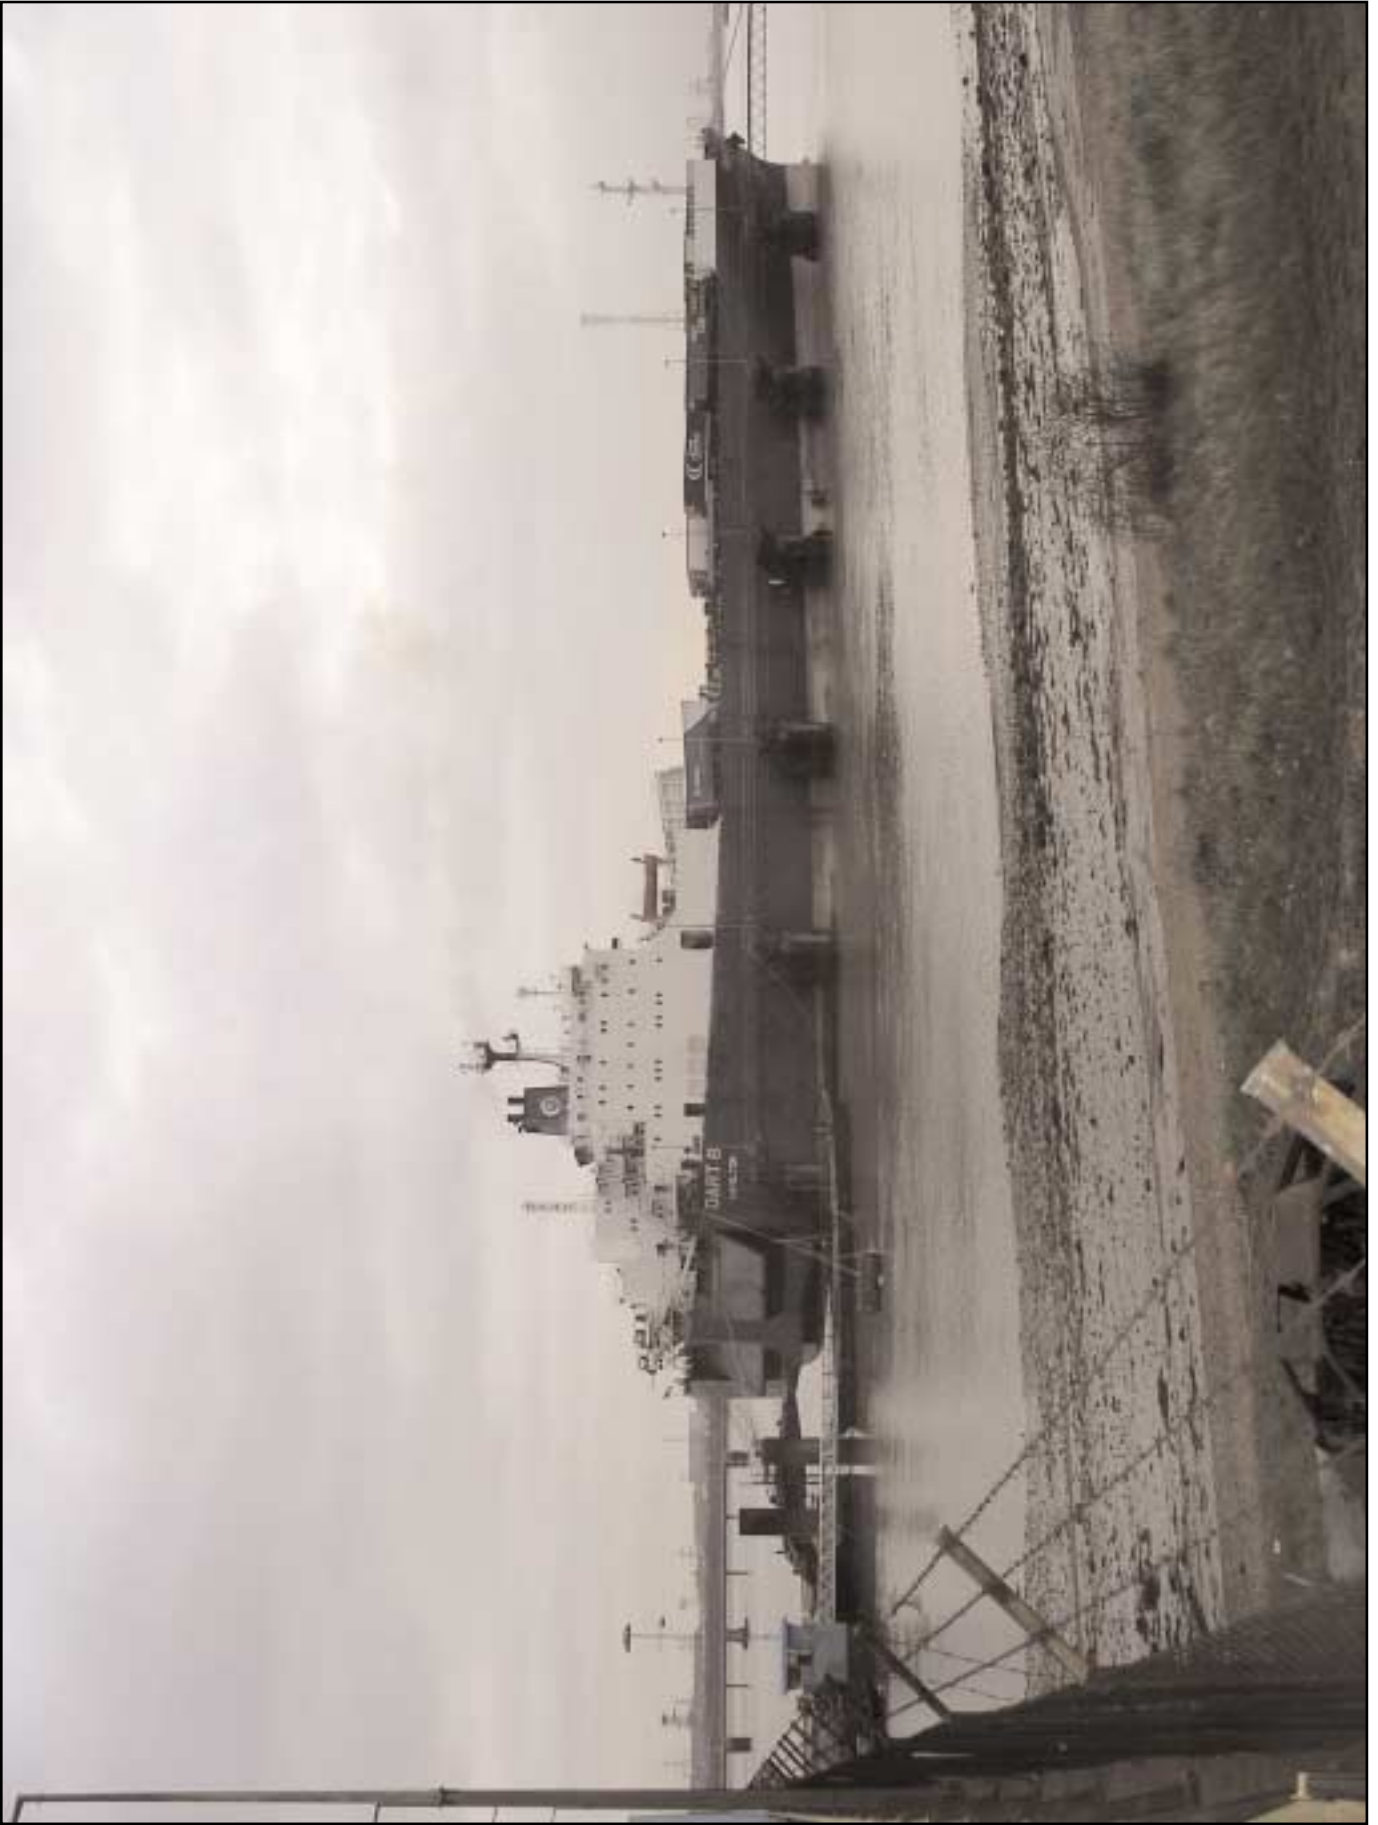
Figure 1

Dart 8

Vessel details (See Figure 1)

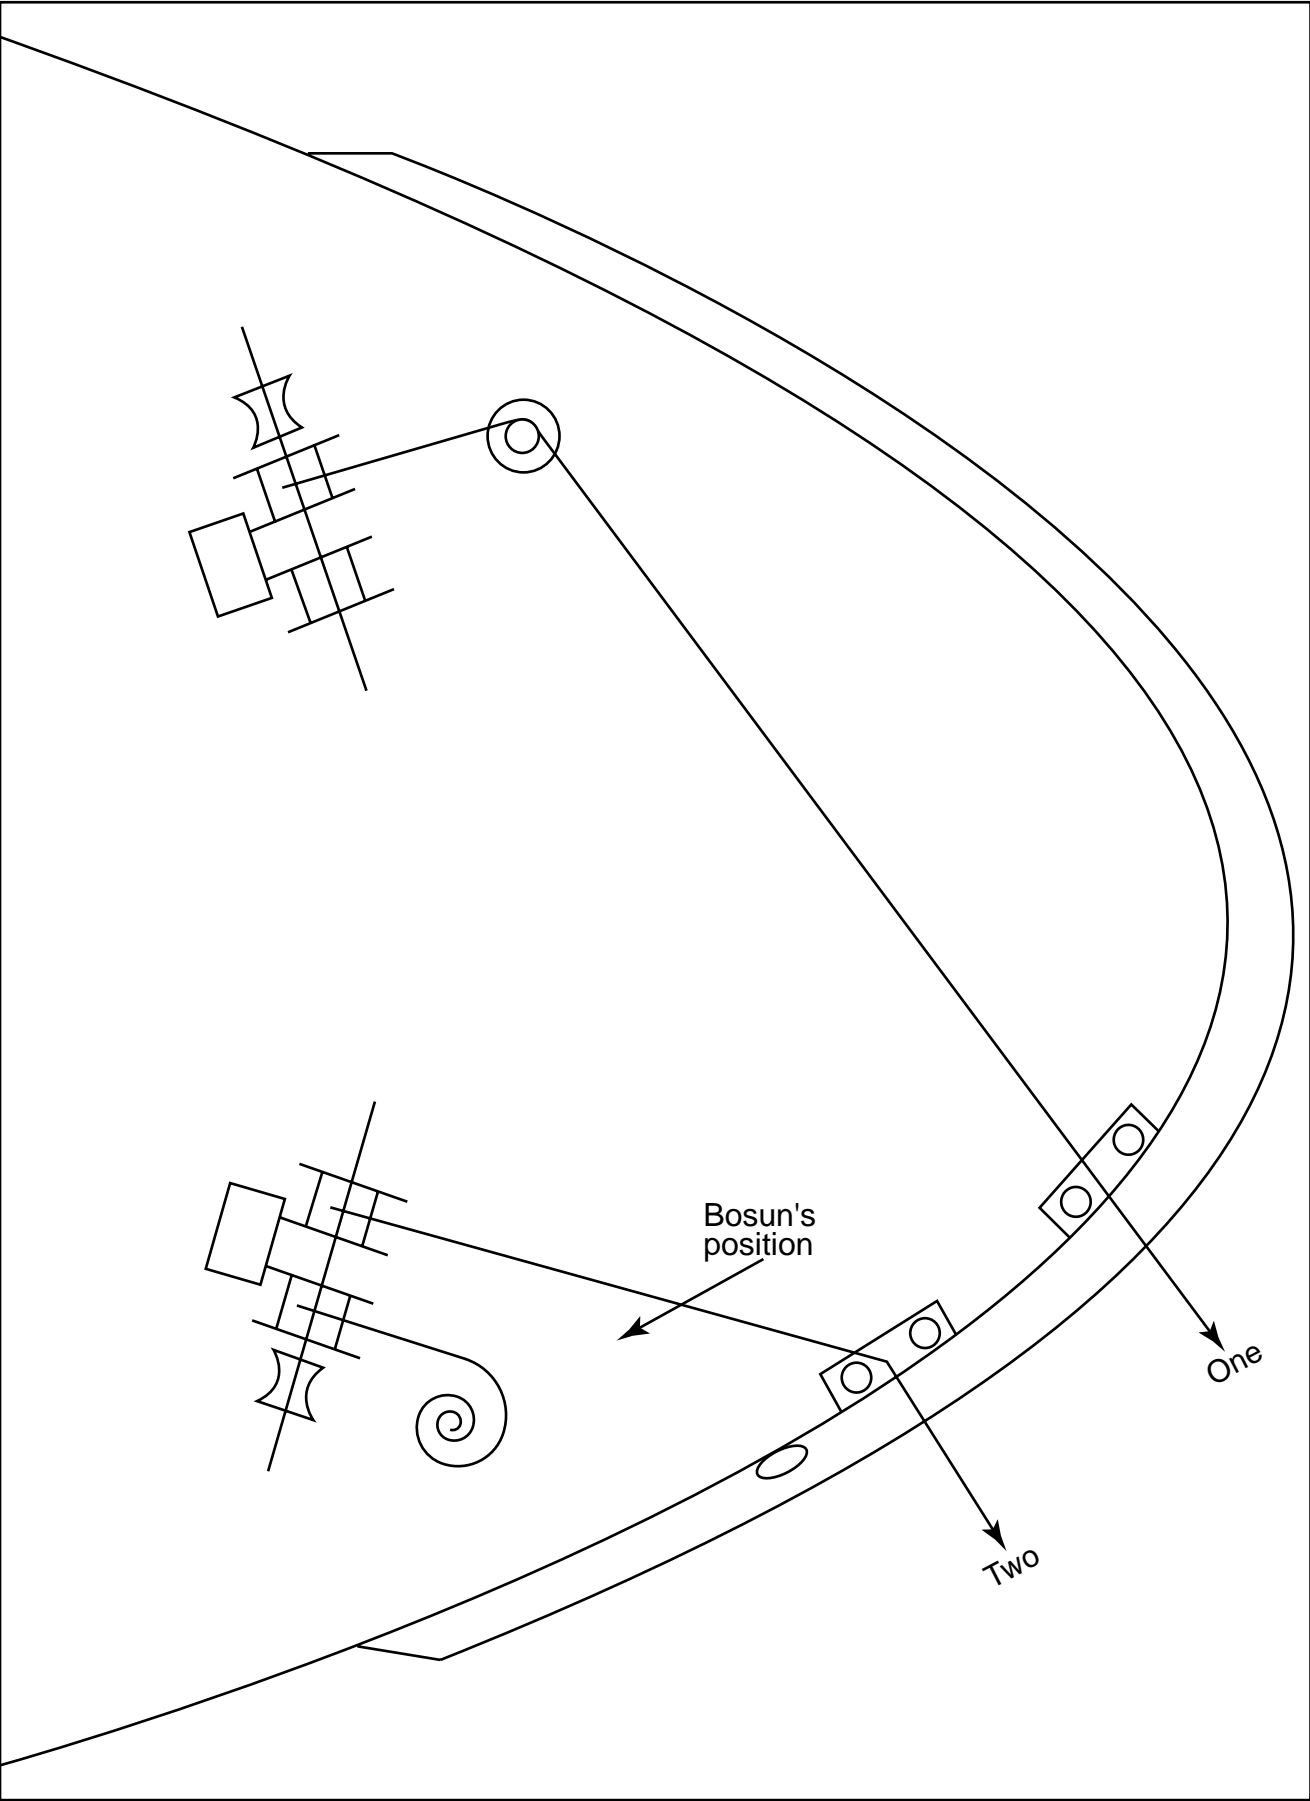
Figure 3

The master swung the vessel off the berth in preparation for berthing starboard side to heading into the strong flood tide (**Figure 2**). The port anchor was let go and the vessel was manoeuvred alongside the berth using engines and thrusters. The windlass brake was left open until *Dart 8* was alongside. It was then tightened, and the port mooring winch was put into gear in preparation for sending the first lines ashore (**Figure 3**).

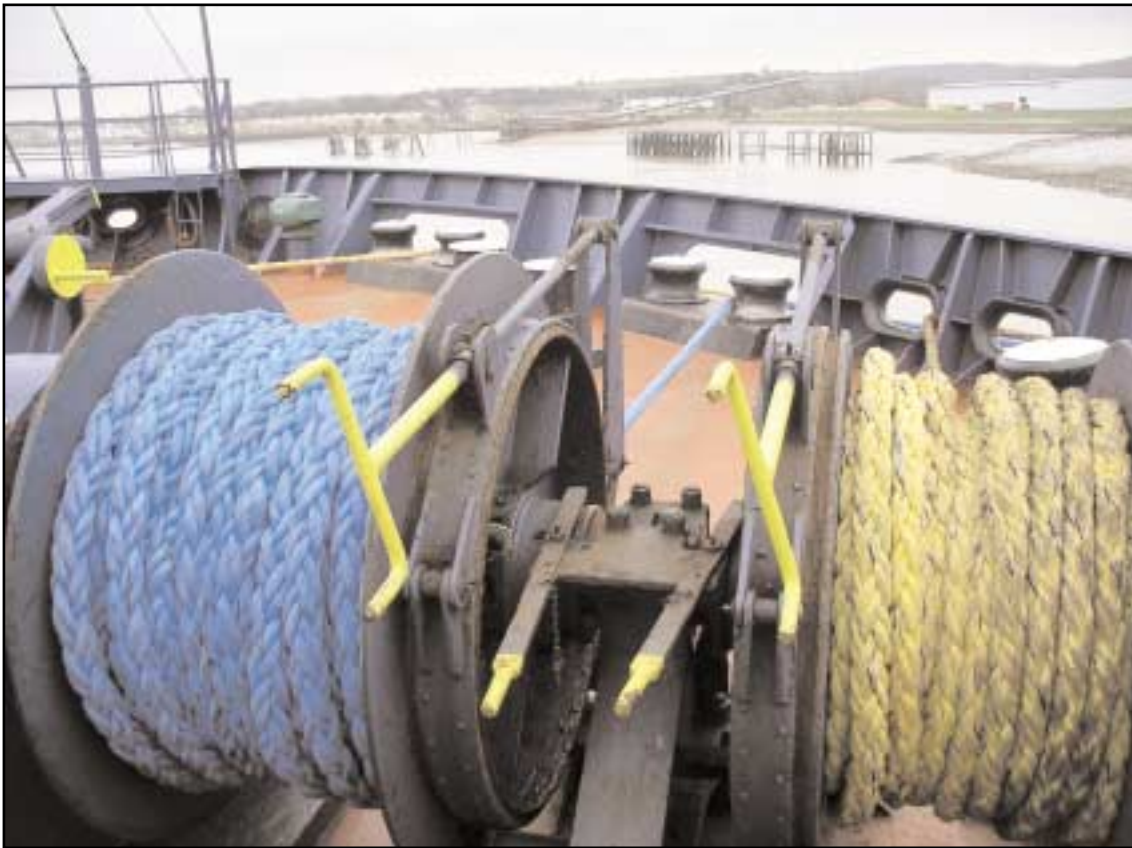
Figure 4

The forward team sent the first head line from the port outboard winch drum, and then another from the starboard inboard winch drum (**Figures 4 & 5**).

Starboard winch drums

The report also states that it is possible that bending of the rope over an acute edge under high tension might also have contributed to the failure of the rope. The MAIB looked further at this possibility. The rope was stowed on a winch drum and deployed as a head / breast line (**Figure 4**). The angle the rope made, as it passed through the roller lead from its stowage position on the starboard winch, was not acute, being about 120°. It offered further protection against abrasion and wear because it was a roller lead as opposed to a fixed one. The roller lead was inspected and found to be well maintained and in good working condition. The ship's side opening in way of the roller lead was also closely inspected for signs that the rope had jumped from the roller lead and suffered damage from the steel edge of the opening; no evidence could be found to support this theory. Additionally, the vertical displacement between the winch, the roller lead, and the shore bollard, would not have allowed the rope to ride up and off the top of the lead.

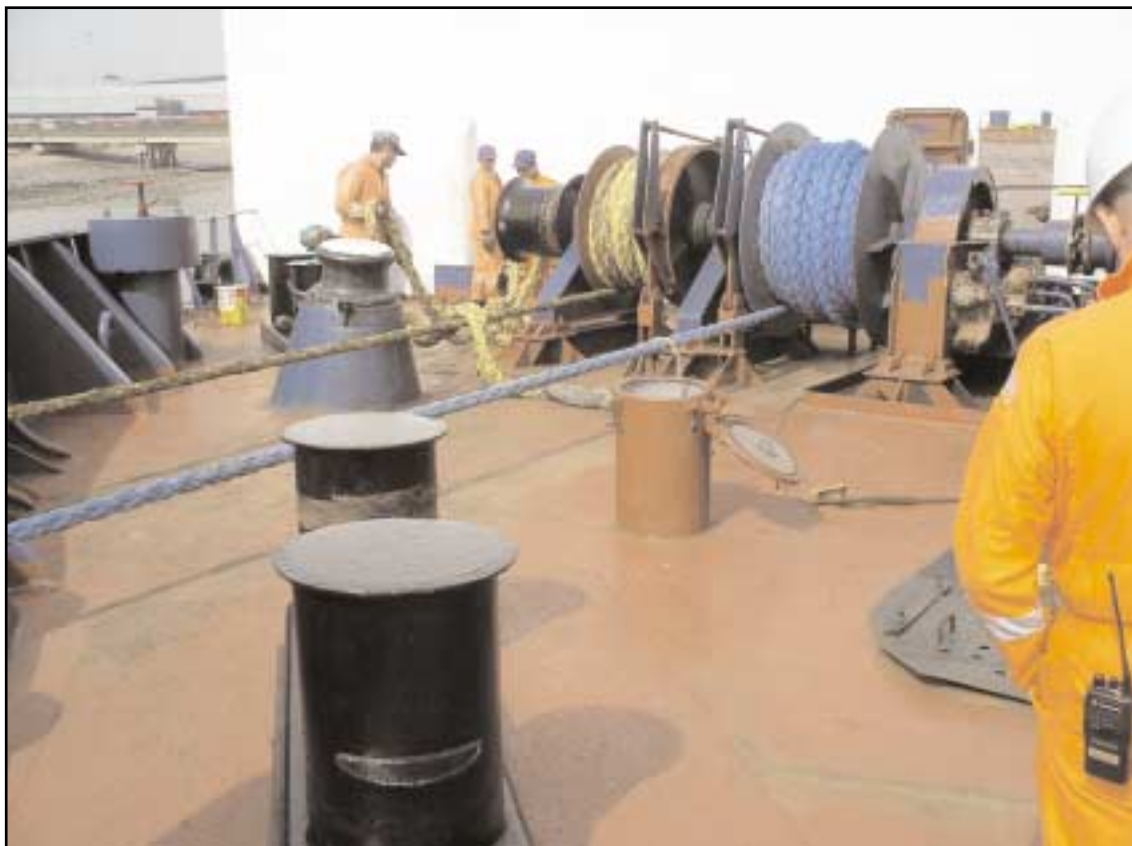
Figure 5

Starboard winch arrangement

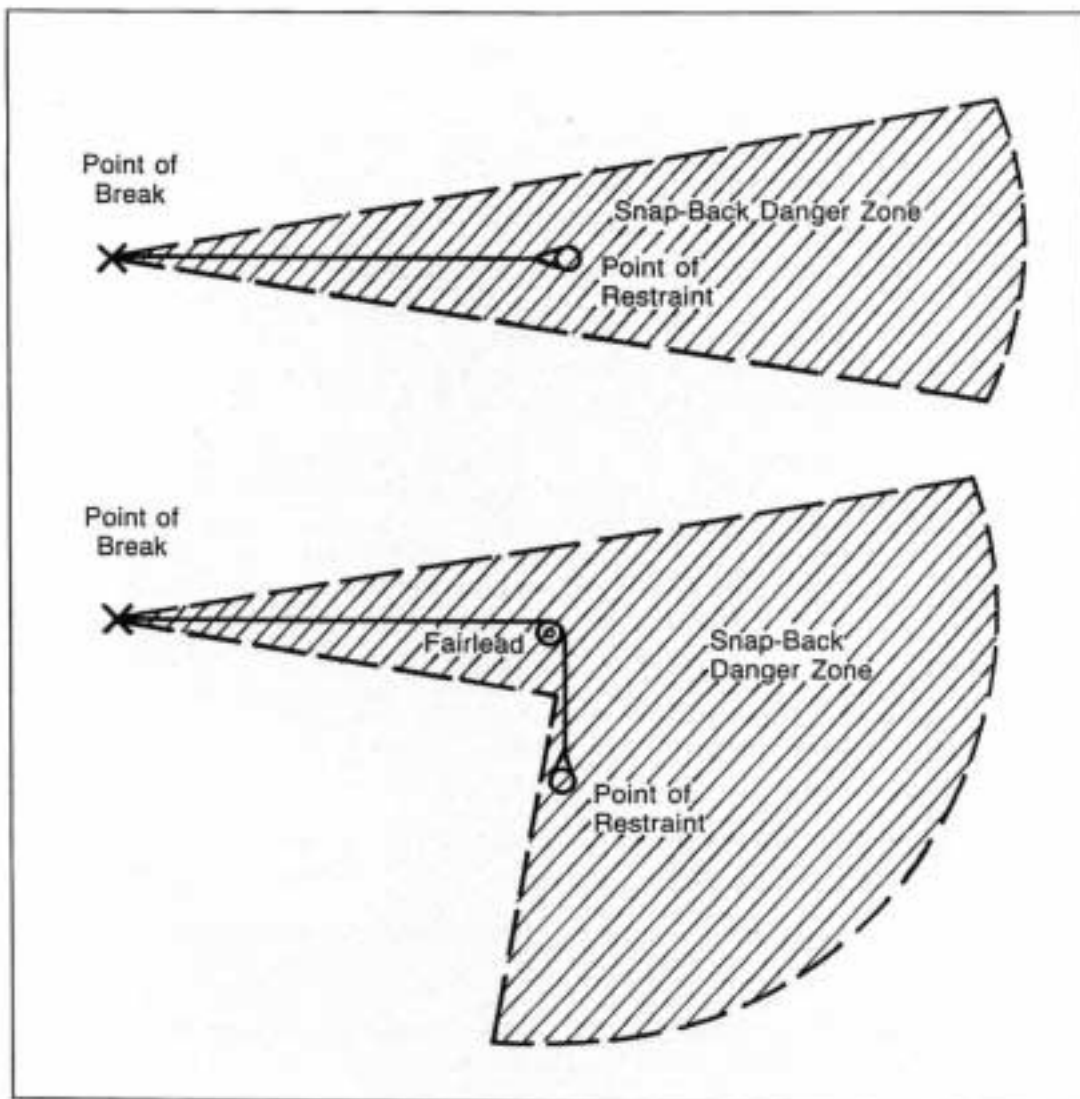
FIGURE 6.6: EXAMPLES OF SNAP-BACK DANGER ZONES

Line handlers must stand well clear of the potential path of snap-back, which extends to the sides of and far beyond the ends of the tensioned line. Figure 6.6 illustrates potential snap-back danger zones.

As a general rule, any point within about a 10 degree cone around the line from any point at which the line may break is in danger. A broken line will snap back beyond the point at which it is secured, possibly to a distance almost as far as its own length. If the line passes around a fairlead, then its snap-back path may not follow the original path of the line. When it breaks behind the fairlead, the end of the line will fly around and beyond the fairlead.

If an activity in a danger zone cannot be avoided, the exposure time can at least be reduced by observing some simple rules. When it is necessary to pass near a line under tension, do so as quickly as possible. If it is a mooring line and the ship is moving about, time your passage for the period during which the line is under little or no tension. If possible, do not stand or pass near the line while the line is being tensioned or while the ship is being moved along

the pier. If you must work near a line under tension, do so quickly and leave the danger zone as soon as possible. Plan your activity before you approach the line. Never have more people than necessary near the line. If the activity involves line handling, make certain that there are enough personnel to perform it in an expedient and safe manner. Instruct observers to stand well clear.

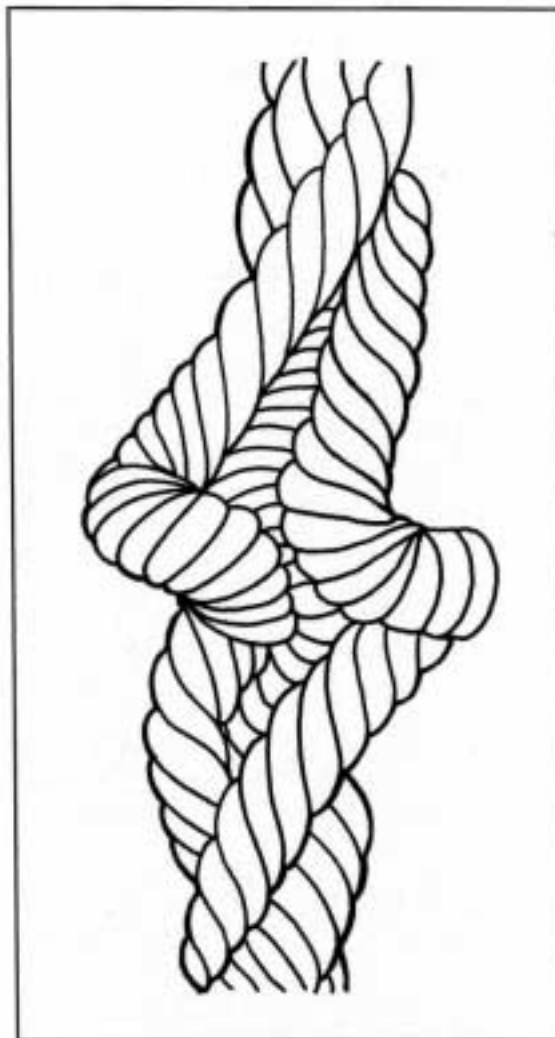
FIGURE 6.7: EXAMPLE OF HOCKLE IN 3 STRAND ROPE

Hockling normally occurs only in twisted ropes. A hockle resembles a knot in the rope, as shown in Fig. 6.7. Hockles greatly reduce the strength of the rope. When a hockle appears in a rope which is otherwise in good condition, it should be cut out and the rope spliced.
