Report on the investigations into the
two engine room fires, subsequent flooding and foundering of the

fv Elegance

Report No 9/2004
August 2004

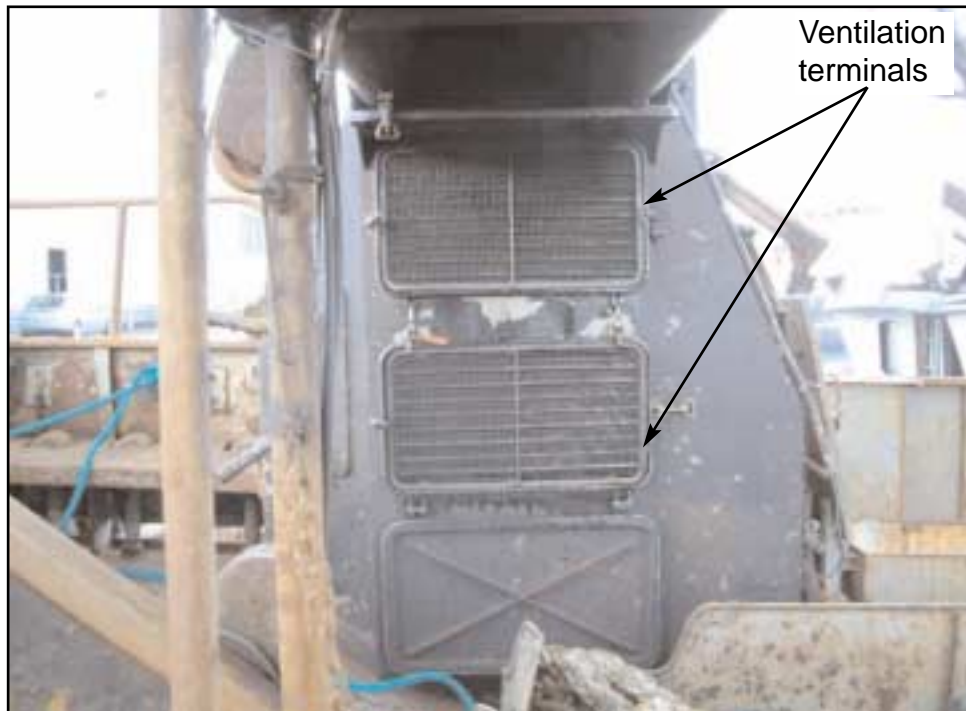
Figure 1

Elegance had been towing for about 3 hours when, at 1750, the skipper went outside the wheelhouse and noticed smoke coming from the port side of the engine room ventilation exhaust trunking (**Figure 1**). At that time no fire alarms were enunciating from the surveillance system located in the wheelhouse. The skipper immediately went to the engine room, although he had no particular concerns at this time.

Engine room exhaust ventilation system terminals situated on the port galleys

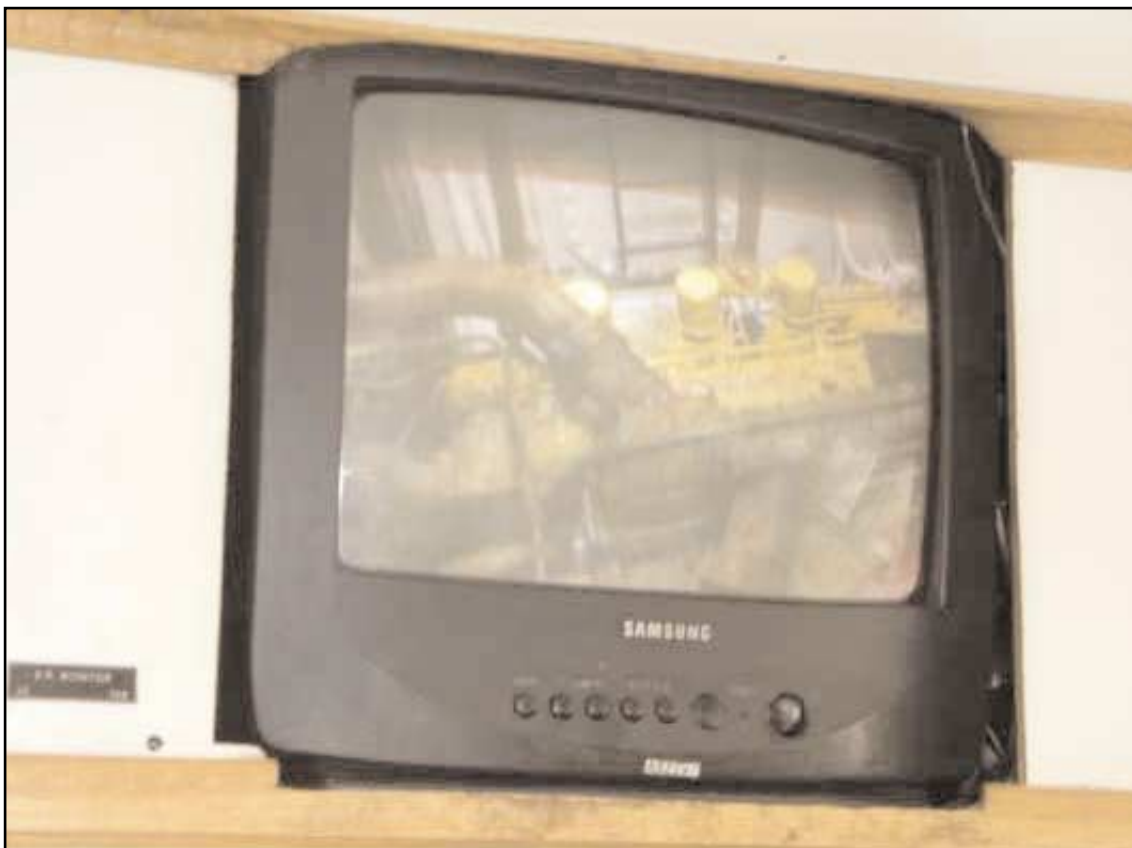
Figure 7

The skipper then went directly to the CO₂ compartment, situated immediately aft of the starboard galleys. Both crew members went to the wheelhouse. One crew member watched the fire on the engine room camera wheelhouse monitor. The flames were seen at the bottom left of the screen (**Figure 7**), which coincides with the vicinity of the starboard turbo charger, fuel oil purifier and fuel transfer pump. The flames which could be seen were yellow, about 1.25 metres high with black smoke, but not extending to the port side of the engine.

Engine room monitor showing fixed coverage

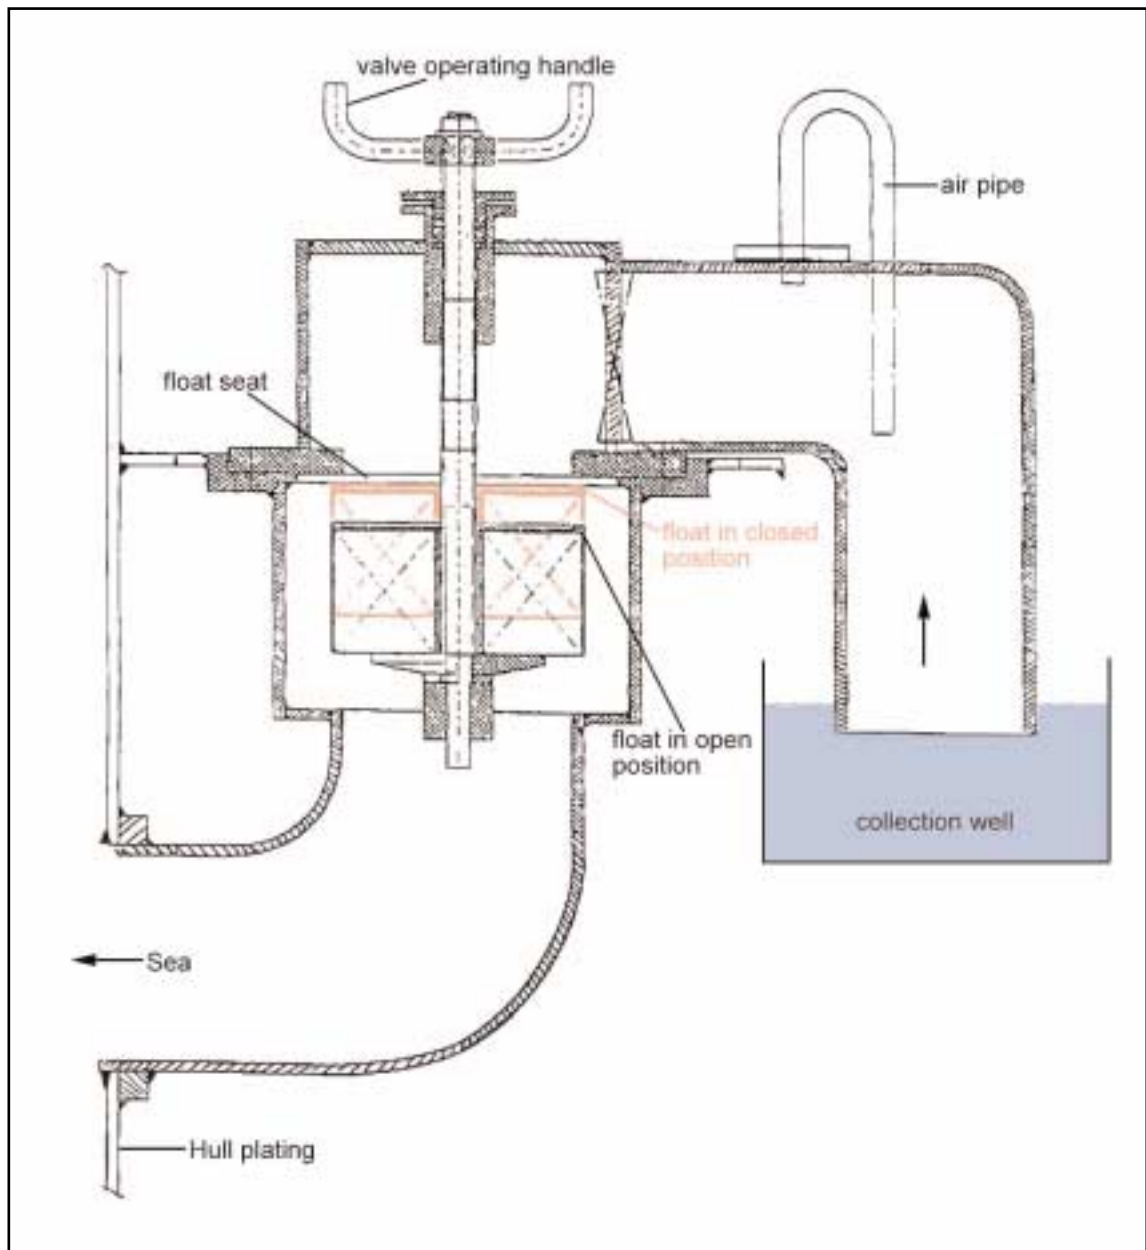
Figure 9

The purpose of the tonnage valves is to evacuate water from deck wells through the action of the internal float, which creates a siphon and discharges the water overboard (**Figure 9**). When the valve is in the closed position, the float is hard up against the valve seat; this prevents any passage of water. In the open position, the float is free to operate, when water attempts to travel back from the sea, the float rises and shuts the outflow back to the well.

Tonnage valve arrangement

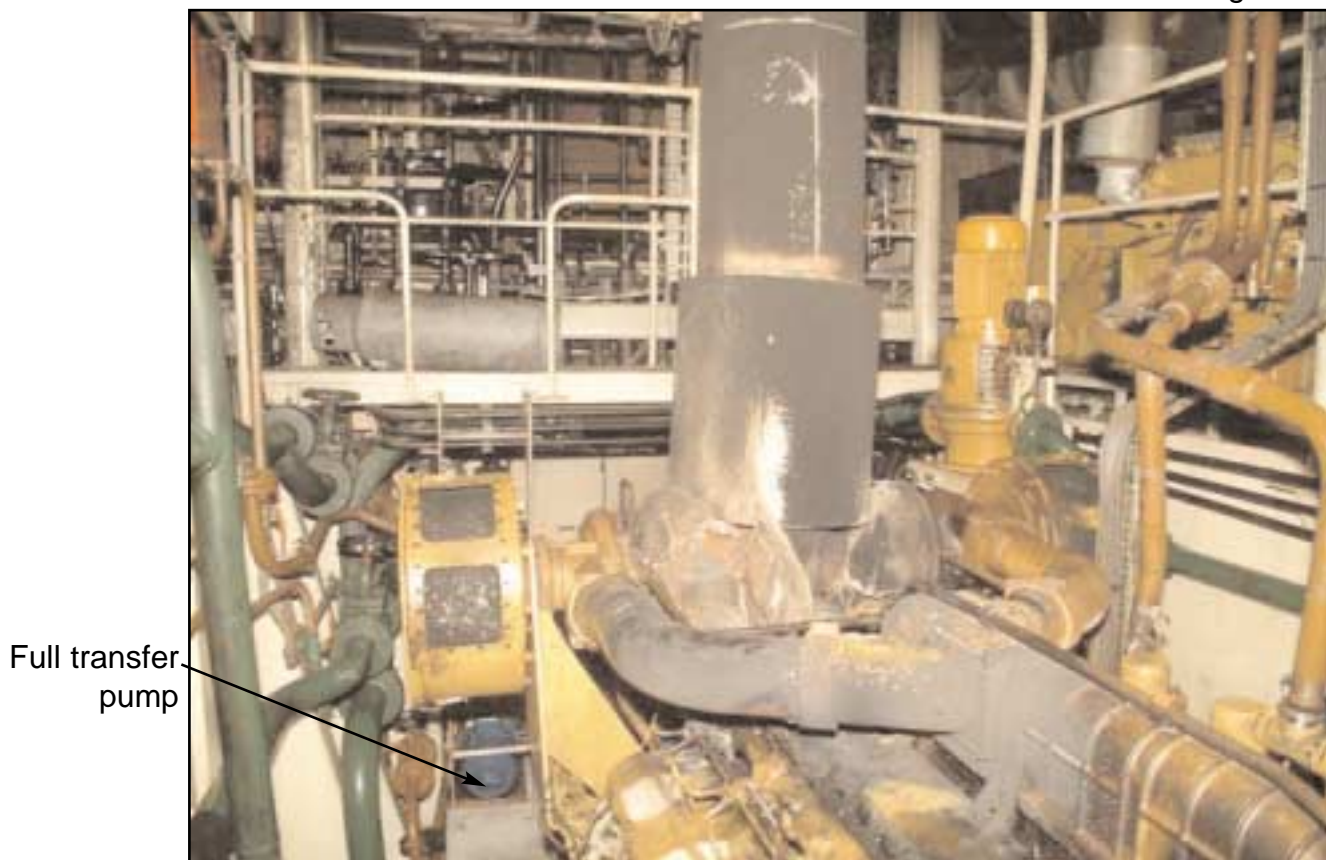
Figure 13

Position of fuel oil transfer pump in relation to main engine

It should be noted that in the event of an engine room fire, the fuel oil purifier will be automatically shut down if the fire alarm system is activated. However, the fuel transfer pump is not connected to the fire alarm system in the same way. Therefore, in the case of a fire, the fuel oil transfer will continue to run with the possibility of feeding fuel to the fire.

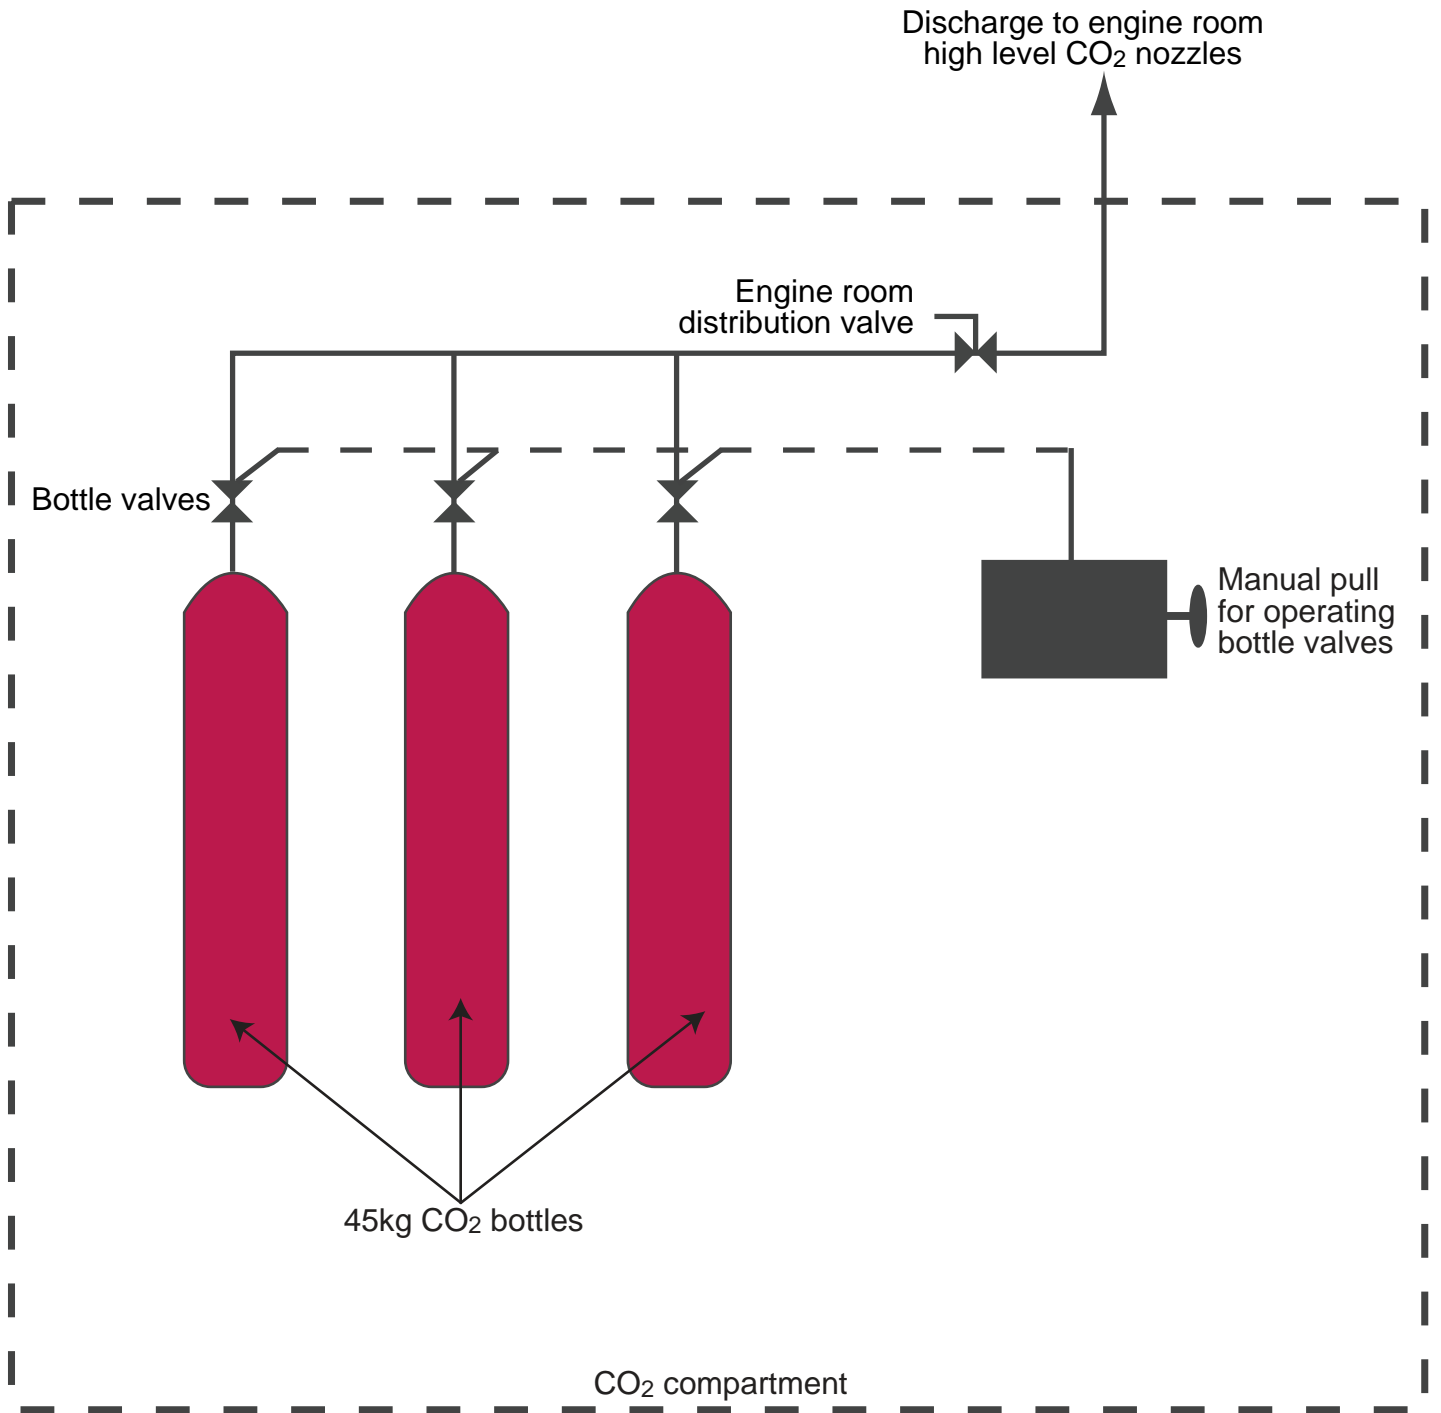
The CO₂ system extinguishes fires by reducing the oxygen content in the compartment. A reduction by about 6% is usually sufficient to put out the fire. It is, therefore, essential that the compartment ventilation flaps are closed prior to system operation, to ensure that the correct CO₂ concentration is achieved.

CO2 fixed fire-fighting system
