Report on the investigation of
the failure of the starboard bow door on

Pride of Provence

at Calais

**Report No 16/2004
December 2004**

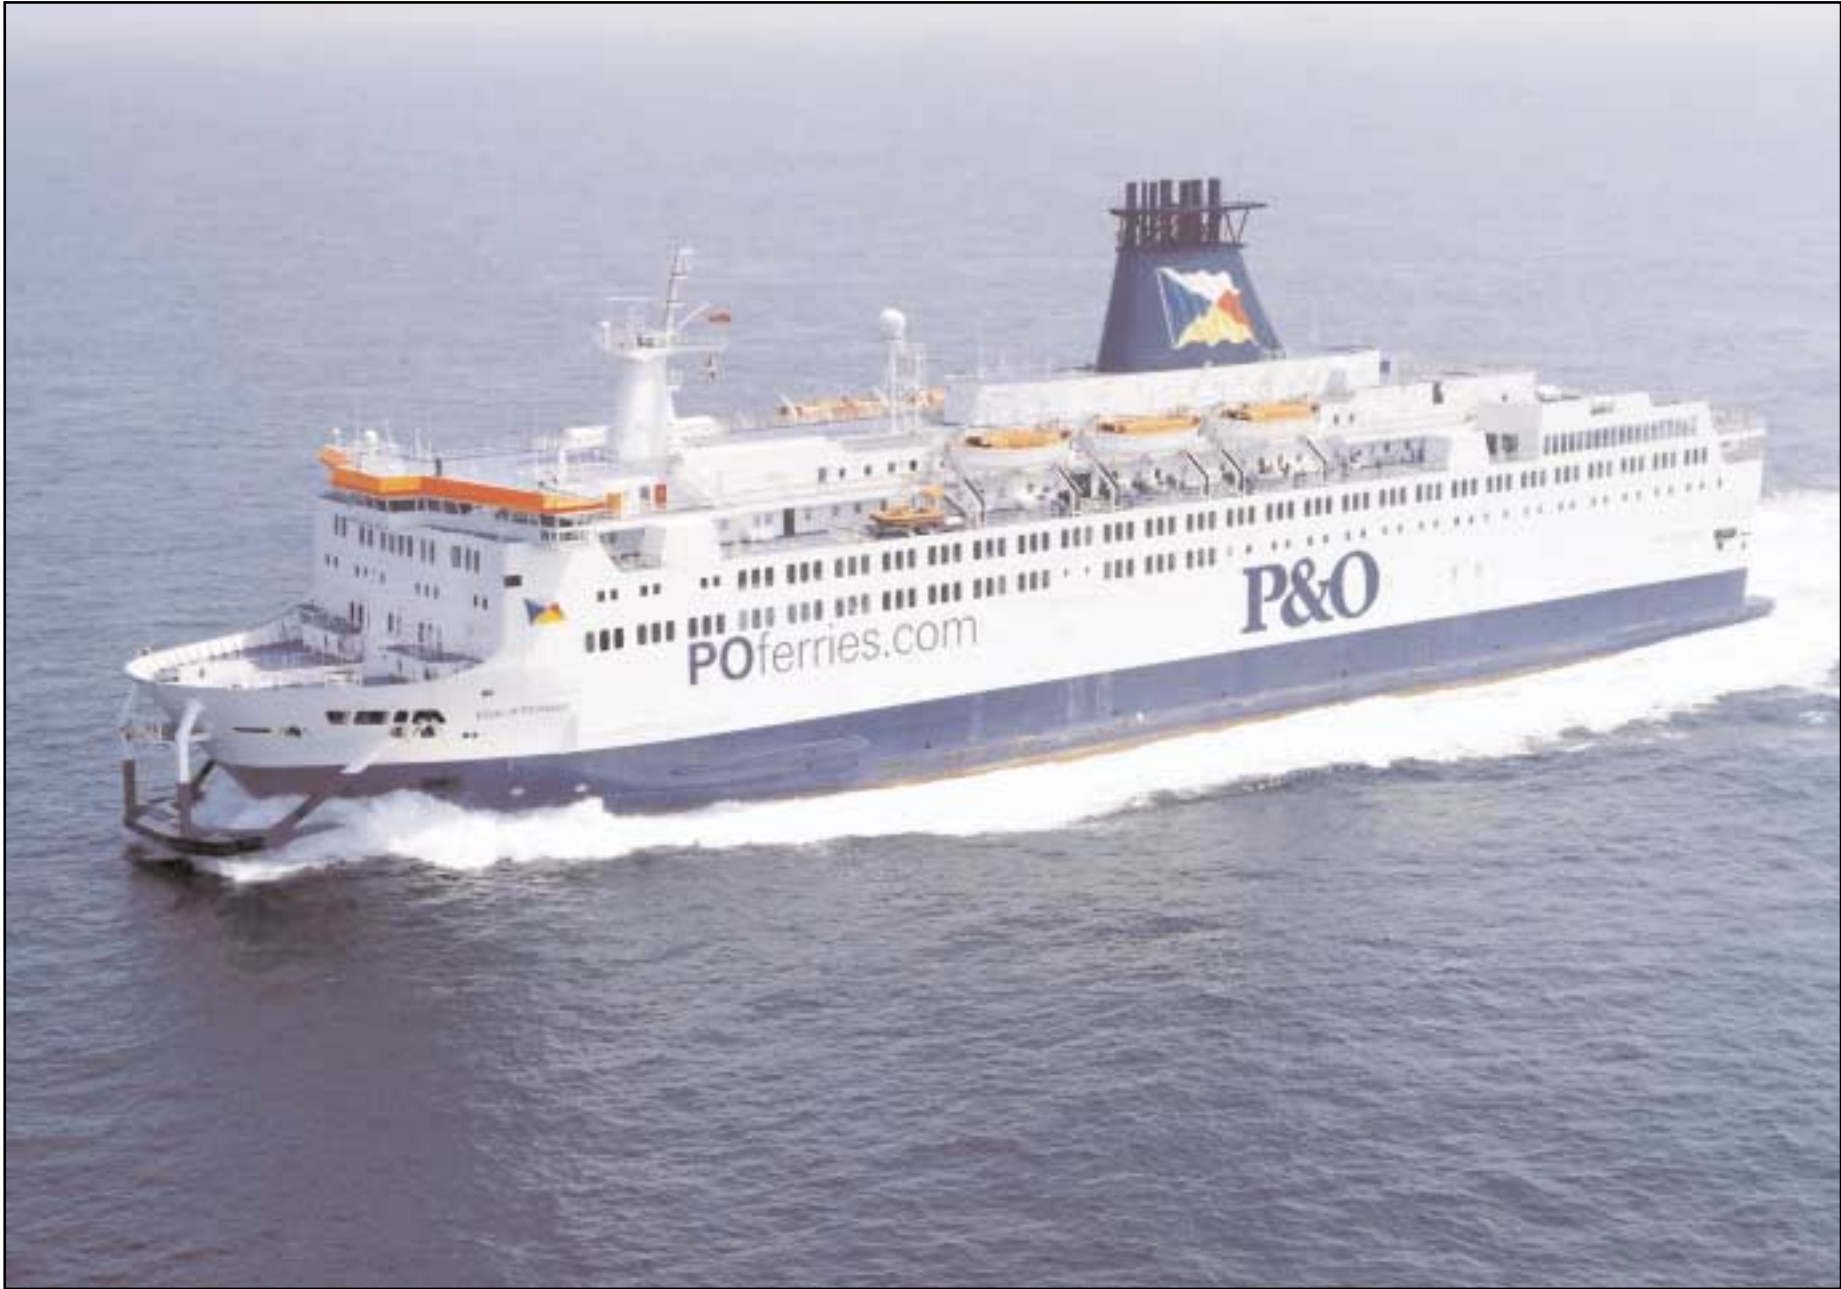
Figure 1

Pride of Provence

The “cowcatcher” was added in 1996 (**Figure 1**), some time after the vessel was built. It was therefore not considered a factor in the original design and fitting of the bow doors. The structure of the “cowcatcher” was intended to have been welded to the vessel such that it cleared the open bow doors. This was almost certainly the case on the port side, but the starboard door might have been contacting the “cowcatcher” from the time it was fitted.

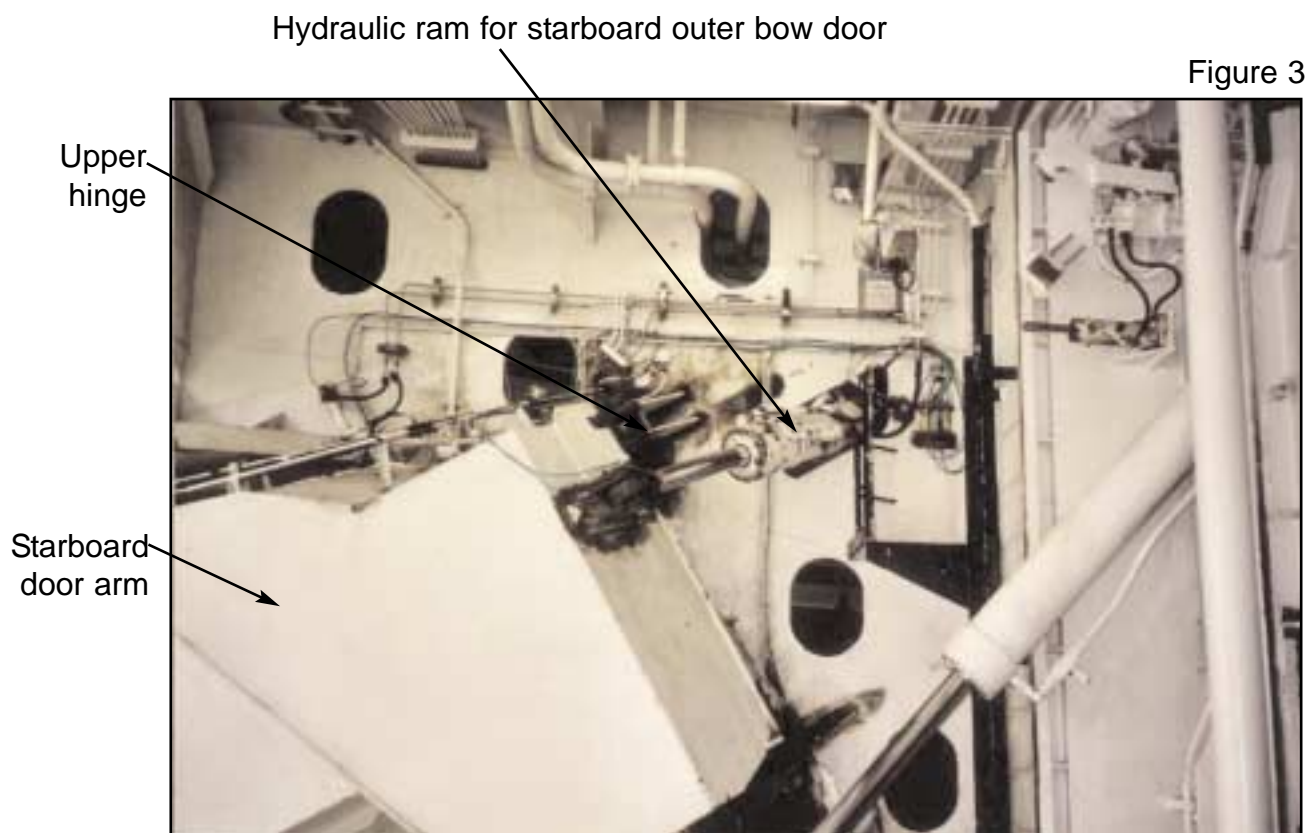
Figure 3

Pride of Provence is fitted with the side opening or clam type of bow door. The design comprises two doors positioned port and starboard of the ship's centreline. Each door originally weighed about 18 tonnes, but this increased to about 20 tonnes with the addition of further steelwork to strengthen each door so that it complied with updated Classification Society Rules. Each door has two hinges and is operated by a hydraulic ram, which has a pivot at each end (**Figure 3**).

Photograph of starboard side outer bow door opening mechanism

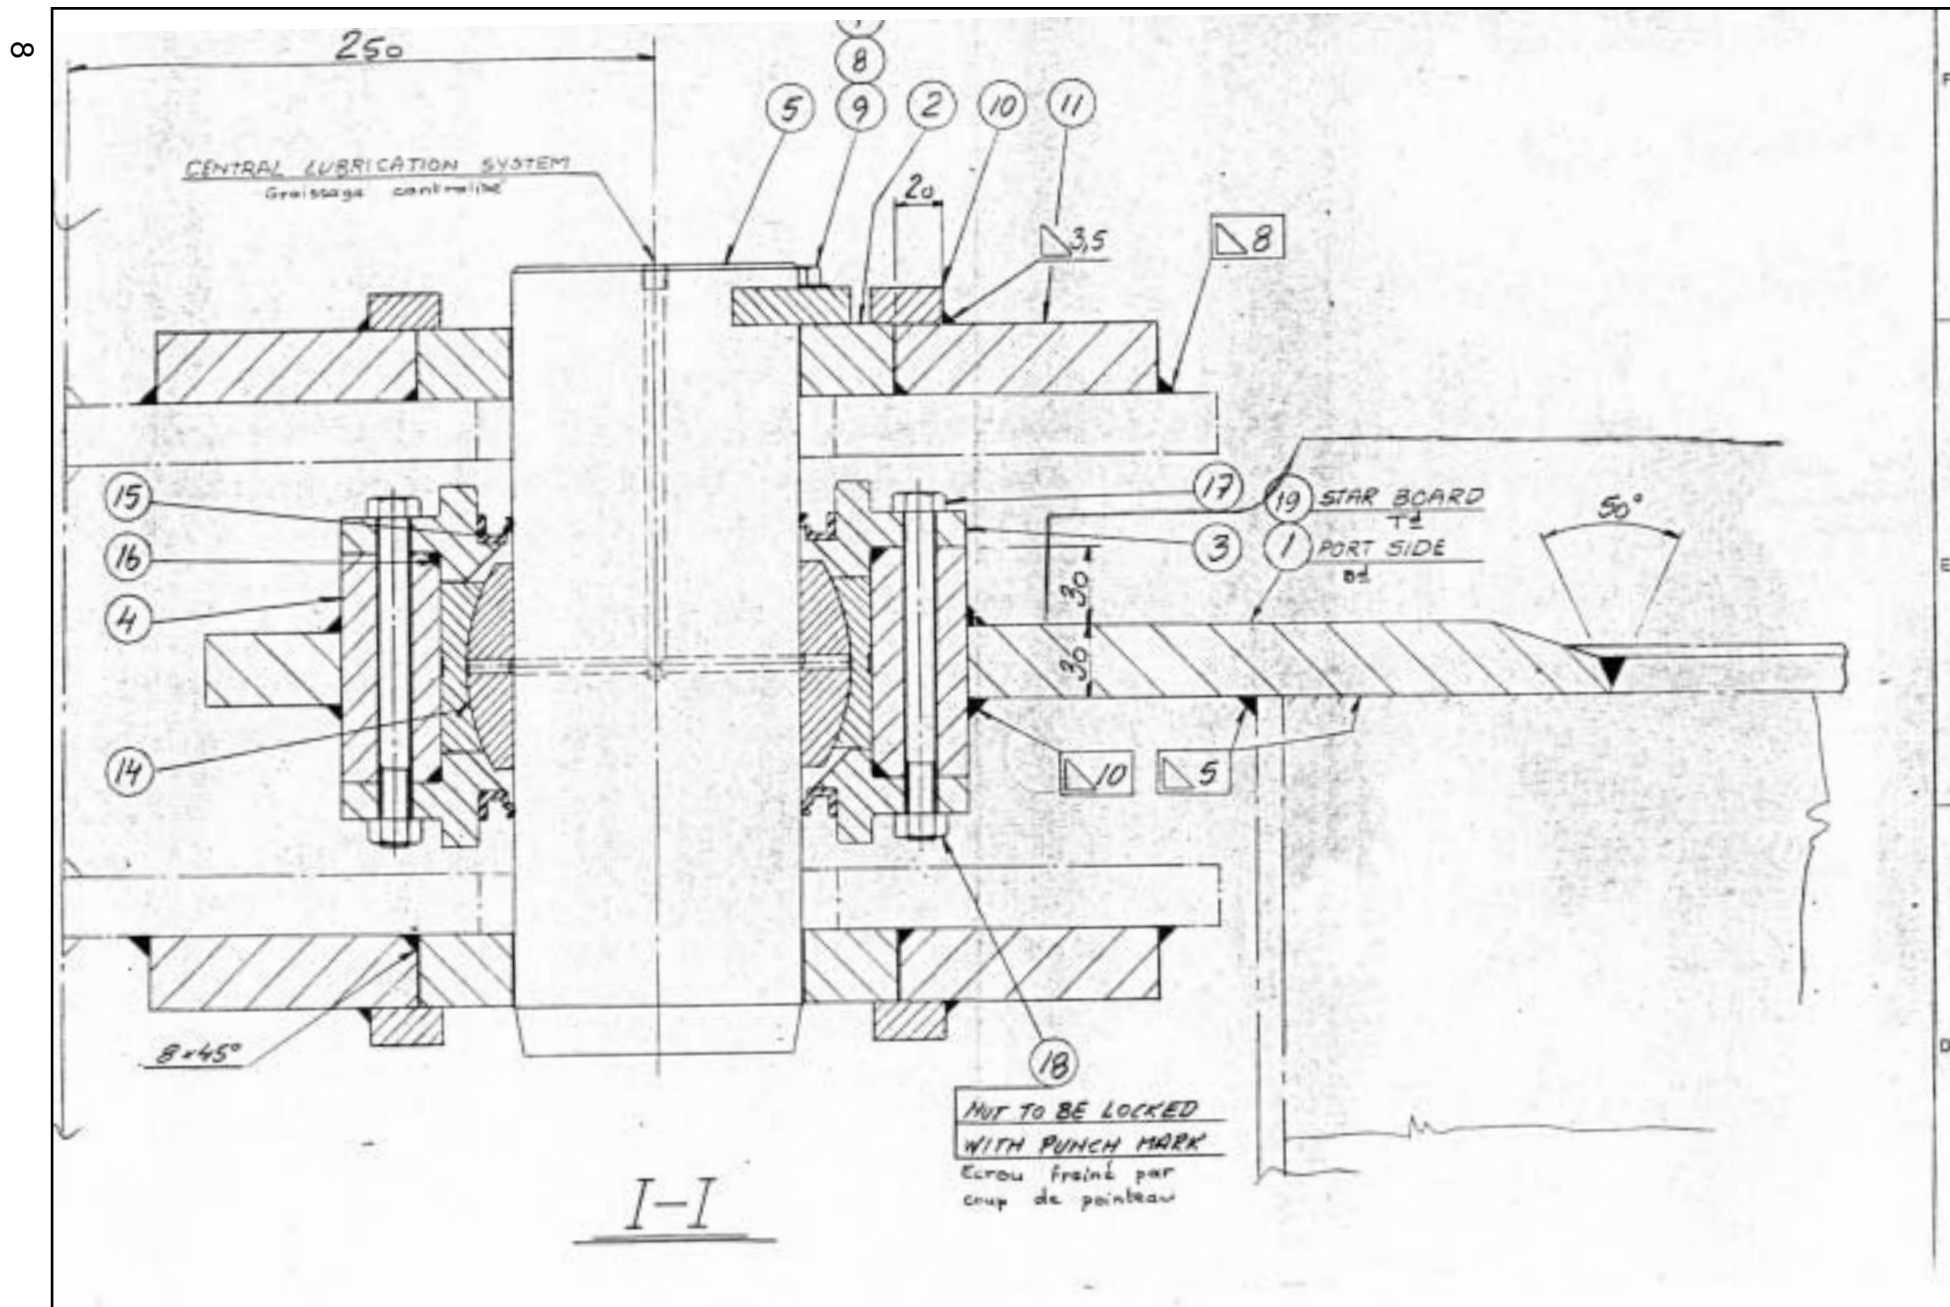
The upper hinge on each door uses a spherical bearing mounted on a bearing pin held between cheek plates. The hinge plate, connected to the door box section hinge arm, is welded to the bearing retaining ring. The hinge plate from the original construction drawing (**Figure 4**) was 30mm thick. The bearing is lubricated through a central lubrication channel in the pin.

Drawing of bow door upper bearing hinge arrangement

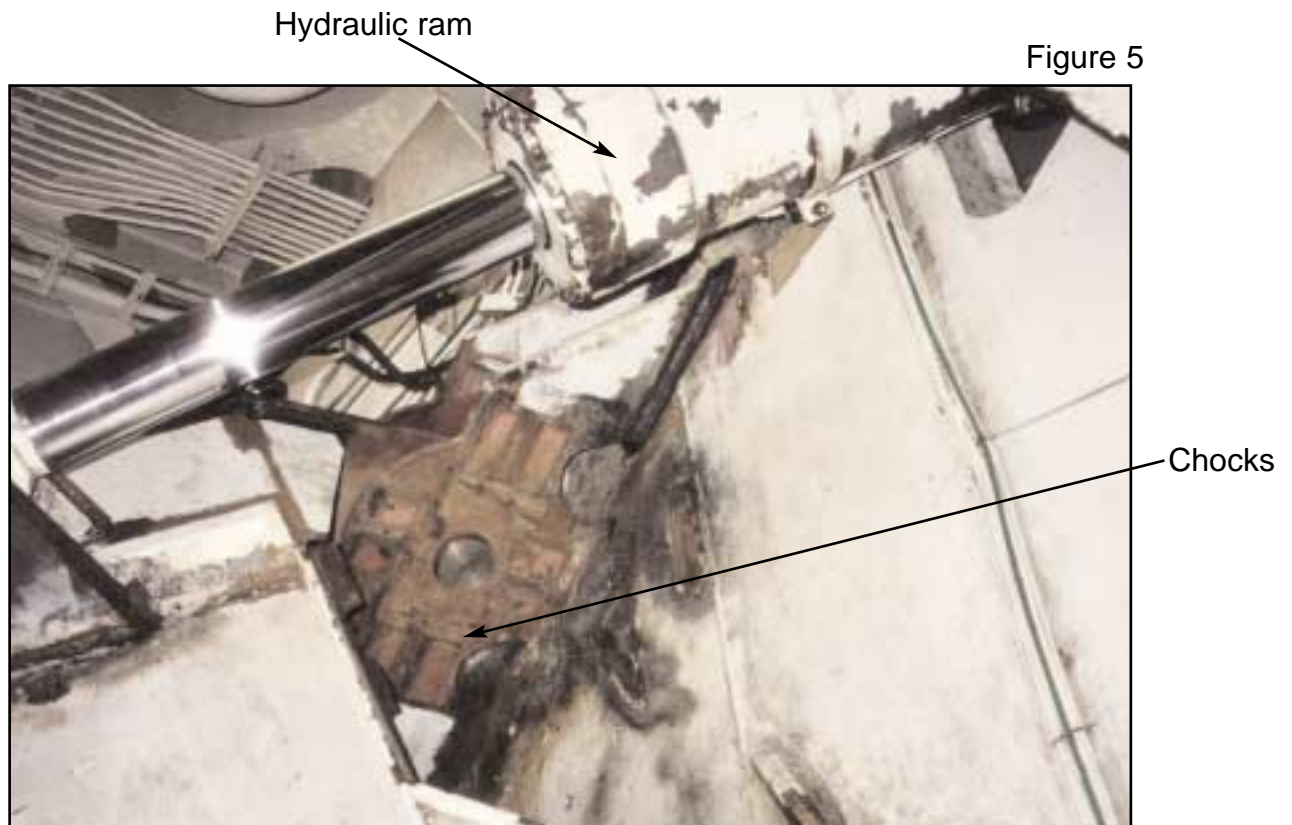
To accurately position the upper pivot point to ensure good location and weathertight sealing of the door, the bearing can be adjusted using steel chocks. The chocks are located on both the upper and lower cheek plates, and are welded in position (**Figure 5**). Alignment checks and adjustment at regular intervals are necessary to keep the doors operating correctly.

Underside of upper hinge assembly
(chocks are fitted similarly on the upper side)

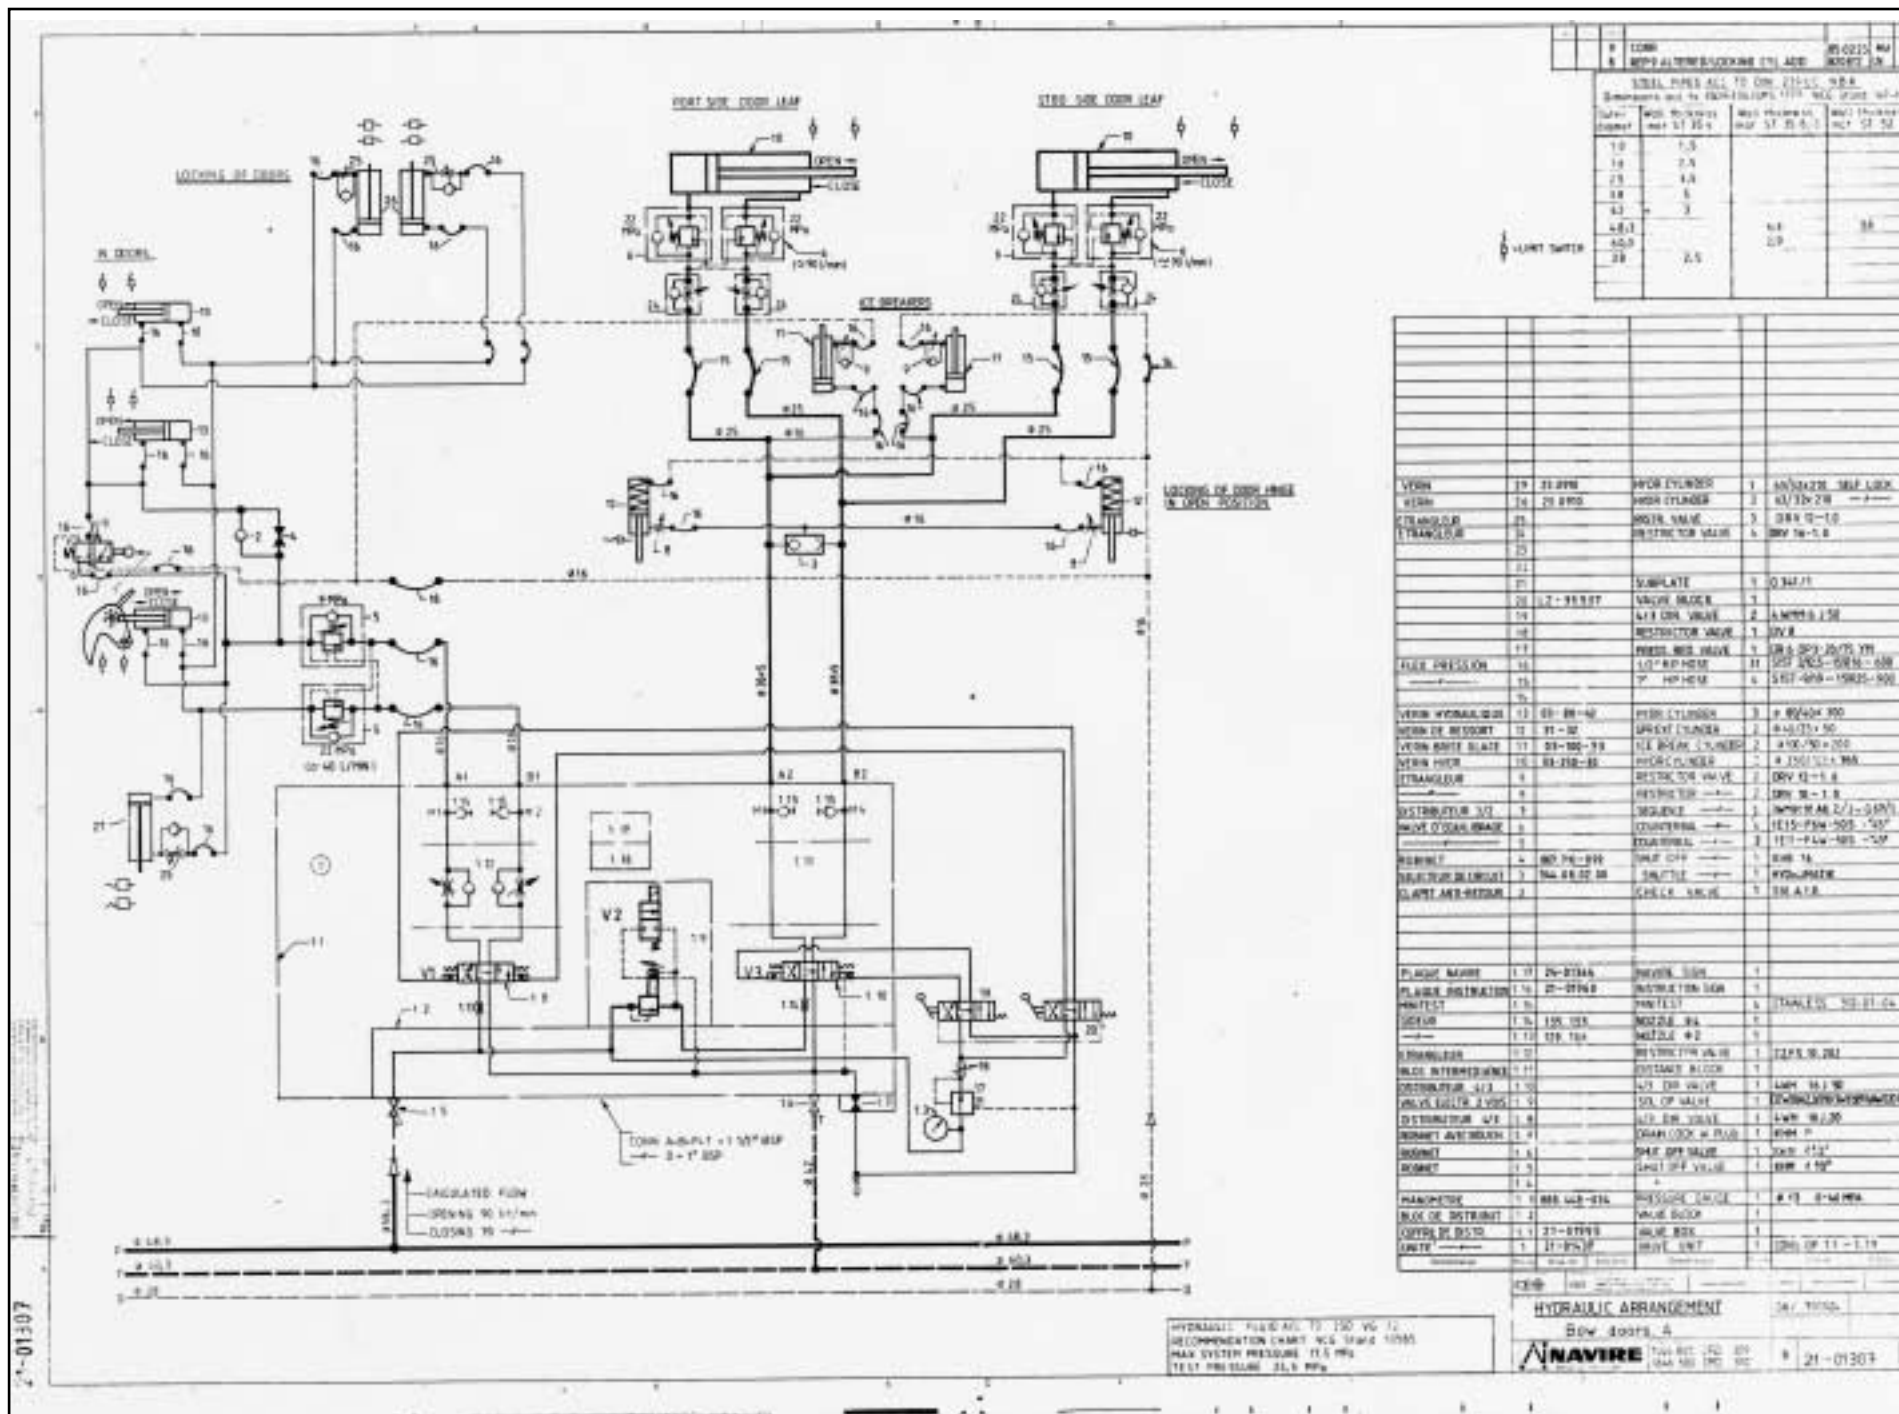
Figure 6

In addition to the above, the hydraulic system drawing depicts three hydraulically operated locking pins or wedges (items 26 and 27 of Figure 6). Two are for attachment to the upper forward end of the doors, and are intended to hold the upper part of the door closed against the vessel structure, the third locking pin is at the lower part of the doors for the same purpose.

Diagram of outer bow doors hydraulic arrangement

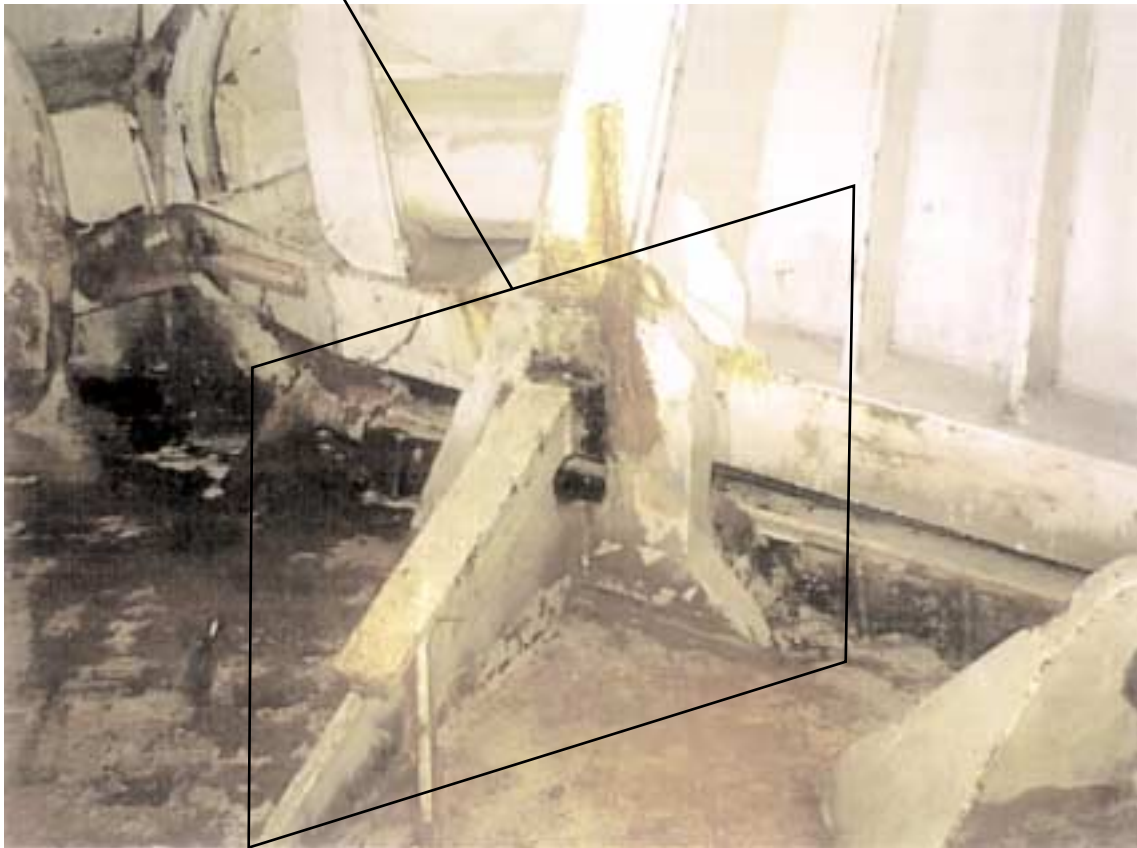
Figure 17

View of port bow door additional securing arrangement to comply with IACS UR S-16

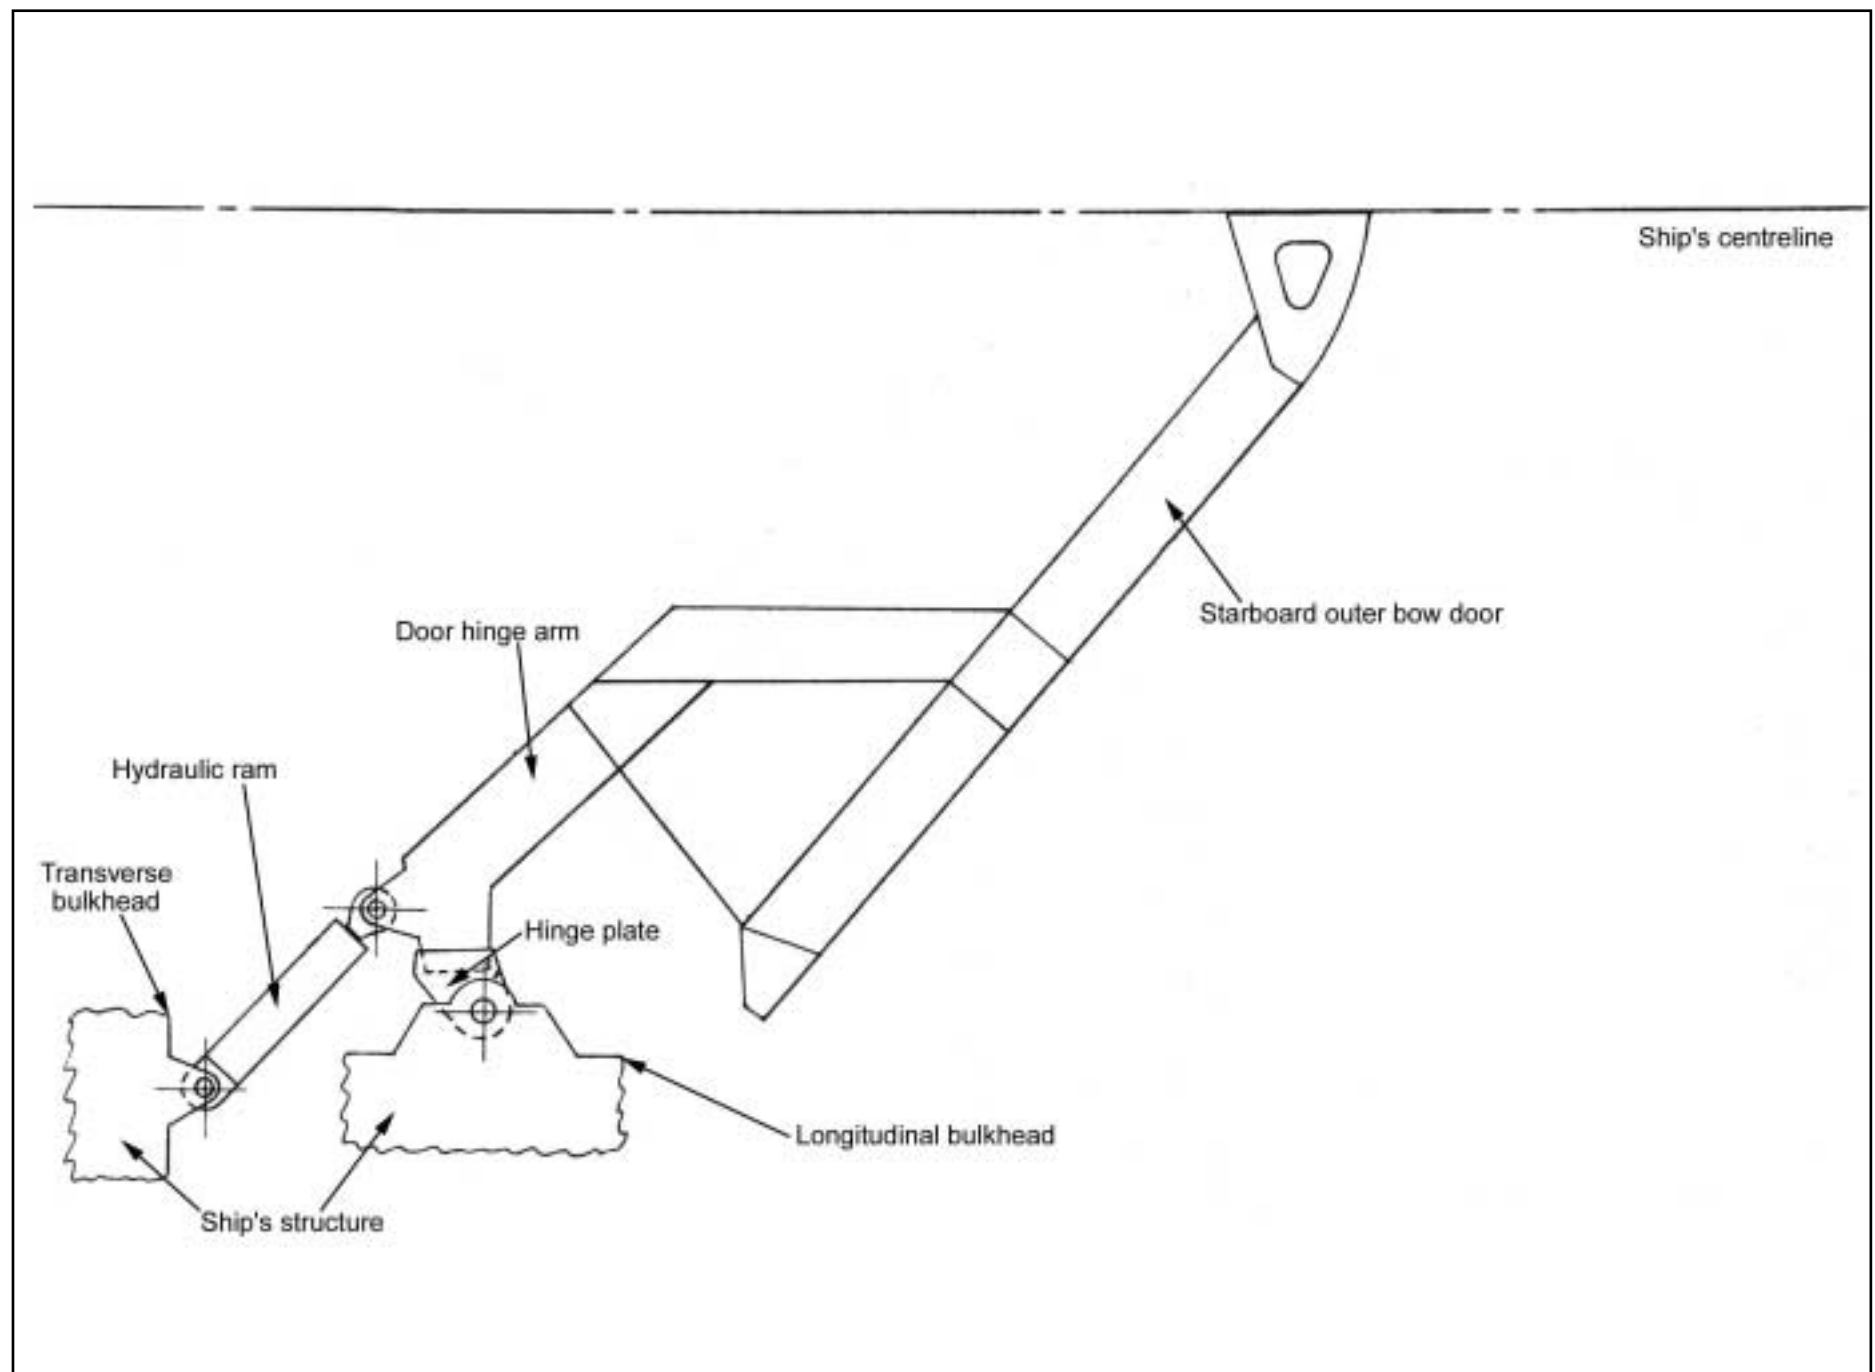
A diagram of the starboard outer bow door in the closed position is shown in **Figure 24**. A diagram of the door in the open position is shown in **Figure 25**. Contact with the “cowcatcher” prevents the hydraulic ram reaching its full extension. Structure around the pivots of the ram, and the hinge plate, were overloaded in this situation. A detailed drawing of the hinge plate is shown in **Figure 26**. Referring to this figure, the image on the right is a view of the hinge plate and its stiffener looking from forward. Another detailed drawing of the hinge plate is shown in **Figure 27**. The cracking, which was the origin of the fracture, is shown; a section through the hinge plate and stiffener at this point is included.

Diagram of starboard outer bow door looking down on top hinge - door closed

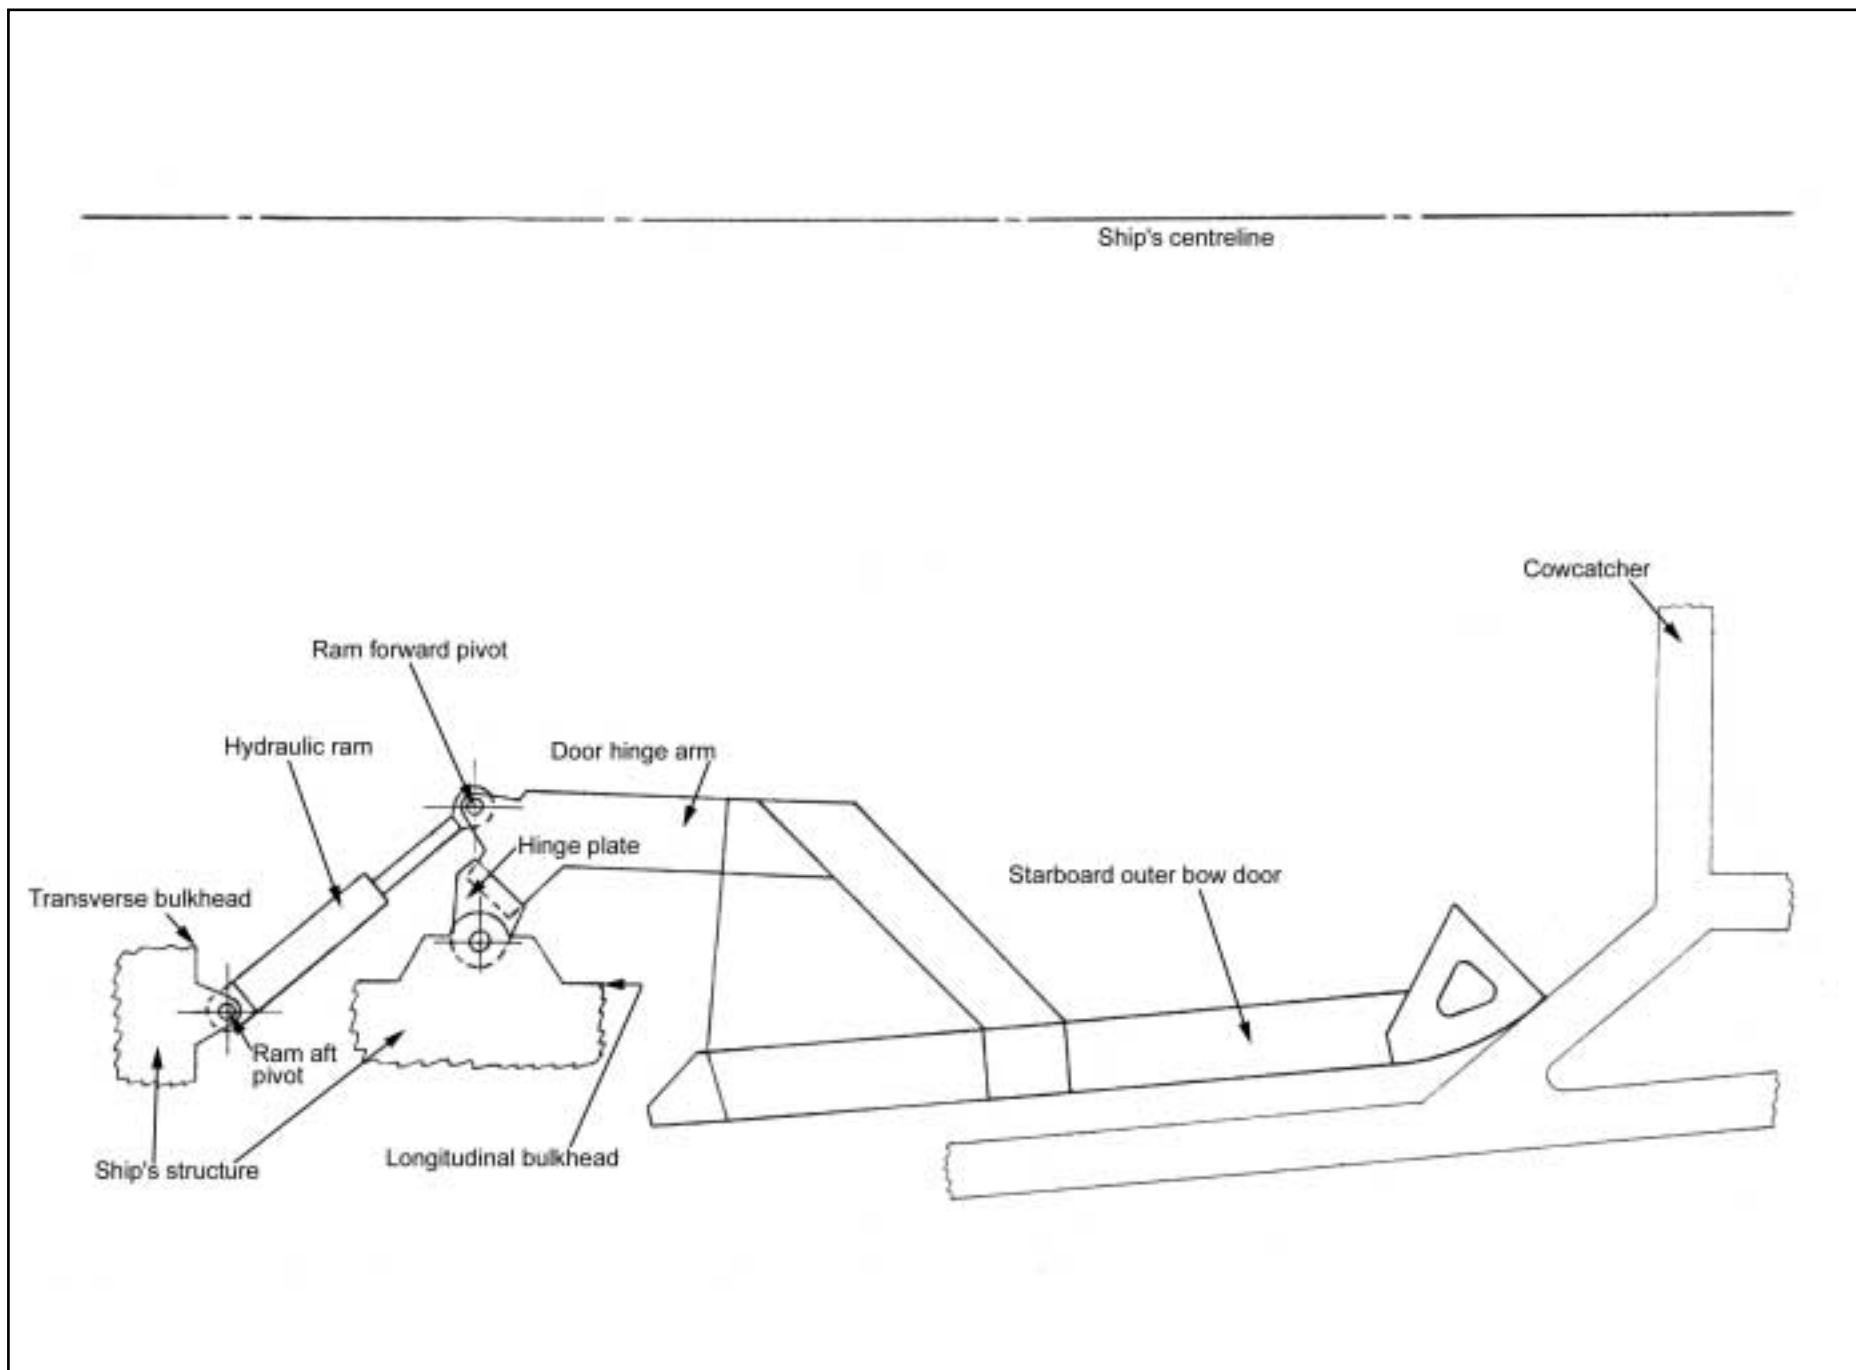
Diagram of starboard outer bow door looking down on top hinge - door open

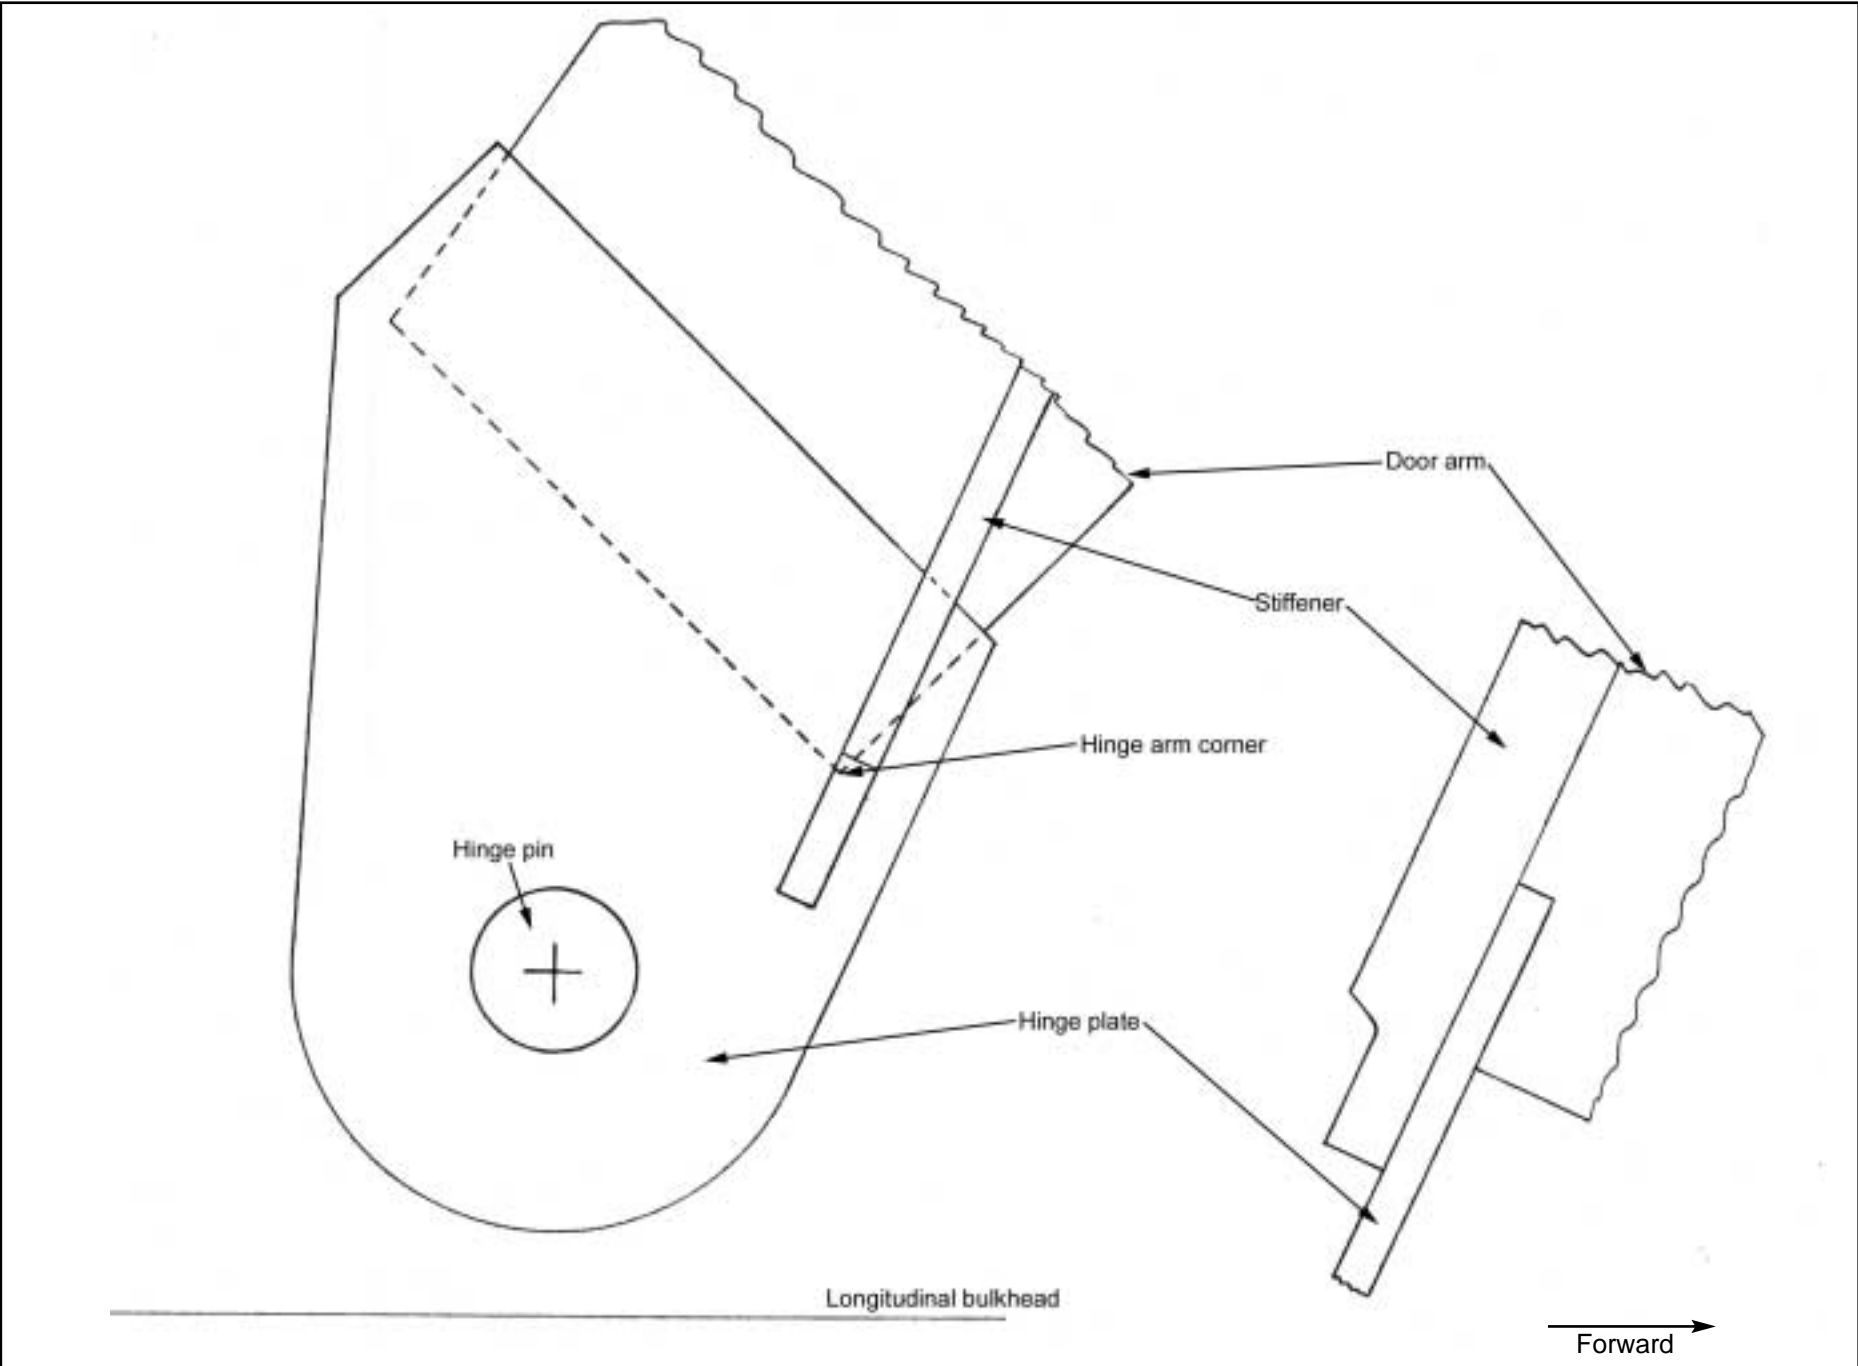
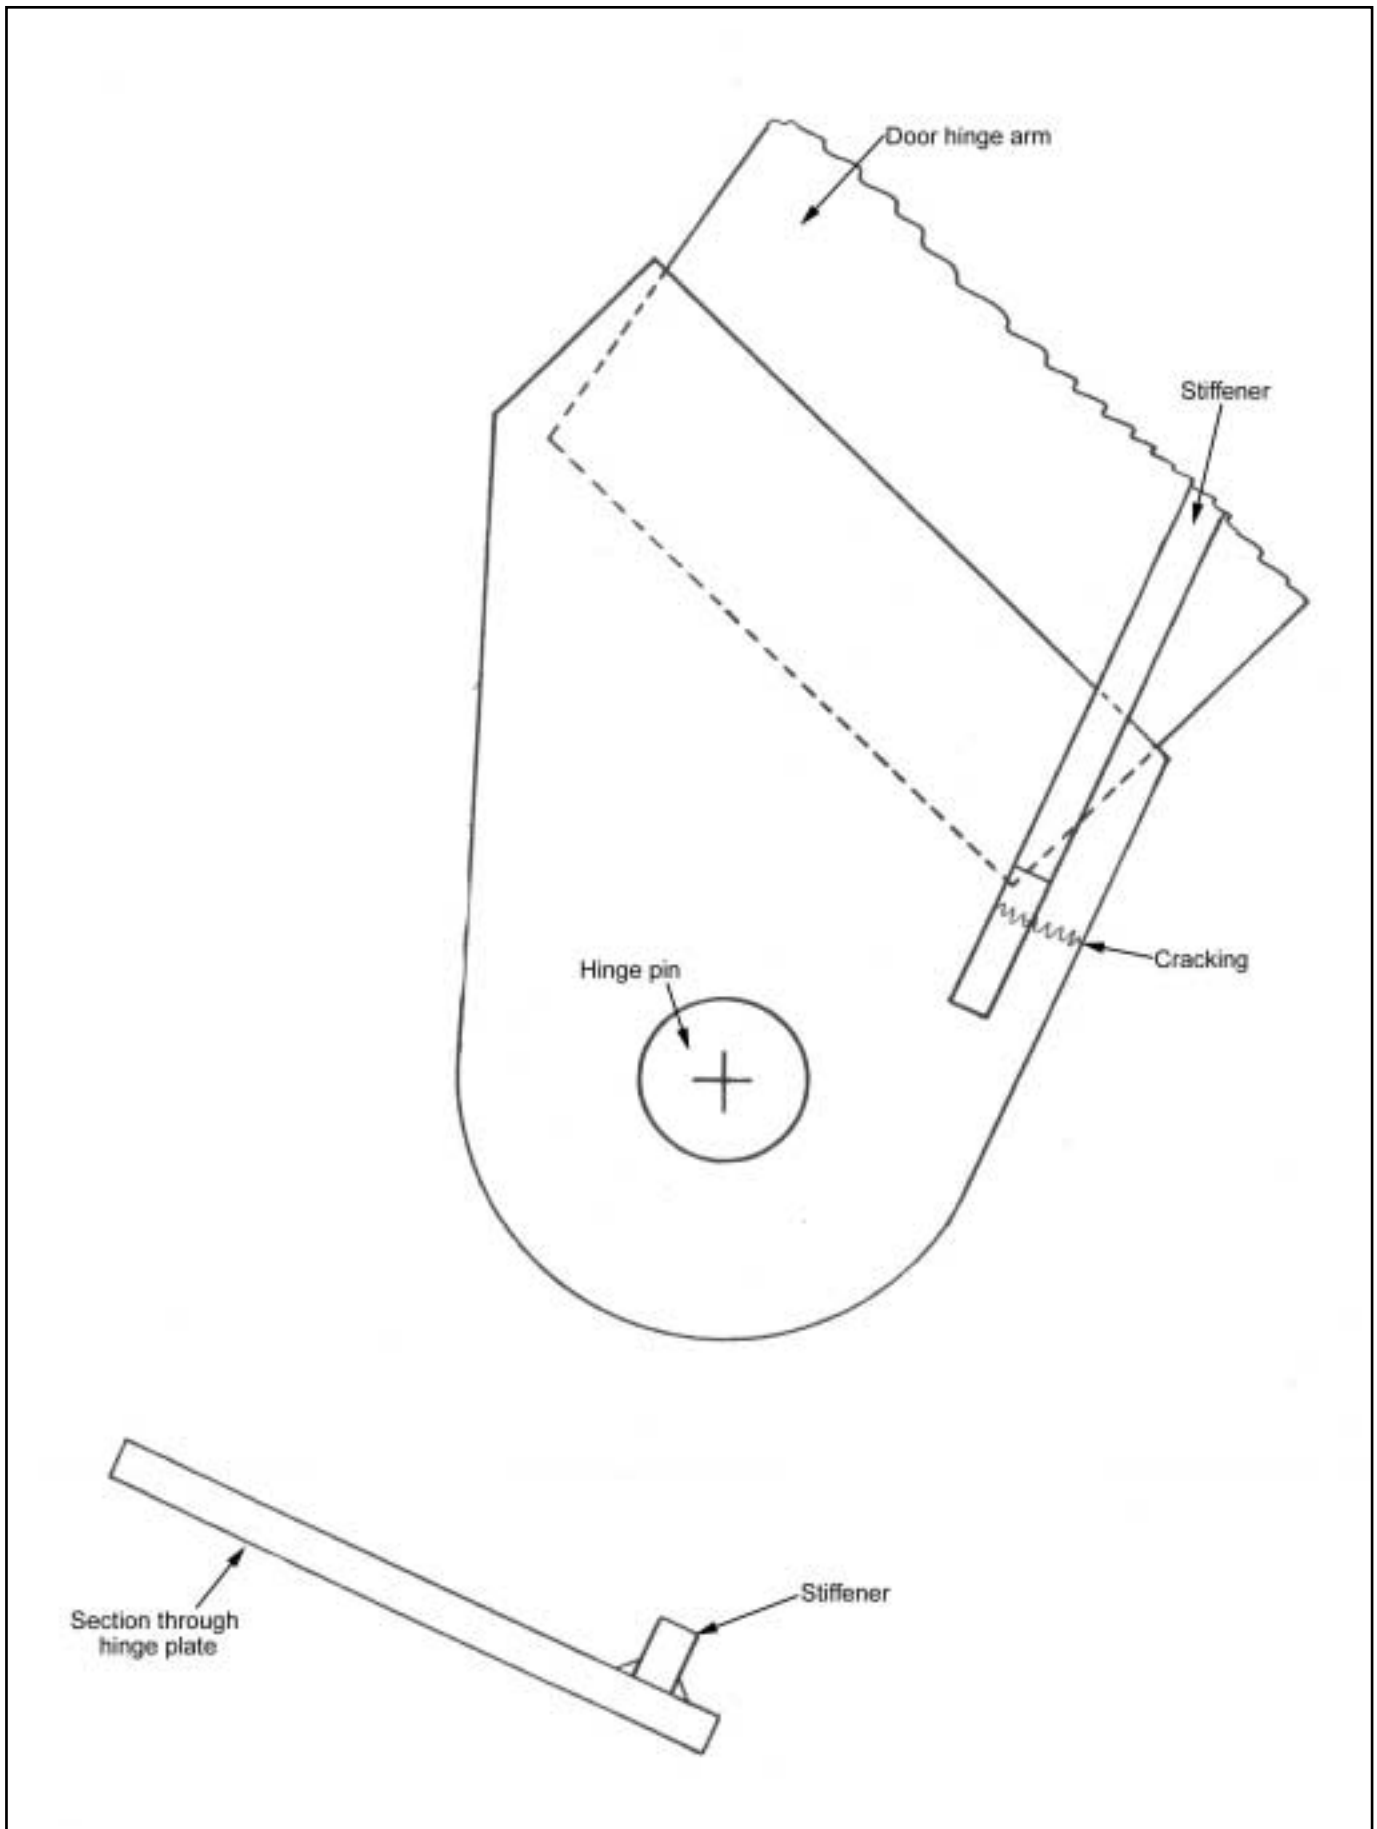
Figure 26

Detailed drawing of the hinge plate

The crack on the right side of the picture is semi-circular in shape, although one side is hidden. The middle of this area is adjacent to the corner of the hinge arm (**Figure 26**), which was identified as being subject to stress close to yield by the structural calculations. The crack began in the underside of the hinge plate, possibly in a weld defect. A stress cycle occurred each time the hydraulic ram exerted its full force on the hinge plate while trying to fully open the starboard bow door. The stress cycles slowly spread the crack, increasing the size of its semi-circular shape. The middle of the semi-circle at the bottom is a darker brown, indicating a greater amount of rusting; the corrosion would have had more time to form in this area. The crack spread until the hinge plate was close to failure. The grey area at the edge of the semi-circle is termed a “beach mark”, which is a crack arrest or fatigue mark indicating changing loading conditions. This area shows a substantial increase in the size of the crack, probably during the stress cycle immediately before the one that caused the failure. This grey area has had insufficient time to corrode.
