Report on the investigation of
contact with Number 16 buoy by

Scot Venture

Drogden Channel, Denmark

**Report No 11/2004
September 2004**

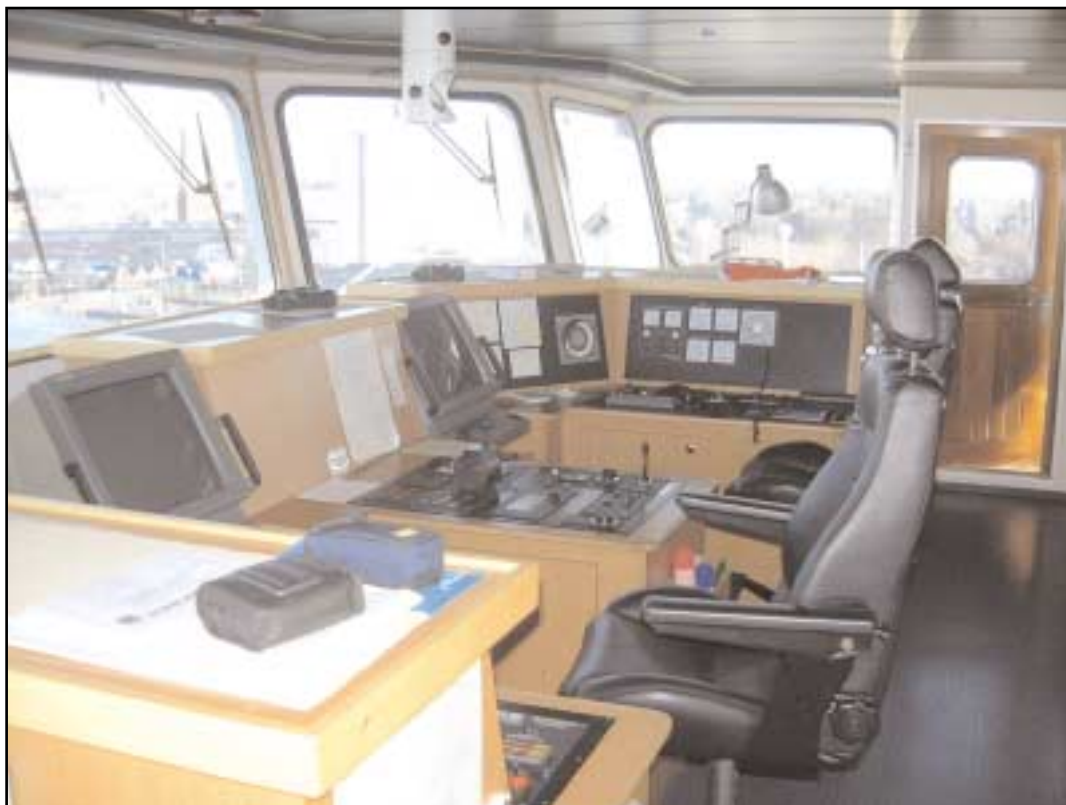
Photograph of the bridge

At the time, the master was in his bathroom, but he managed to reach the bridge within about a minute. During this short period, the chief officer saw Number 16 buoy ahead at about 40m off the starboard bow, and applied port helm to manoeuvre the ship clear. He did this while watching the buoy; he did not monitor the amount of rudder used, or the rate the ship was turning. The manoeuvres were conducted while the chief officer was standing behind the starboard radar display (**Figure 2**), from where the buoy was seen to be passing very close down the starboard side.

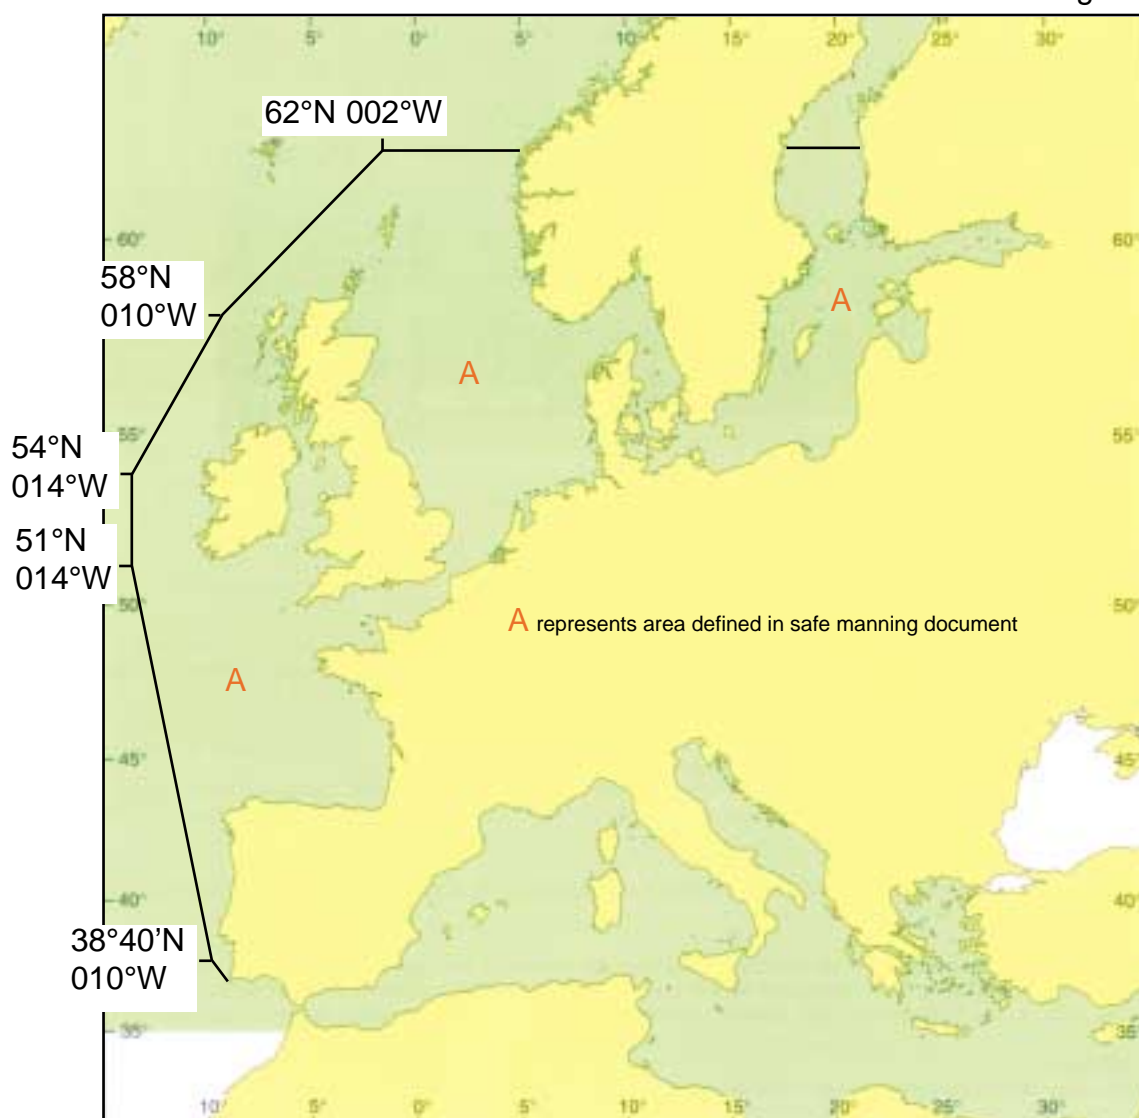
Area defined in the safe manning document

within the area bounded by a line from a point on the Norwegian coast in latitude 62° North to a point 62° North 02° West; thence to a point 58° North 10° West; thence to a point 54° North 14° West; thence to a point 51° North 14° West; thence to a point 38° 40' North 10° West; thence to Cape St Vincent including the Baltic Sea.

This area is shown at **Figure 5**. When operating outside this area, the ship was additionally required to carry a second engineer and an ordinary seaman. The ship's Safe Manning Document was re-issued on 11 February 2004, also making the carriage of an additional OOW (deck) a requirement when operating outside the area outlined above.

19. A requirement to carry an additional bridge watchkeeper when operating within the European Area (**Figure 5**) would contribute more to the safety of the vessel than a requirement to carry one outside this area. [2.6.2]
