Report on the investigation of

the grounding of

HC Katia

while undergoing sea trials in the Solent

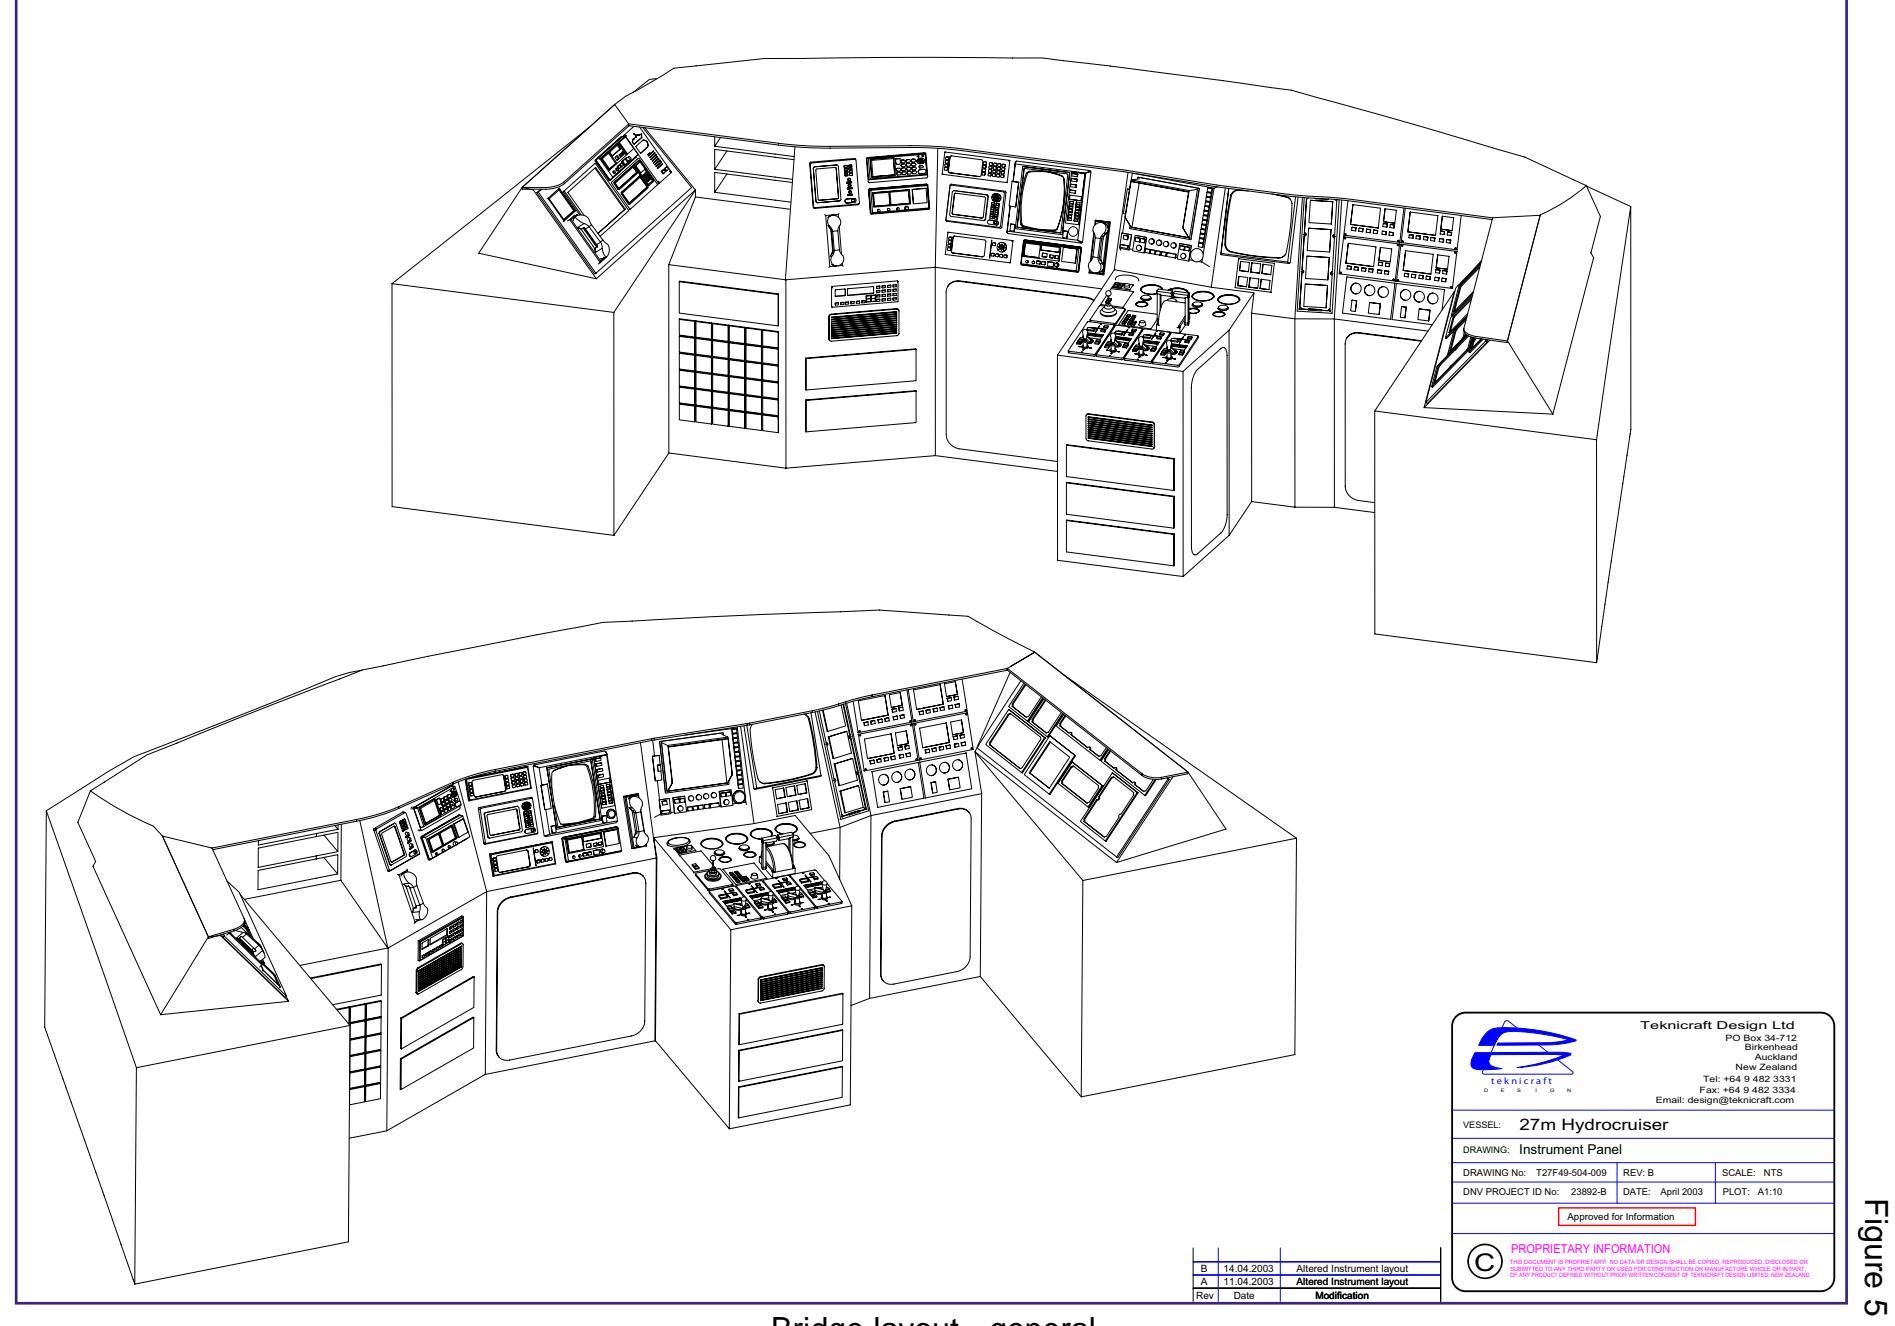
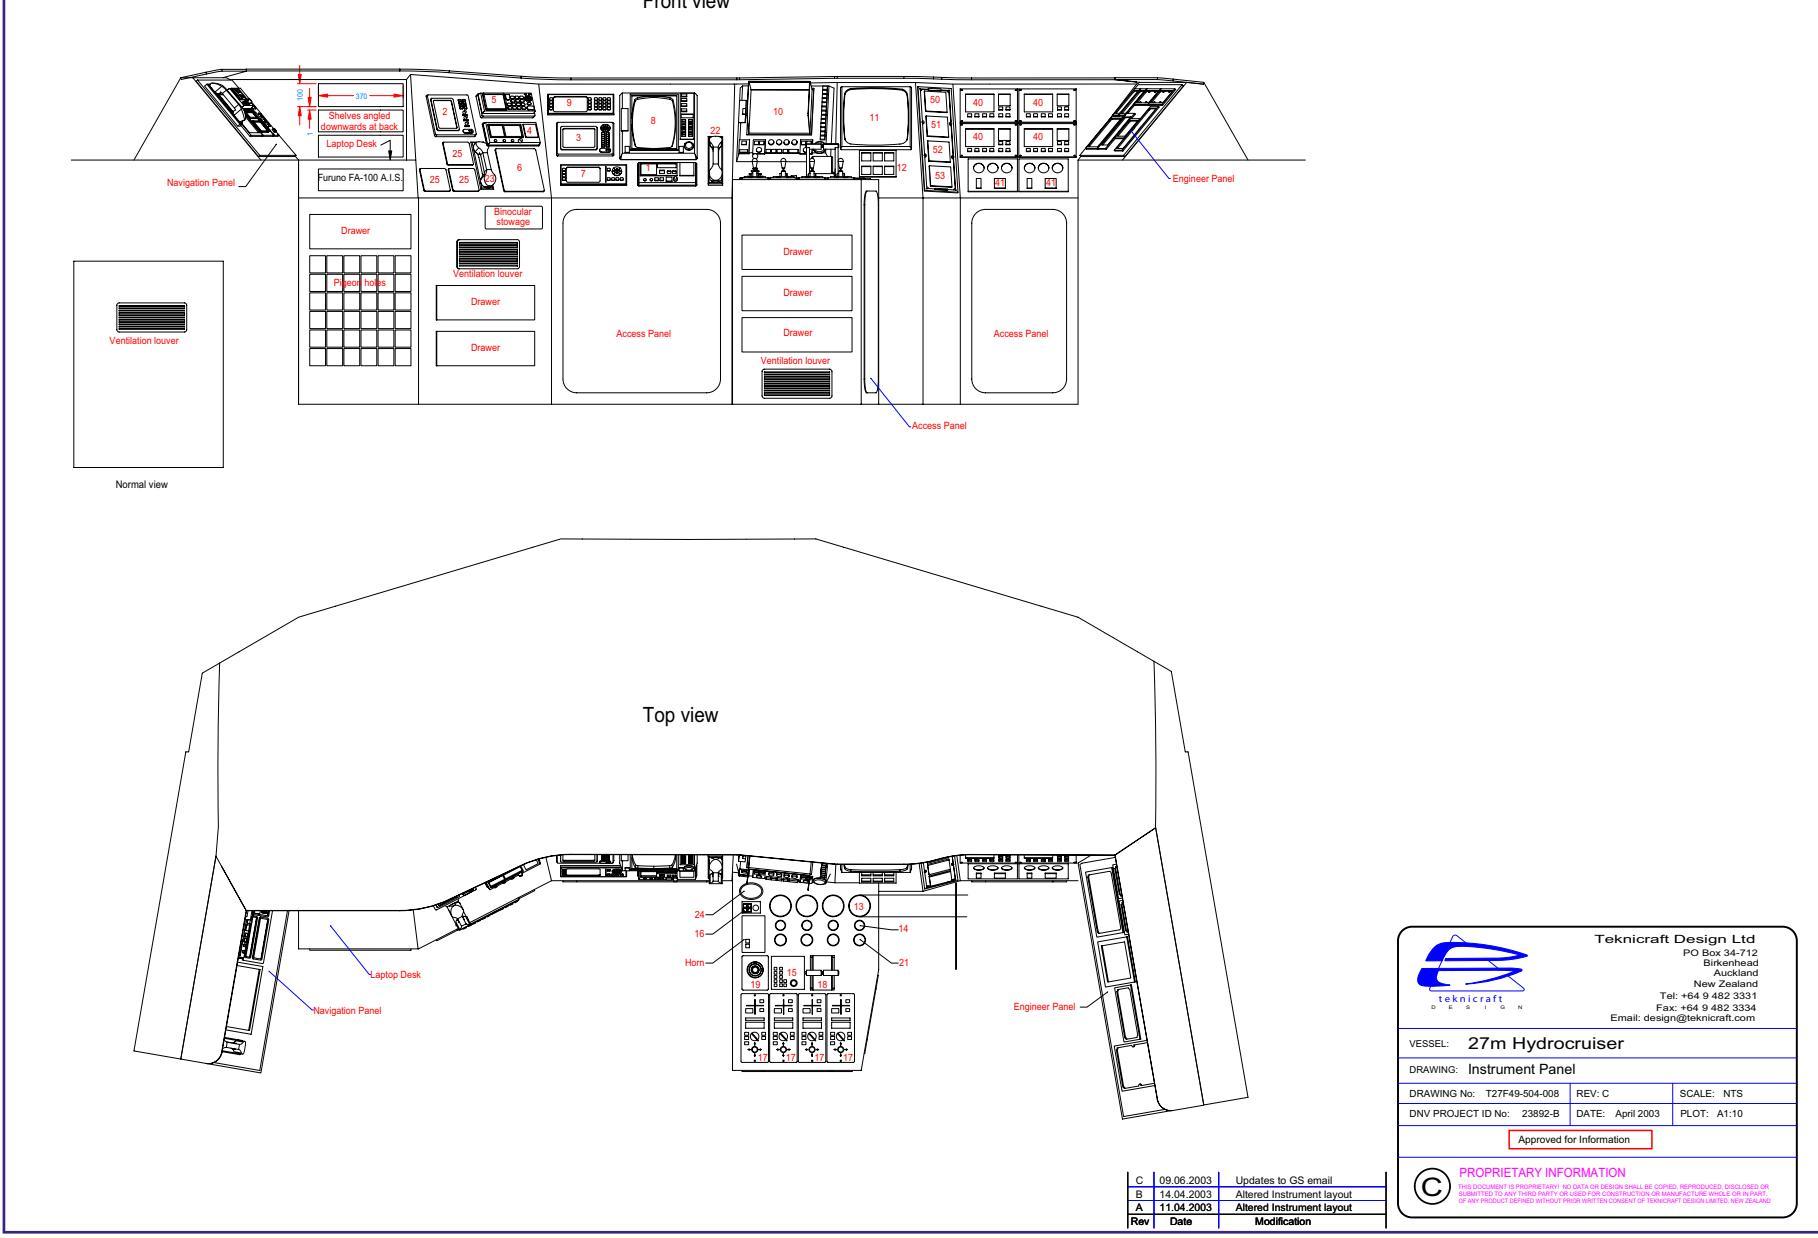
Figure 6

The builder fitted decorative mouldings around the large scantling stiffeners between the bridge front windows, to conceal wiring and pipework, which restricted the visibility from the pilot's control position.

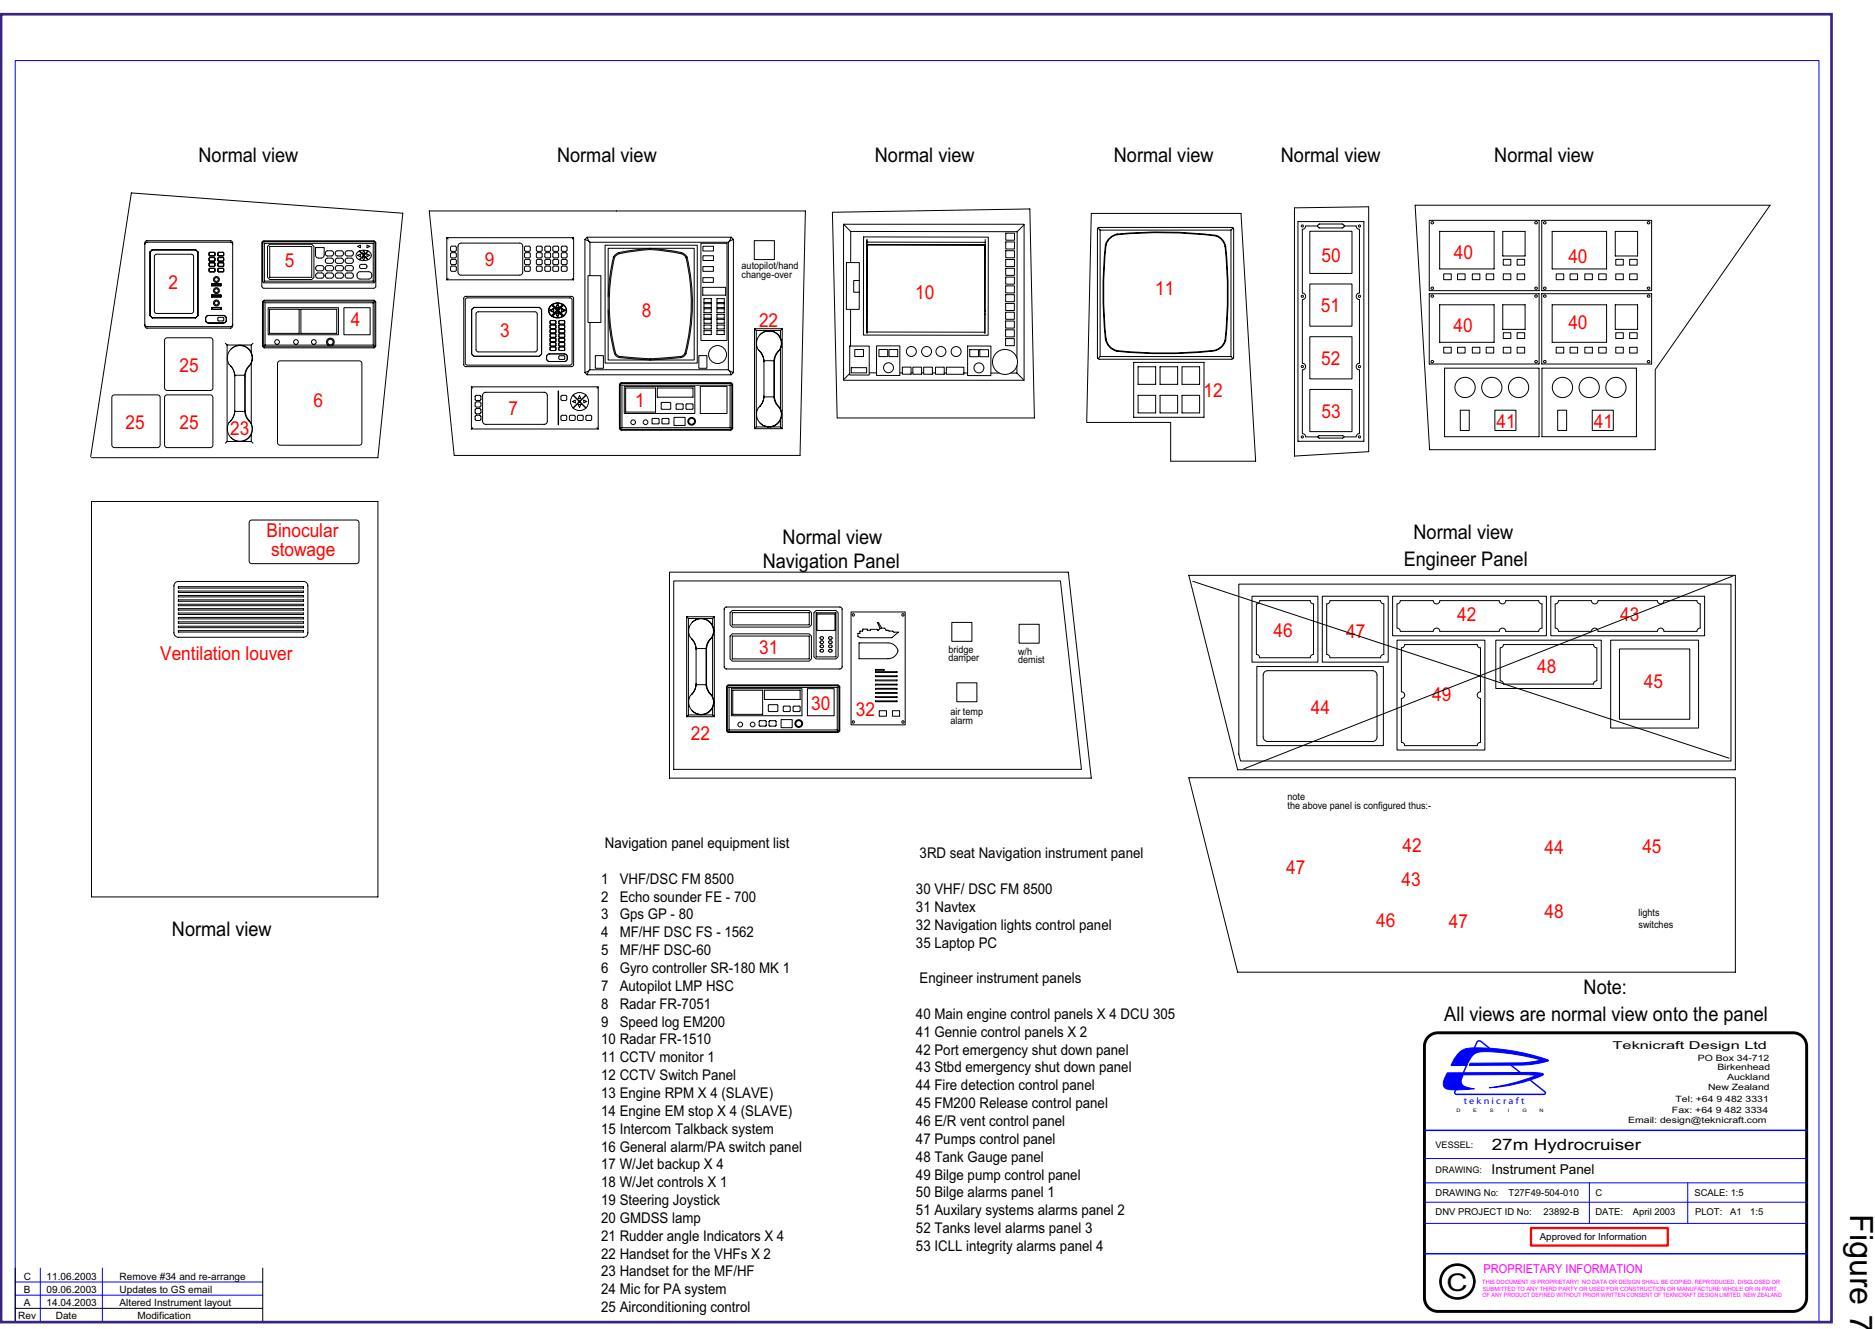
Bridge layout - equipment details

Although outline structural plans of the bridge were submitted to the MCA, detailed bridge control layout plans were not made available before the accident, and therefore no formal approval of the bridge layout, by a flag state nautical professional, was possible.
