Report on the investigation of
Nottingham Princess
striking Trent Bridge Nottingham
on 15 November 2002

Report No 21/2003
August 2003

On 15 November 2002, during an evening river cruise, the river cruiser *Nottingham Princess* collided with repair scaffolding around the centre arch of Trent Bridge, Nottingham.

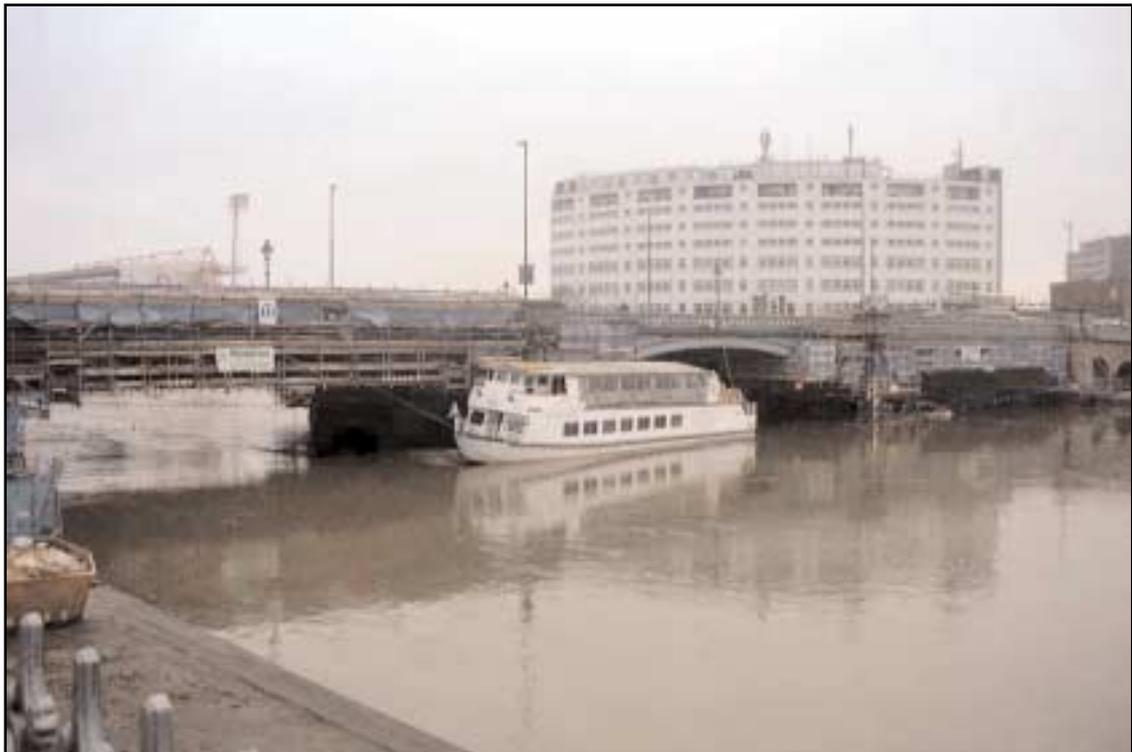
Figure 4

Trent Bridge

The bridge has stone and brick abutments and piers, while the arches, deck and parapets are a mixture of cast iron and steel. The bridge is a listed structure.

The flow under the bridge during high water levels is often confused, consisting of eddies and whirlpools, as the water is funnelled between the two arches. There is also a patch 1.5m deep immediately upriver of the southern buttress. For the river depths in the vicinity of the bridge (**Figure 5**).

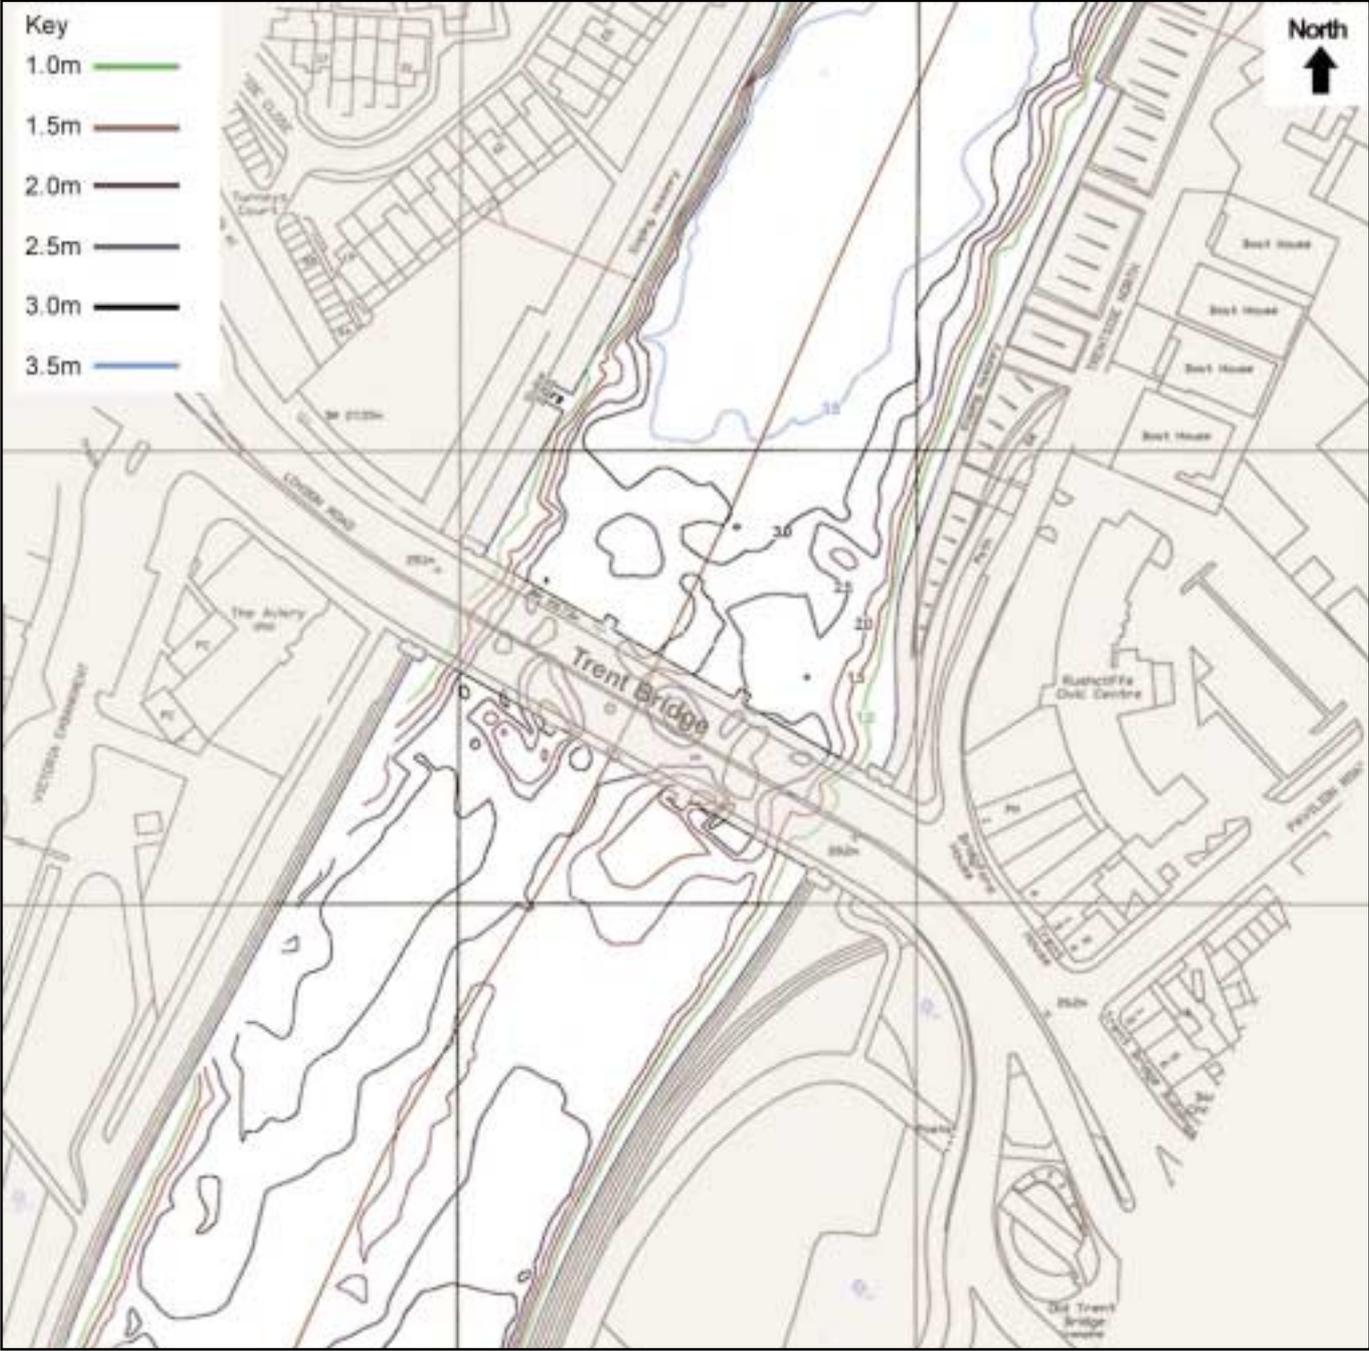
Figure 5

River Trent depths
