Report on the investigation of
the aggregates dredger
Donald Redford
colliding with Hythe Pier,
Southampton Water
on
1 November 2003

Marine Accident Investigation Branch
First Floor
Carlton House
Carlton Place
Southampton
United Kingdom
SO15 2DZ

**Report No 6/2004
May 2004**

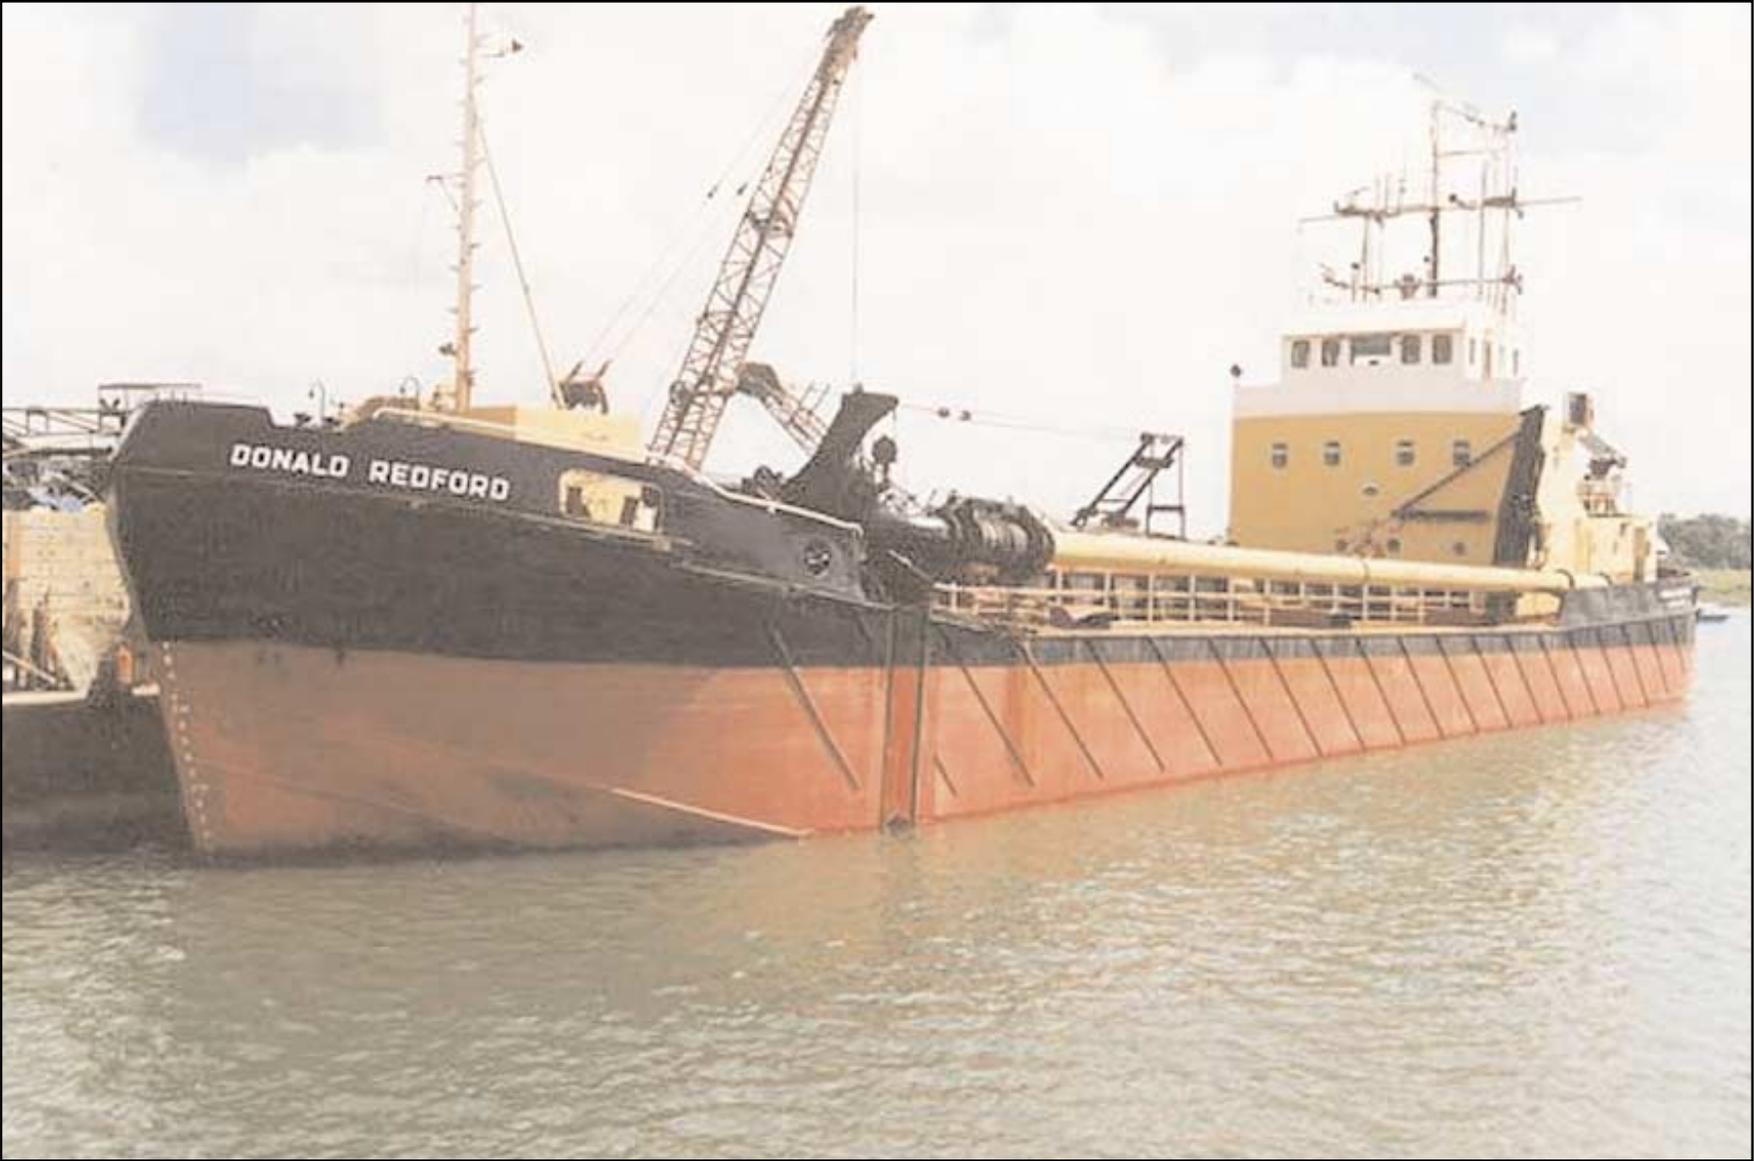
Figure 1

Donald Redford

A view of *Donald Redford* is shown in **(Figure 1)**.

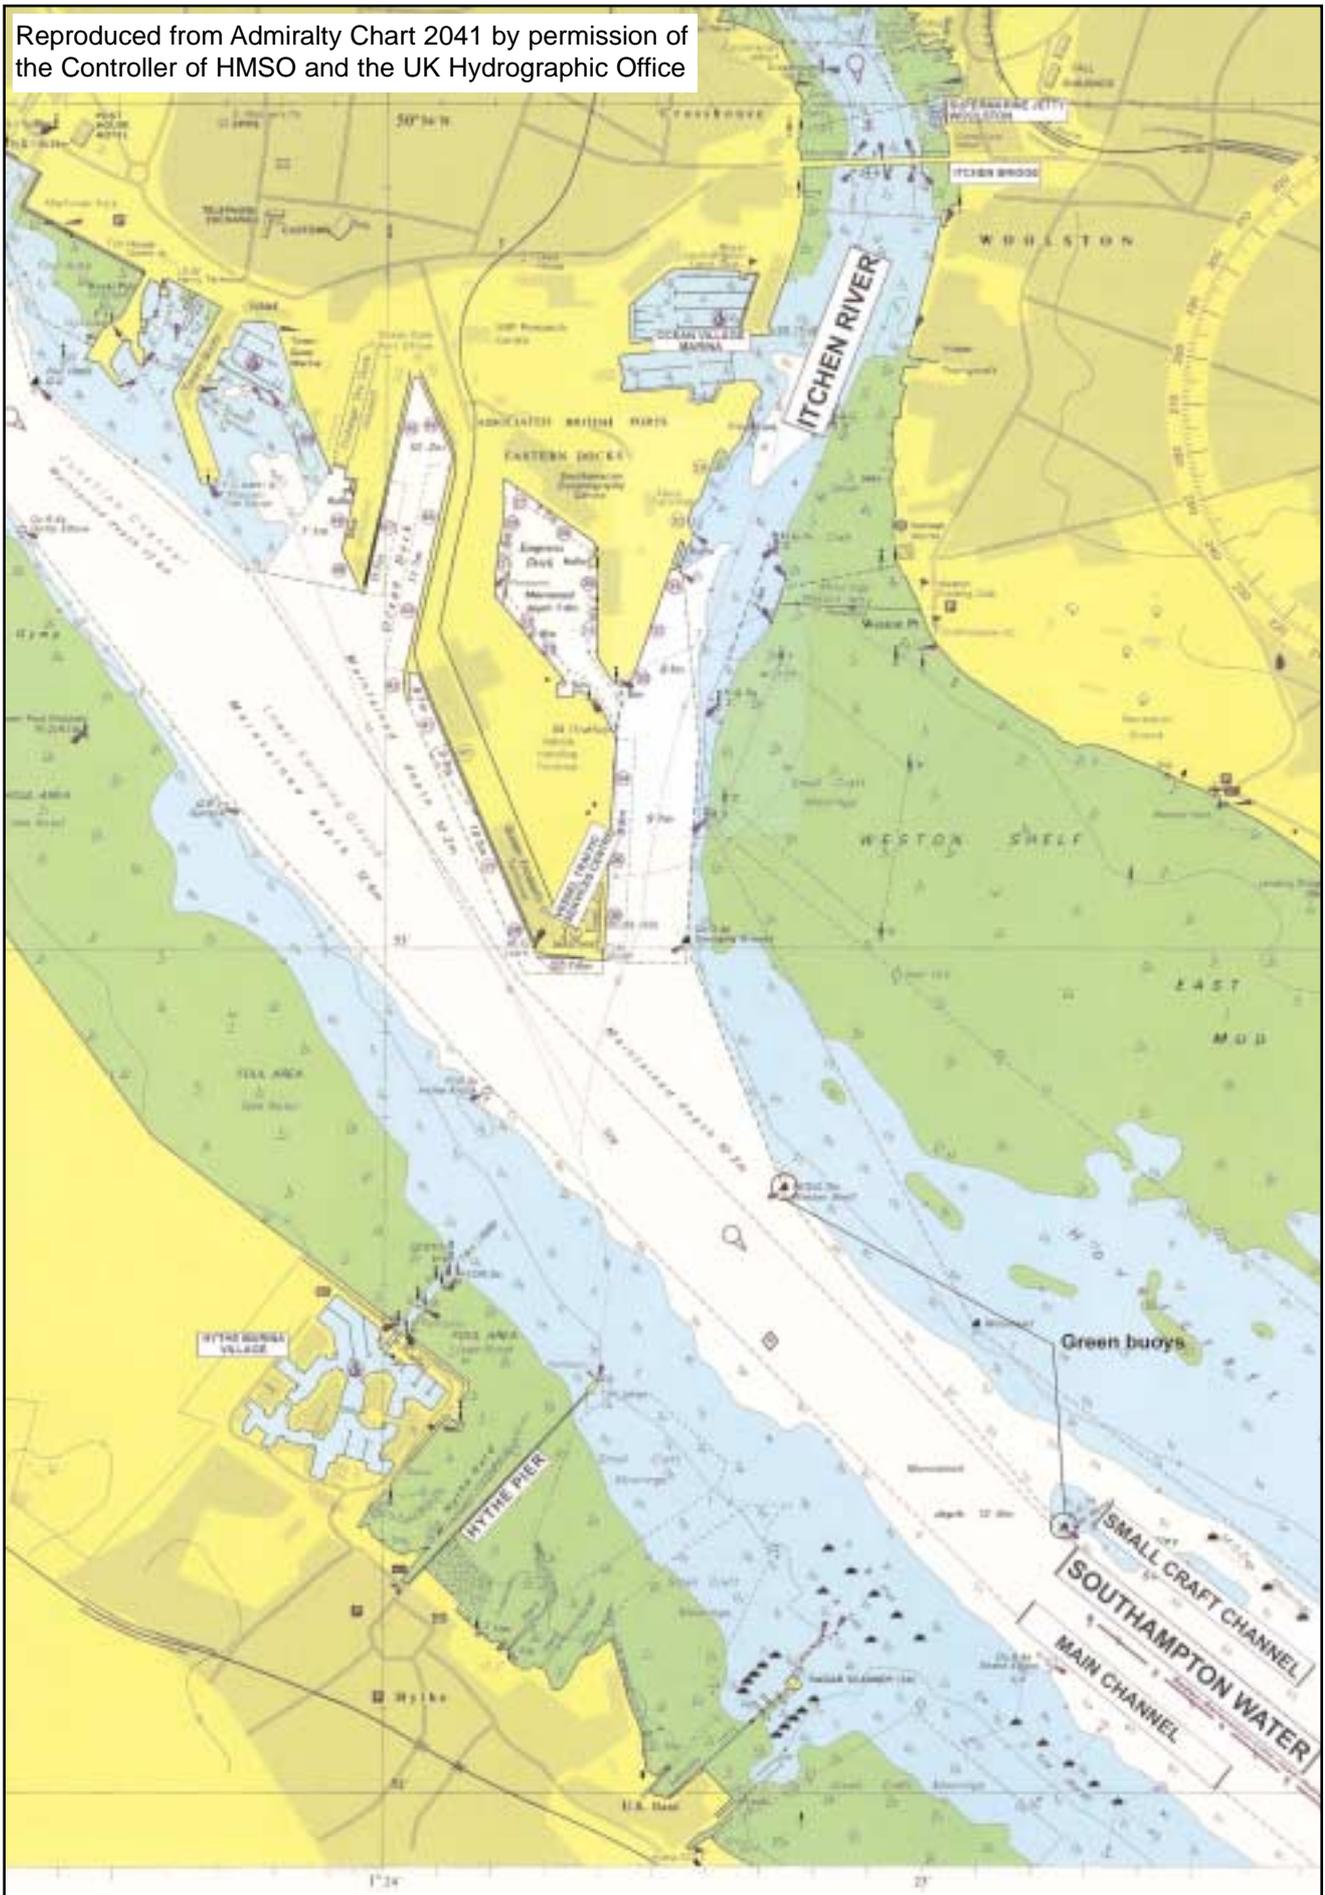
The Port of Southampton

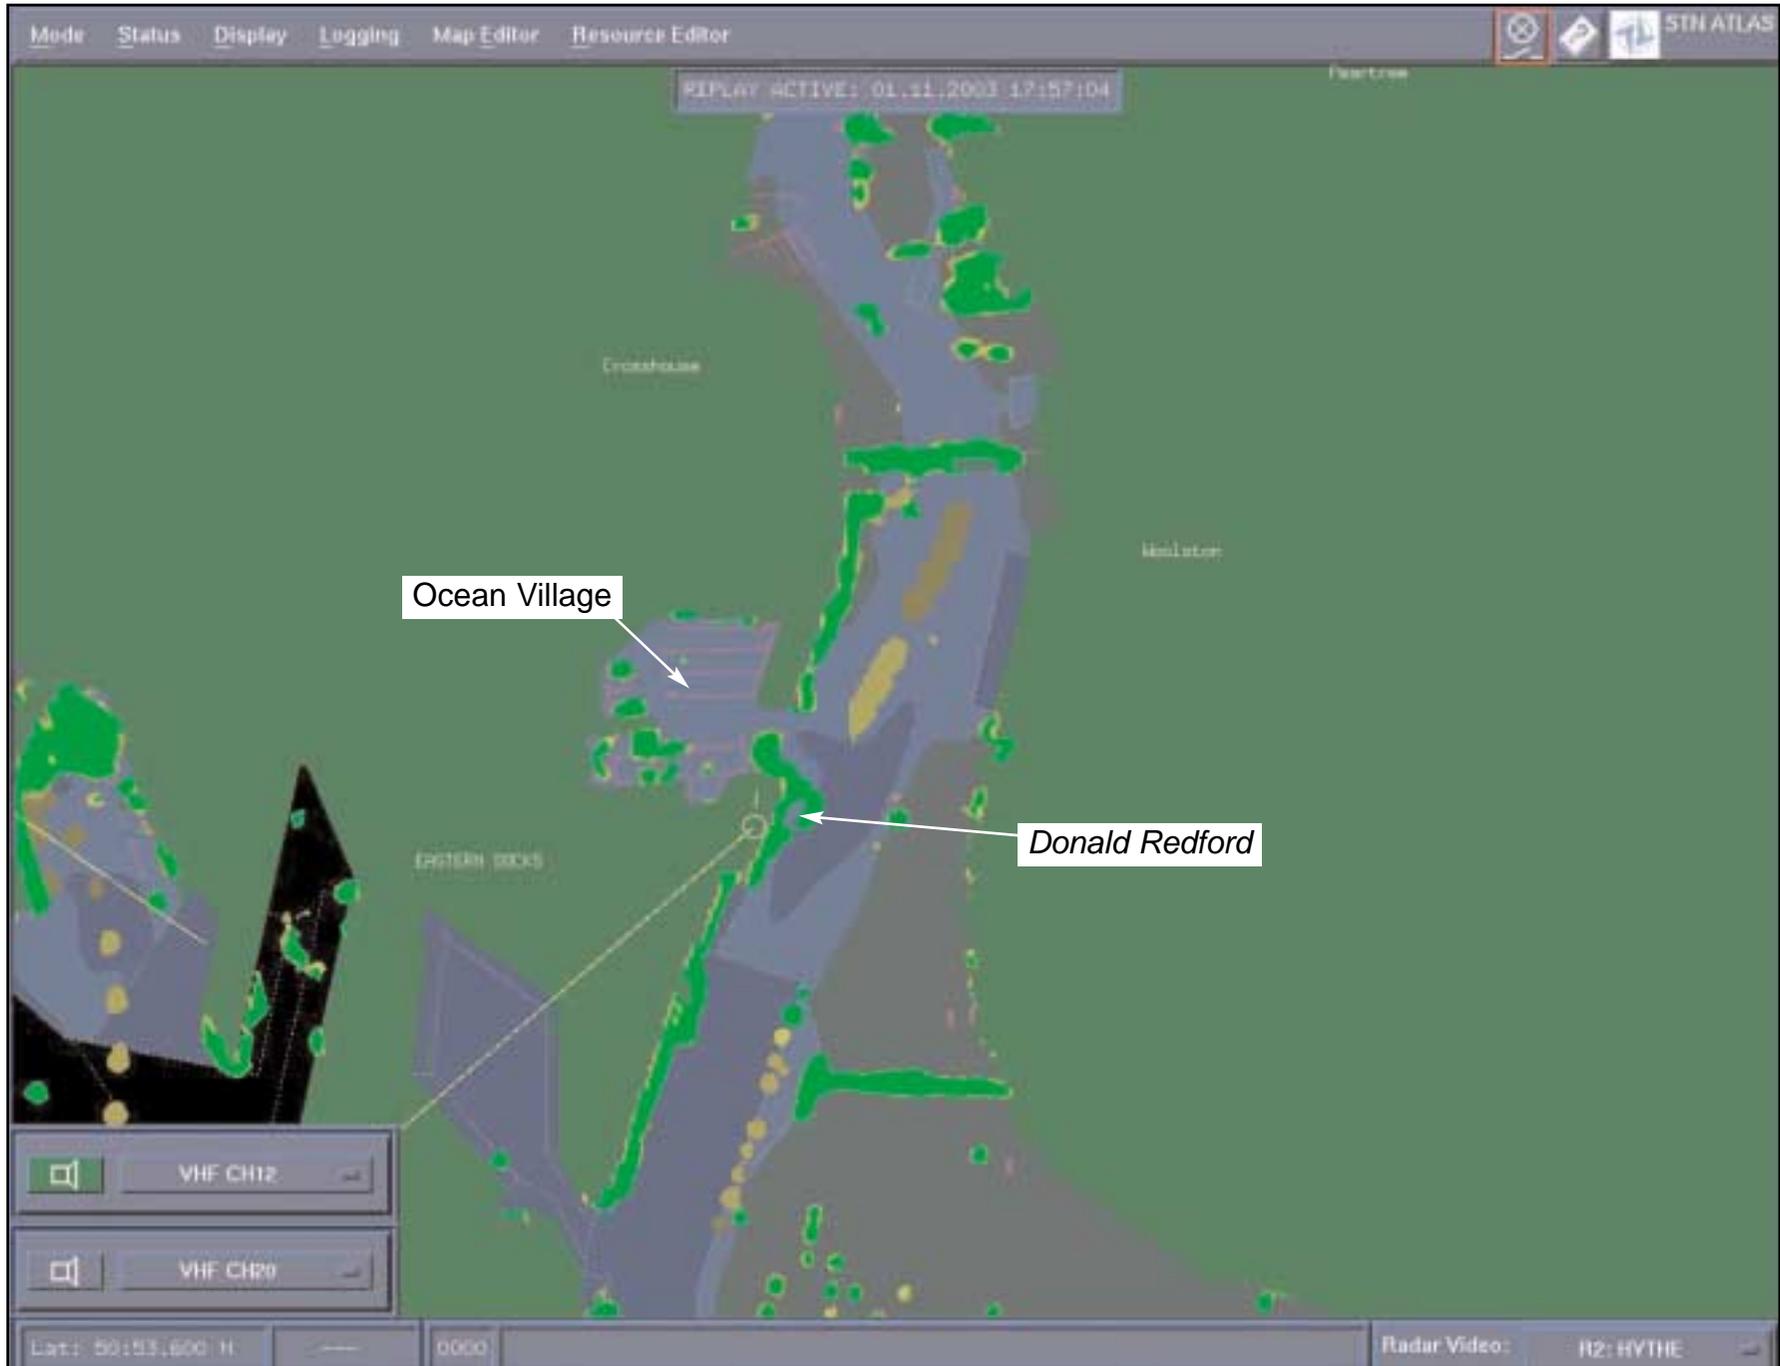
Figure 3

Magnified section of VTS radar screen

The junior master called again, at the reporting point, when *Donald Redford* was clear of the Itchen Bridge (**Figure 3**). The VTS(A) acknowledged receipt and passed more traffic information. The junior master stated once again that his vessel would make passage *east of the greens*. By restating that he would be *east of the greens*, the junior master probably intended to re-emphasise that he would be out of the main channel in Southampton Water. After this conversation, the VTS(A) again expressed his concerns to the VTS(O), because the speech of the junior master was significantly slurred. The VTS(O) was listening to Channel 12 at the time, so would have heard the junior master's voice.

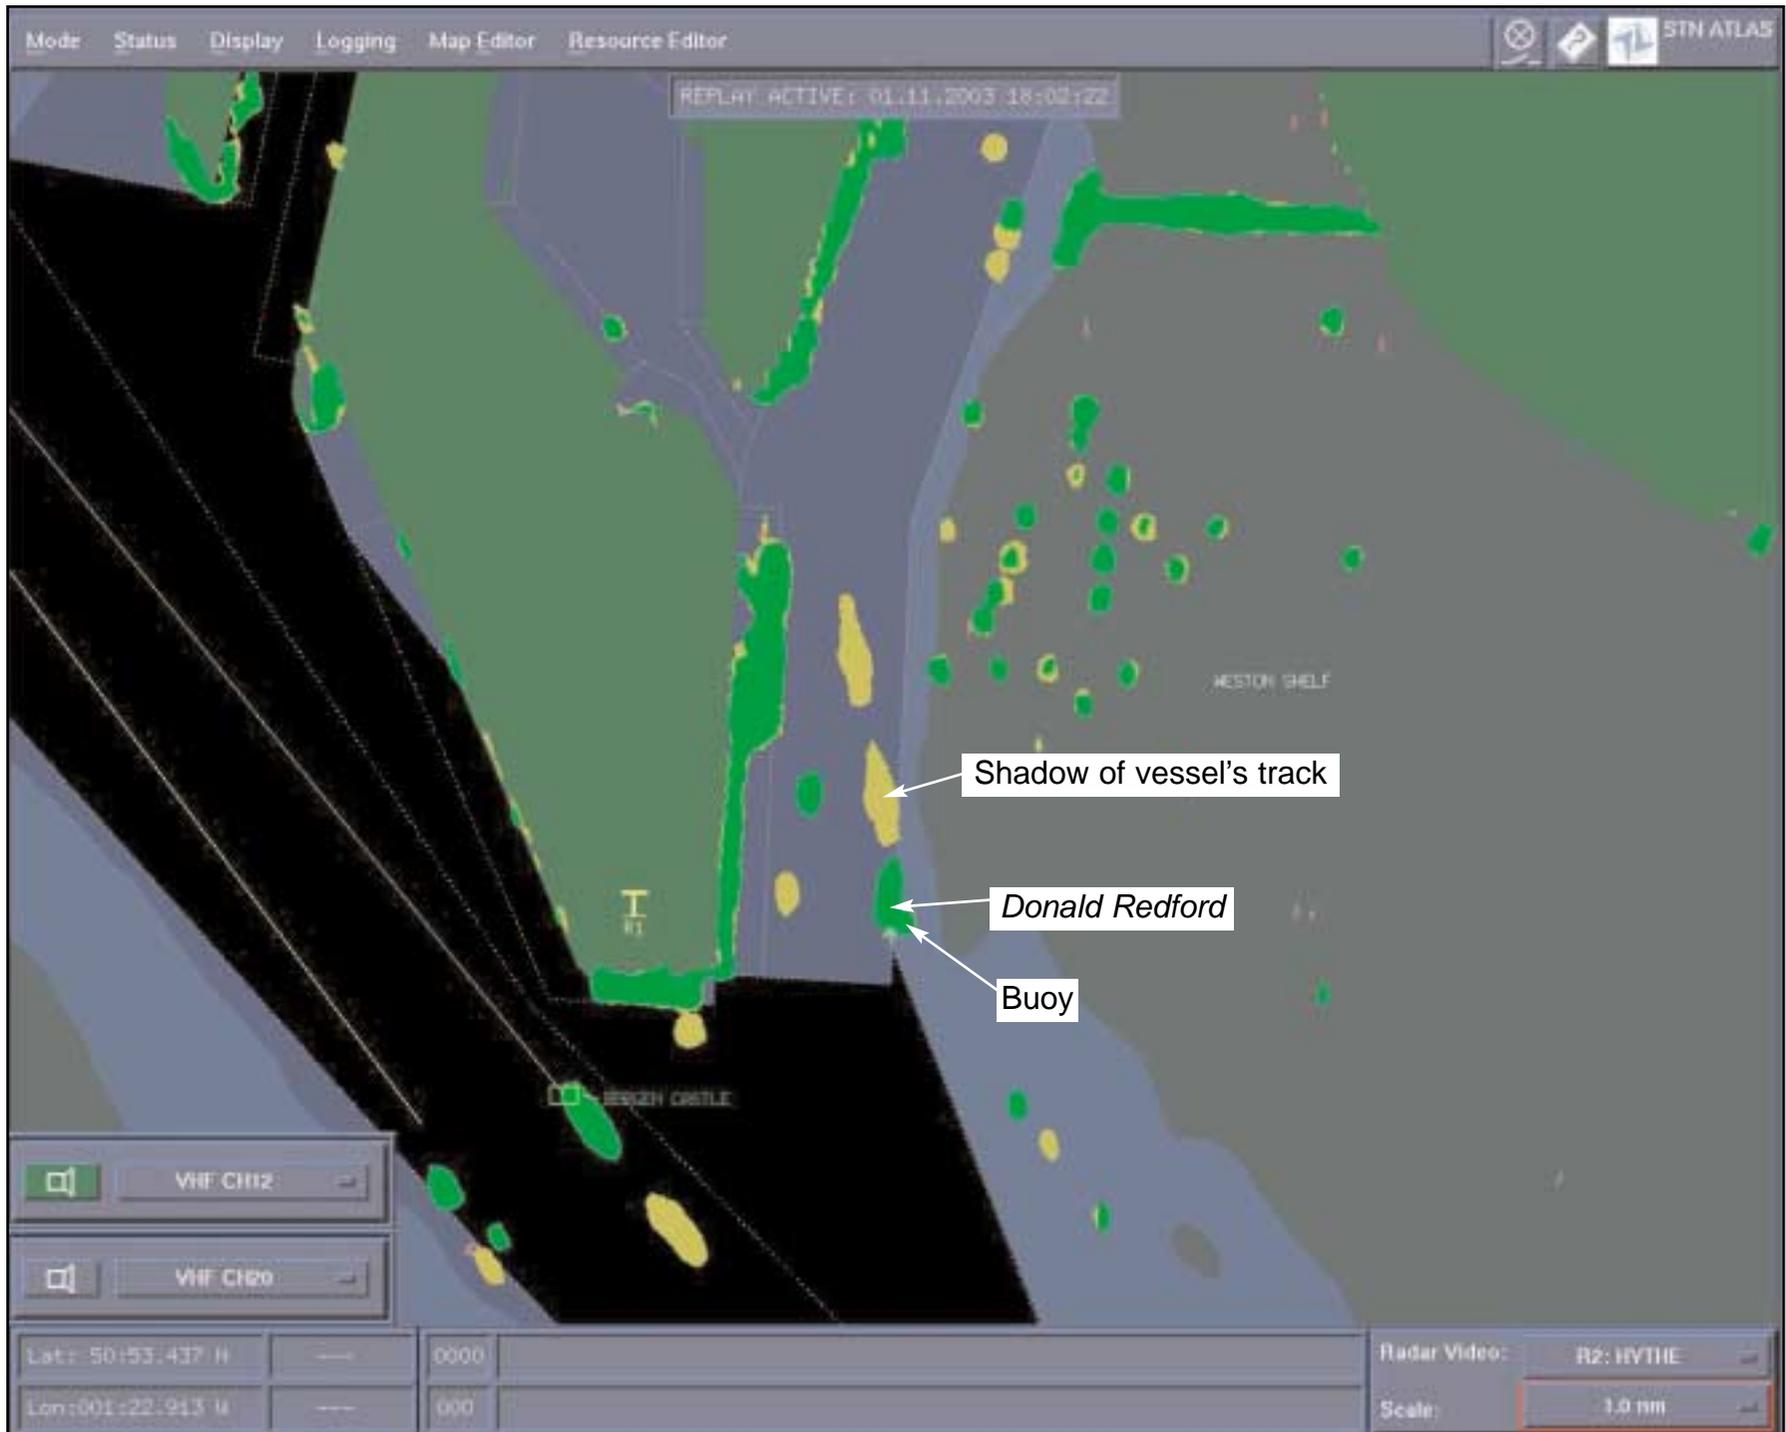
Magnified section of VTS radar screen

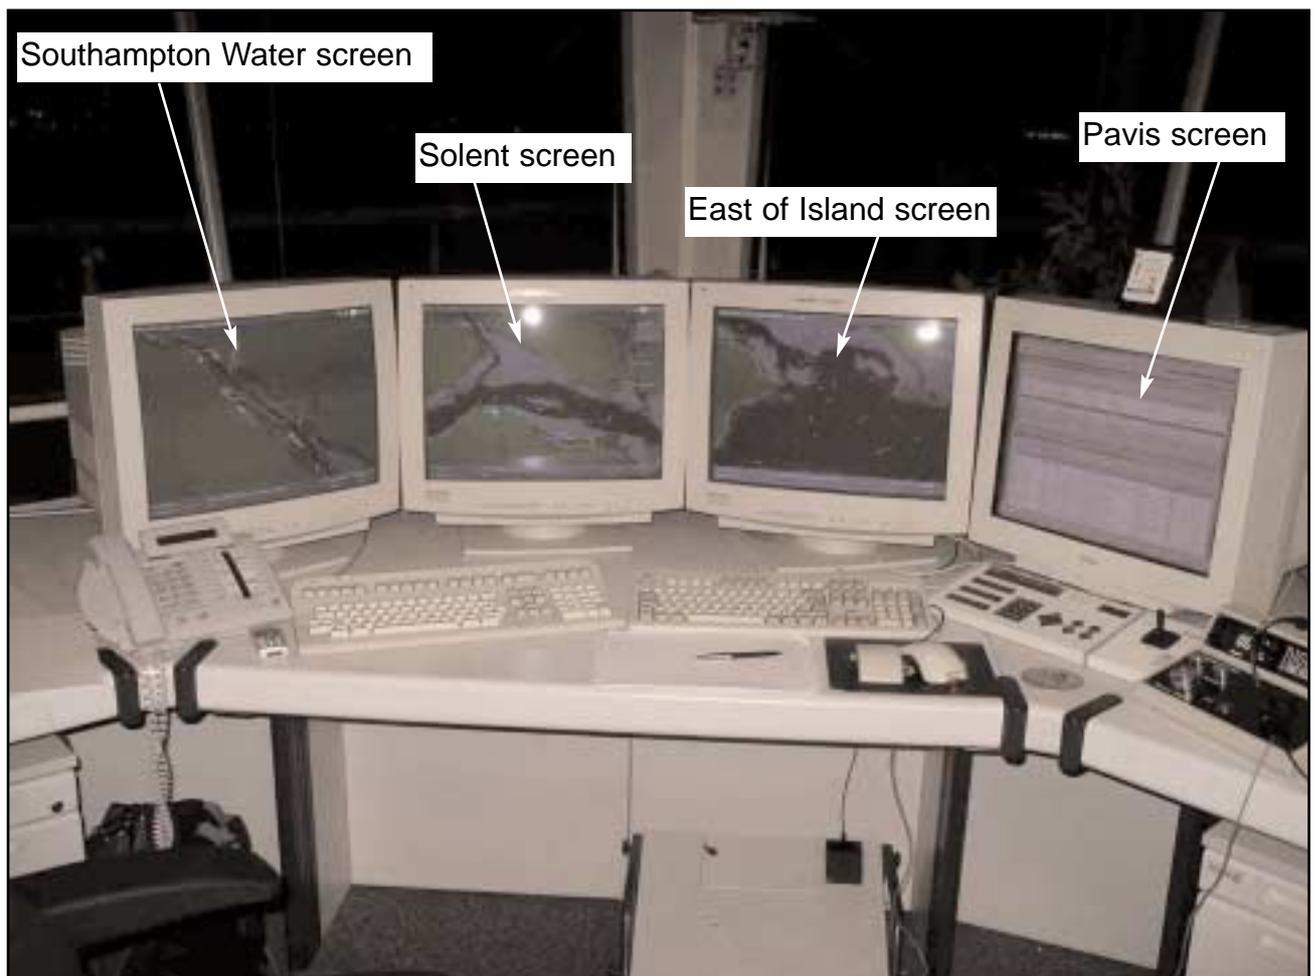
Figure 10

The VTS(A)'s work station

About four minutes later, *Donald Redford* nearly hit the quayside to the south of the entrance to Ocean Village (**Figure 4**). The Channel 12 VTS(A) was monitoring three radar screens, which were on their normal settings to monitor the entire VTS area (**Figure 10**). The one screen which covered Southampton Water was set on a small scale (**Figure 11**), so the event would have been difficult to see clearly. The duty Channel 12 VTS(A) changed at about that time.

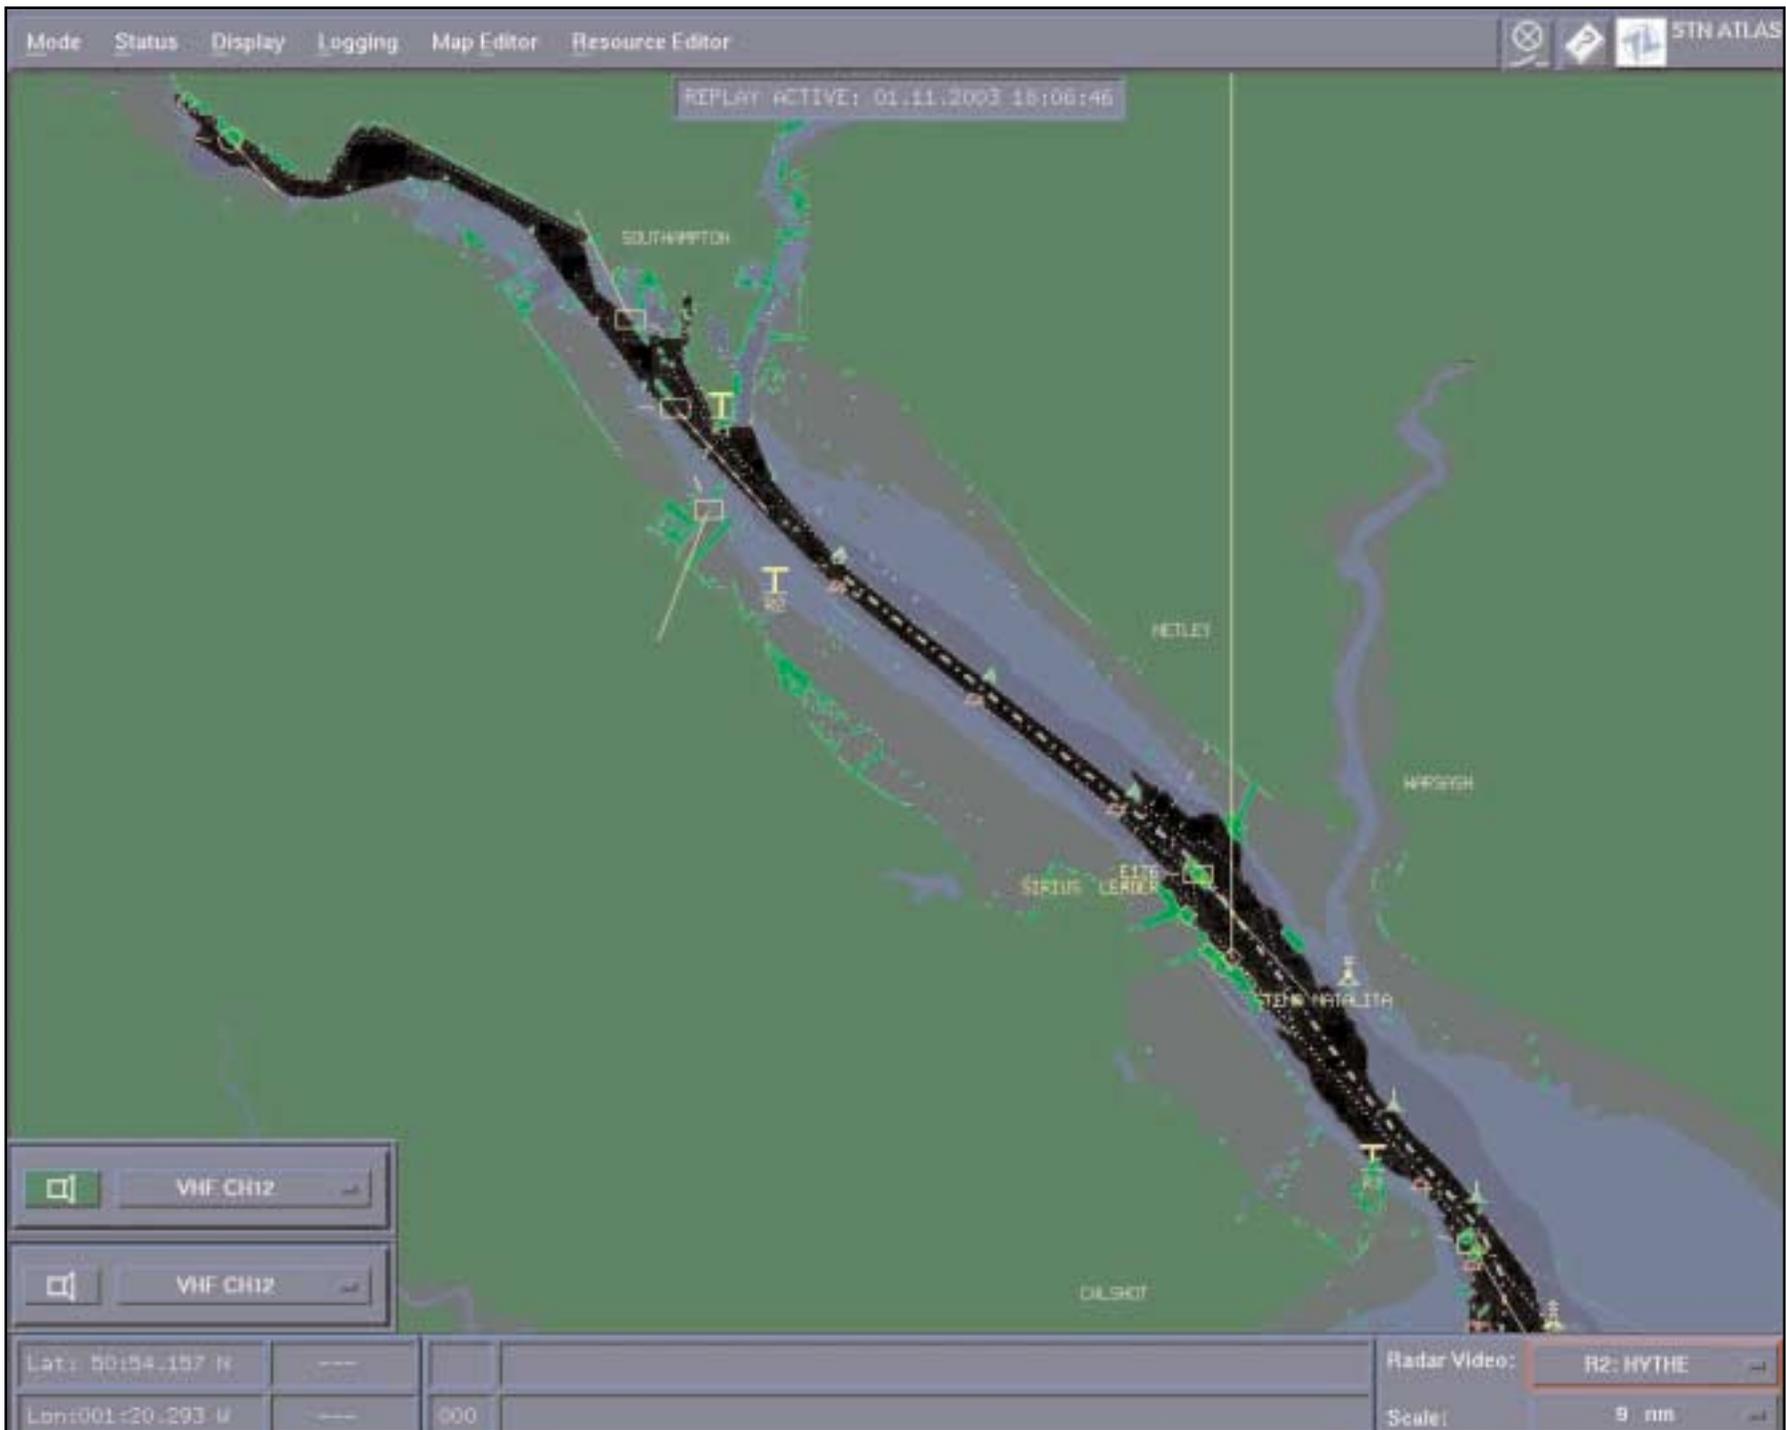
Figure 11

The VTS(A)'s screen showing Southampton Water and the Port of Southampton

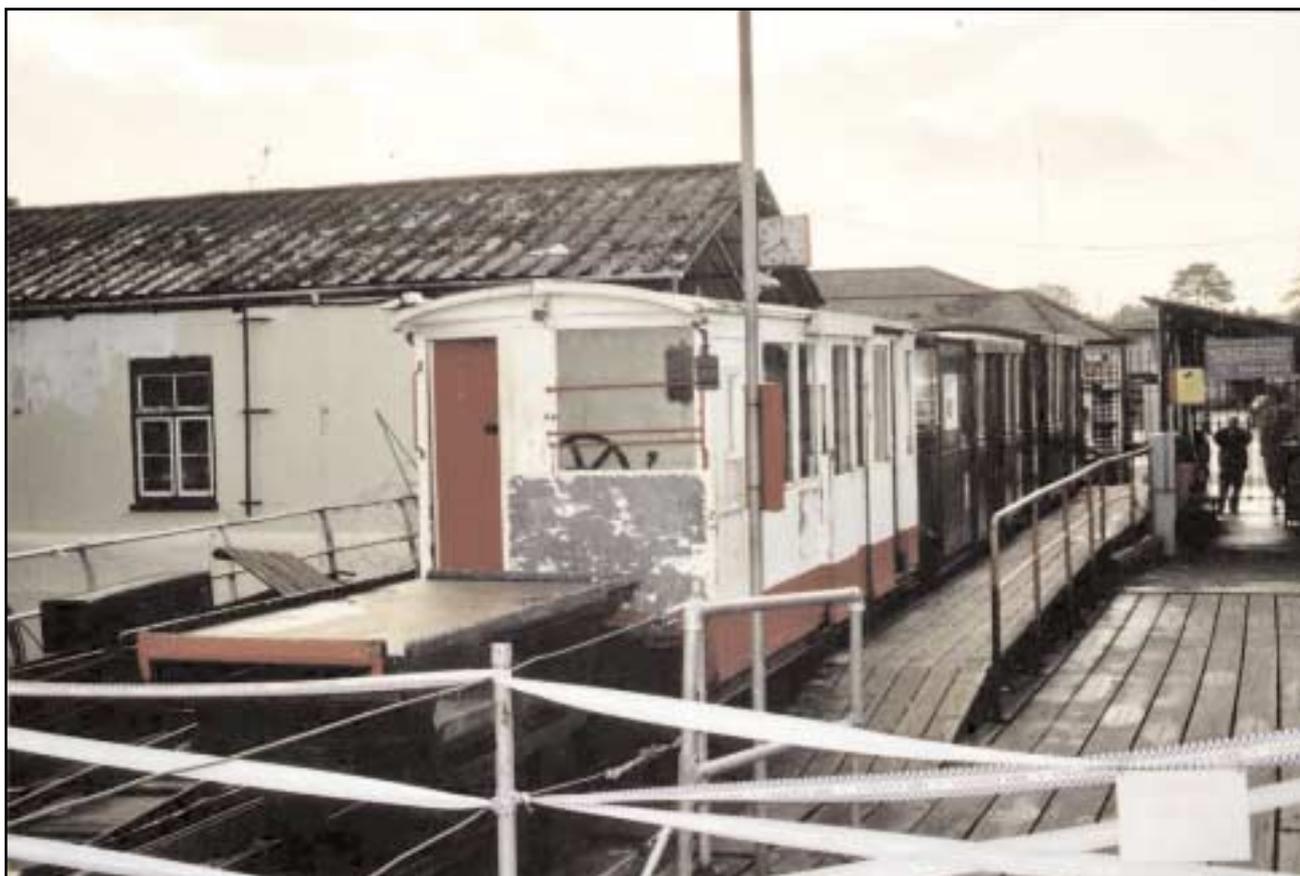
Figure 12

The pier is about 600m long, and has fixed navigation lights at its end. A small electrically-powered train, which could carry up to 50 people, ran along the pier for those passengers who preferred not to walk (**Figure 12**).

The train

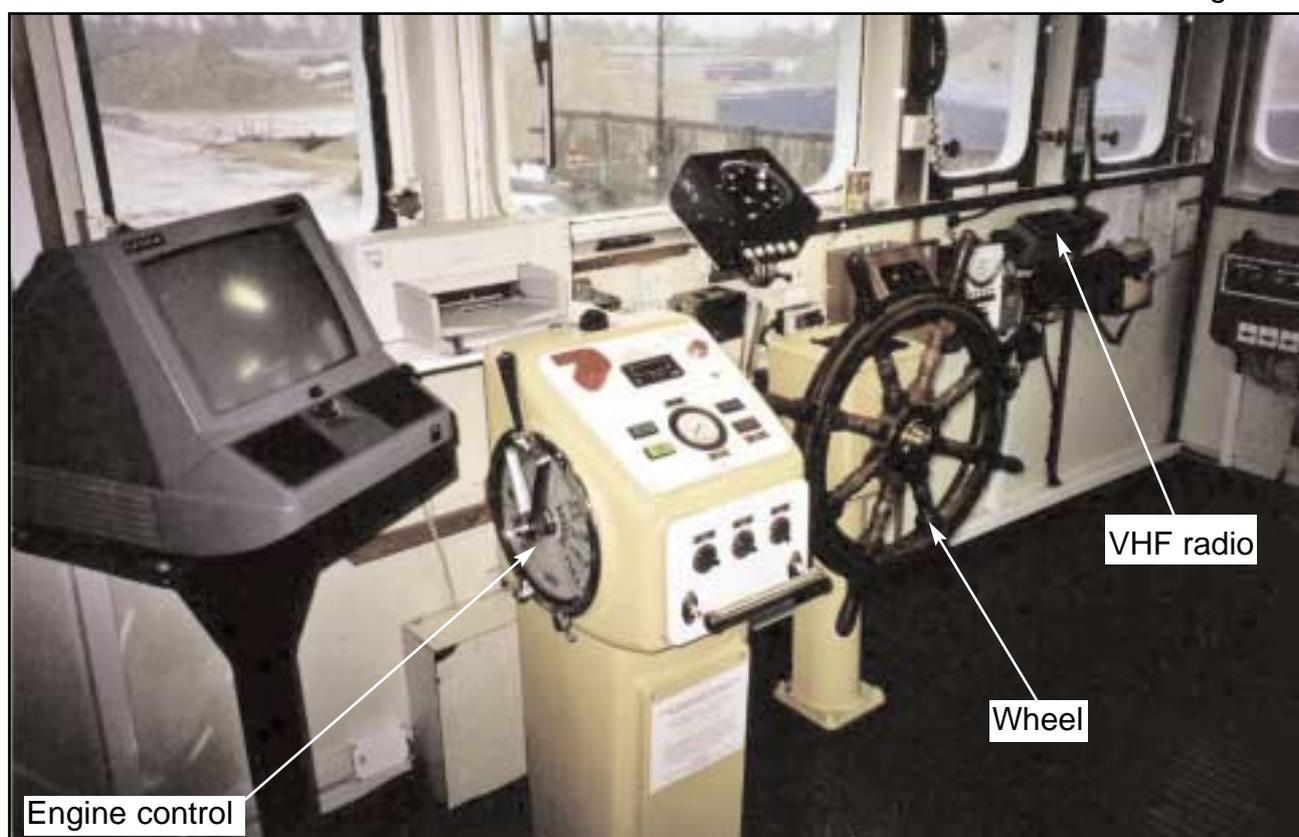
Figure 16

Donald Redford could be hand-steered using the wheel (**Figure 16**), but she could also be steered using the autopilot, the controls for which were mounted on the deckhead above the VHF radio. The junior master vaguely recalls engaging the autopilot in the vicinity of the mouth of the Itchen River. It is probable that the autopilot was engaged, and that the junior master was steering the vessel using the autopilot controls near to where the VHF radio was mounted. During the passage, the junior master was attempting to navigate by eye, was controlling the vessel and dealing with communications.

The bridge on *Donald Redford*
