Report on the investigation of  
the capsizing and sinking of the fishing vessel

***Chelaris J (GU323)***

1 October 2003

**Report No 7/2004**  
**July 2004**

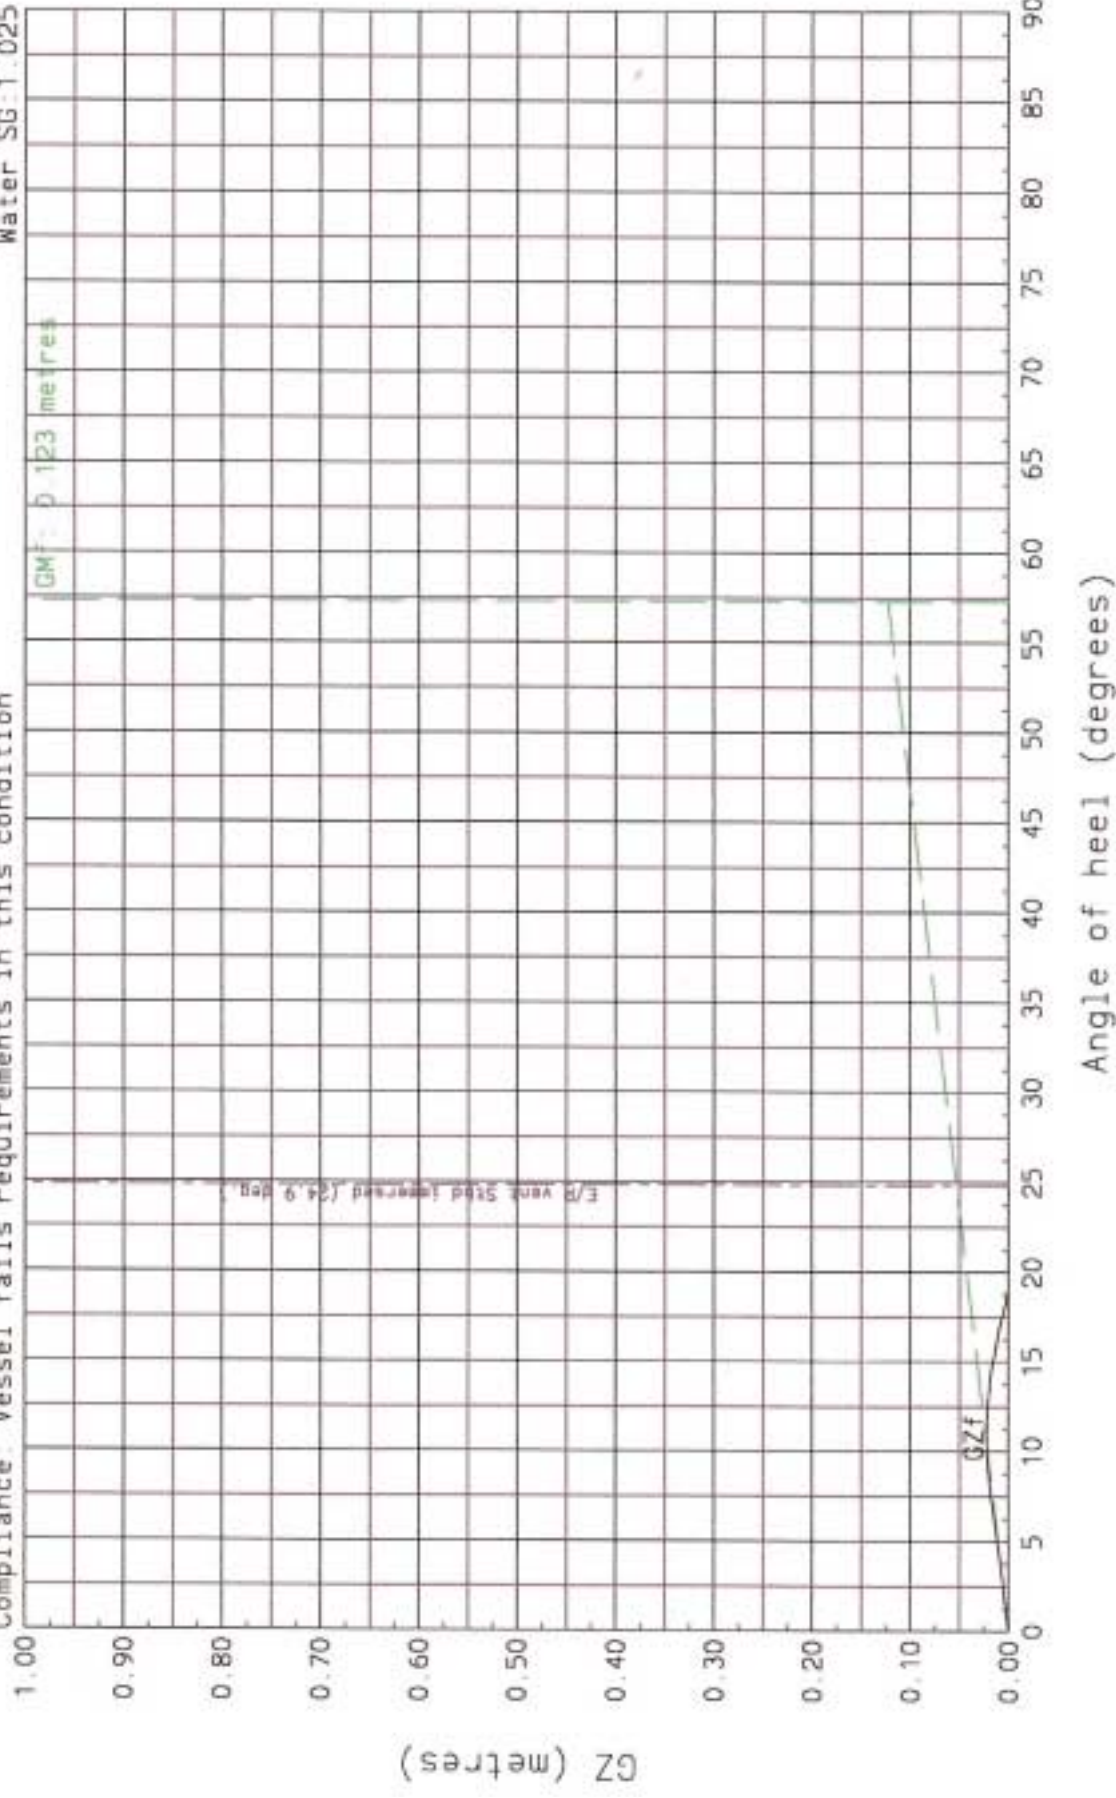
Compliance: Vessel fails requirements in this condition

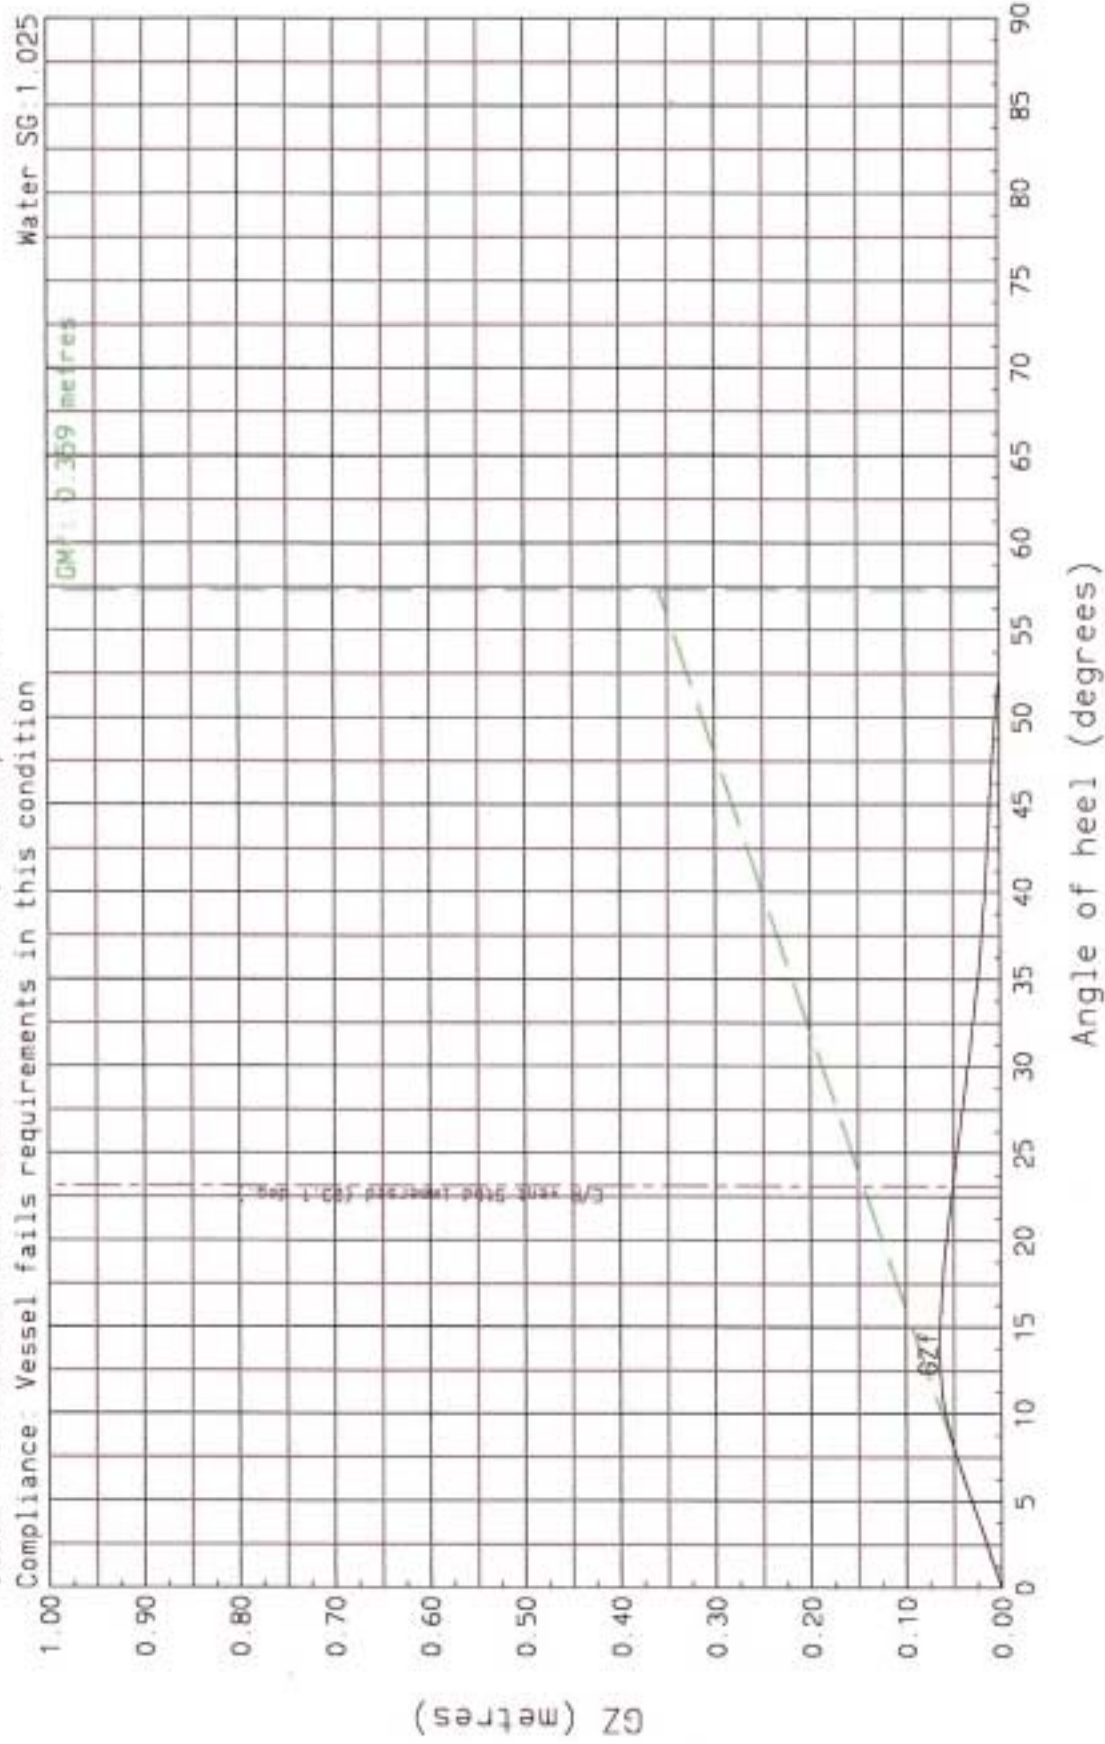
Condition.: Vessel condition immediately prior to accident  
 State.: Intact inc. shelterdeck volume, exc. W/H volume  
 Compliance: Vessel fails requirements in this condition
