Report on the investigation into the flooding
and foundering of the fishing vessel

Elhanan T

about 110 miles east-north-east of Fraserburgh
on 14 August 2003

**Report No 3/2004
March 2004**

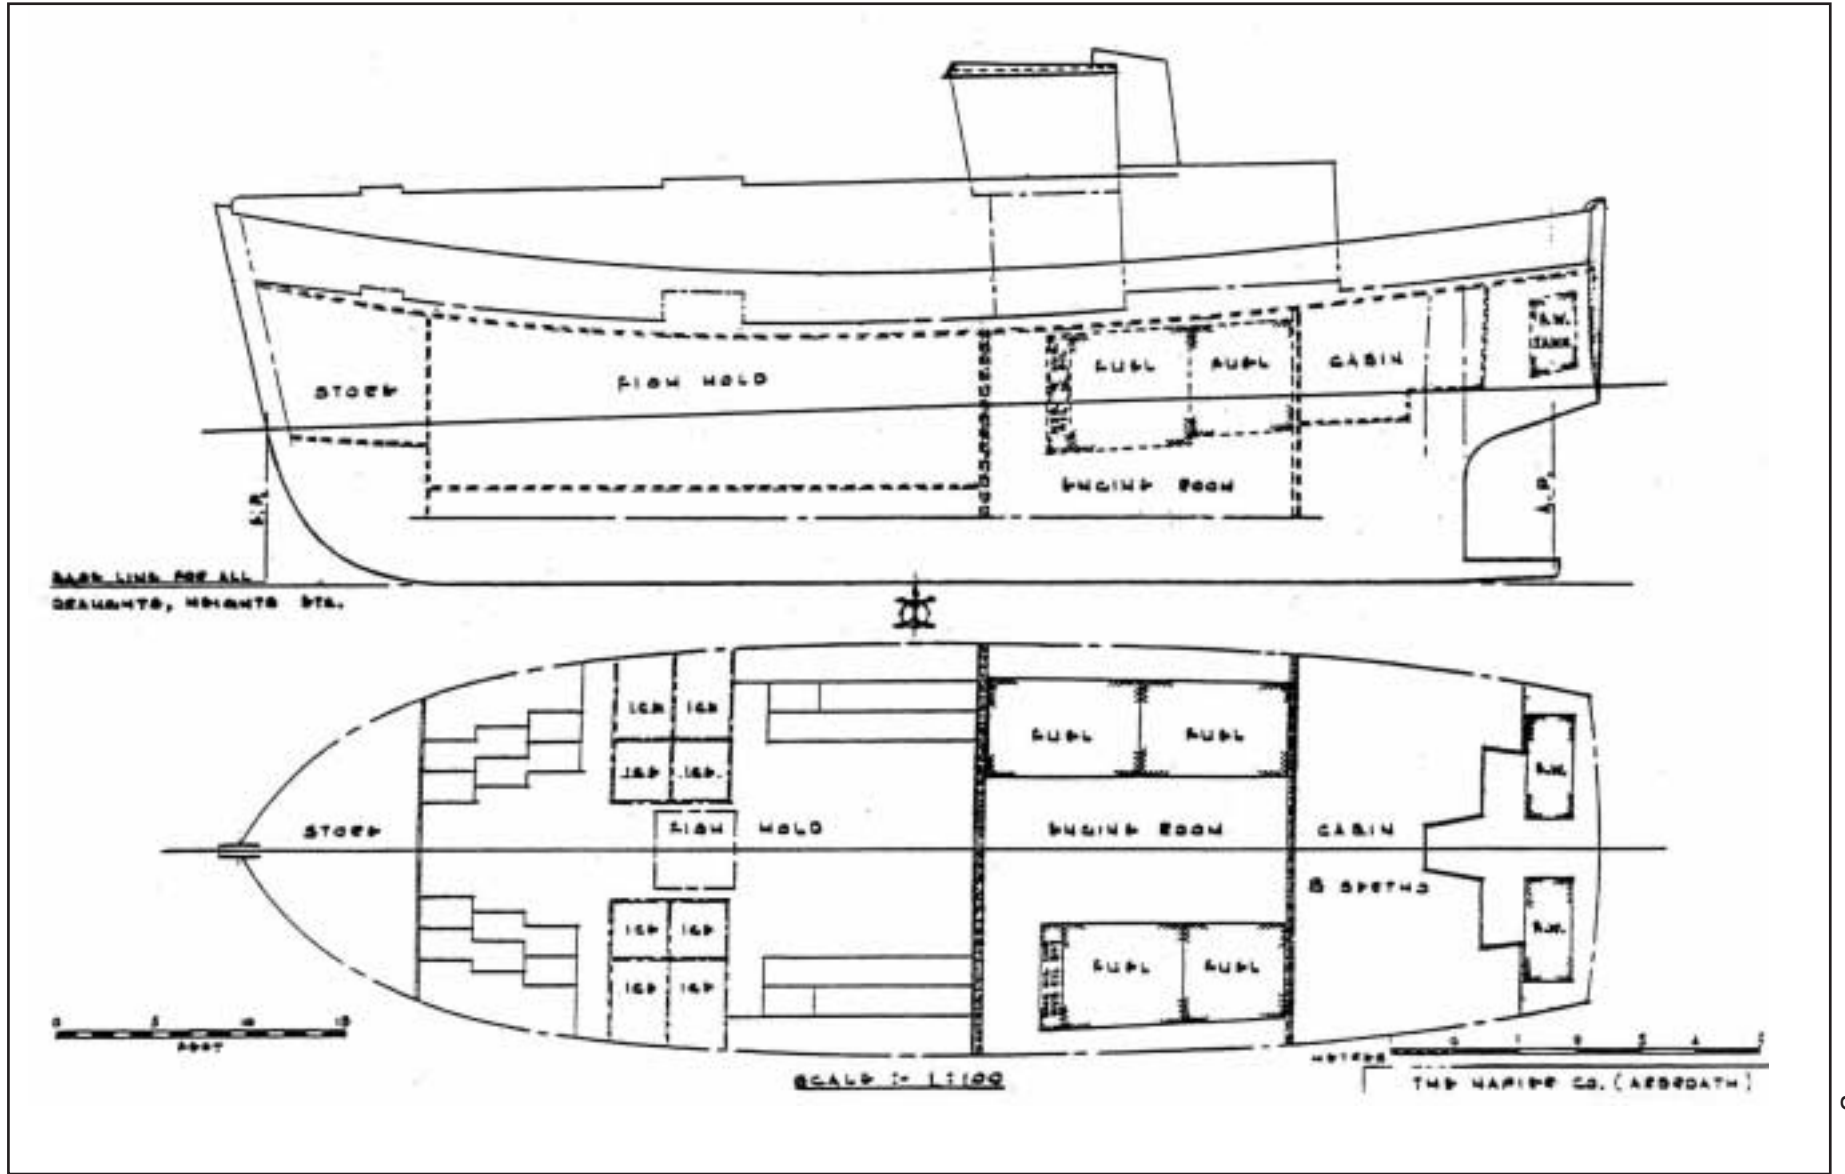
Figure 4

General arrangement

The keel of the wooden hulled *Elhanan T* was laid at Sandhaven on 16 September 1980. She was of traditional north-east of Scotland build, with a slightly raked stem and a transom stern (**Figure 4**).
