Report on the investigation of the grounding and loss of the  
Cypriot-registered general cargo ship

***Jambo***

off Summer Islands

**Report No 27/2003  
December 2003**

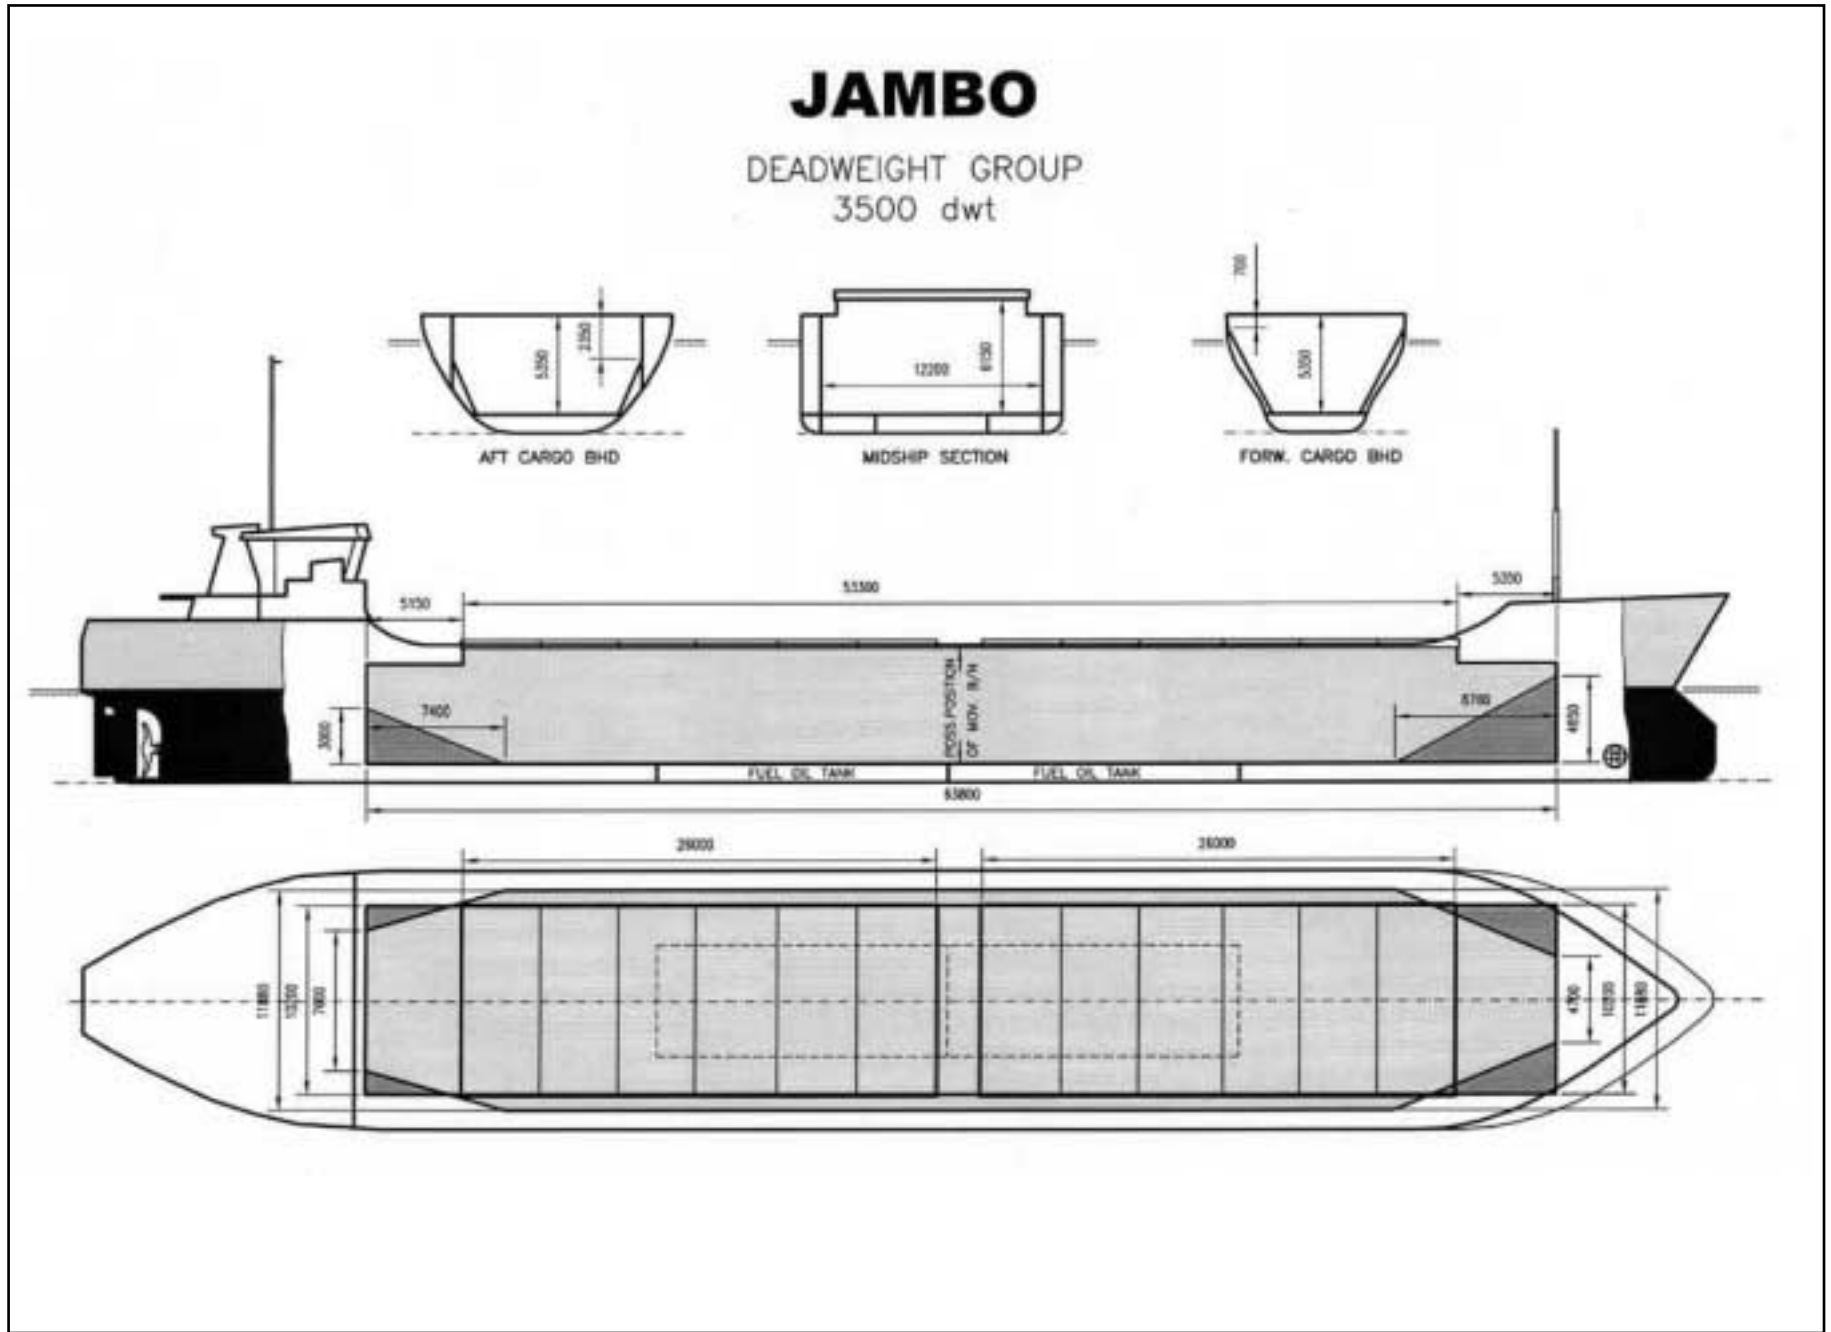
General layout of vessel

The chief officer reported that the forepeak tank, bow thruster compartment, and No 1 double bottom port ballast tank were all flooded, and that there were about 2 metres of water in the forward end of the hold (**Figure 3**). He then took soundings around the vessel to find out to what extent she was aground.
