Report on the investigation of  
the collision between  
the container ship

***P&O Nedlloyd Vespucci***

***Wahkuna***

**Report No 28/2003  
December 2003**

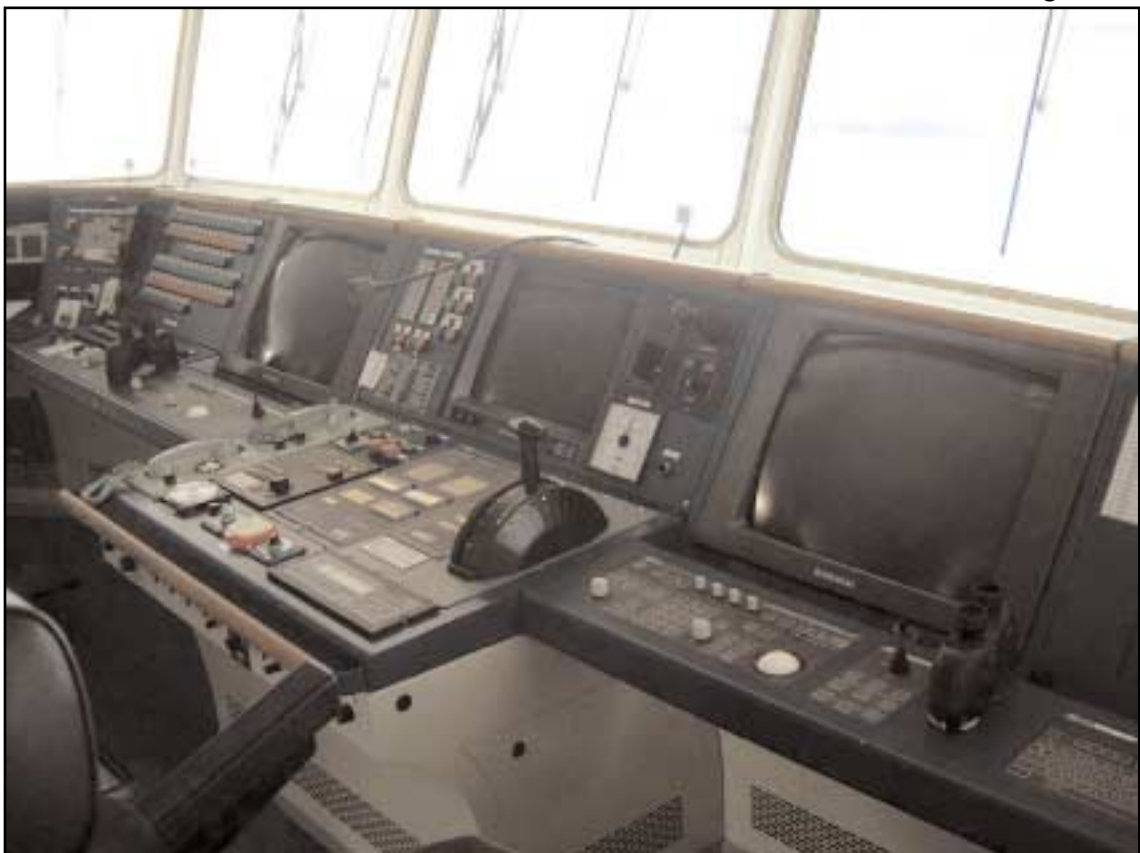
Figure 3

The ship's superstructure, which included the accommodation and bridge, was situated aft. The bridge ran the full width of the vessel. Positioned central to, and aft of, the forward end of the bridge was an operating console fitted with the main engine controls and navigational equipment (**Figure 3**).

Photograph of the operating console on board *P&O Nedlloyd Vespucci*
