Report on the investigation of  
the contact between  
***Pride of Provence***  
and  
The Southern Breakwater,  
Dover Harbour, eastern entrance  
on  
18 April 2003

Marine Accident Investigation Branch  
First Floor  
Carlton House  
Carlton Place  
Southampton  
United Kingdom  
SO15 2DZ

**Report No 26/2003  
November 2003**

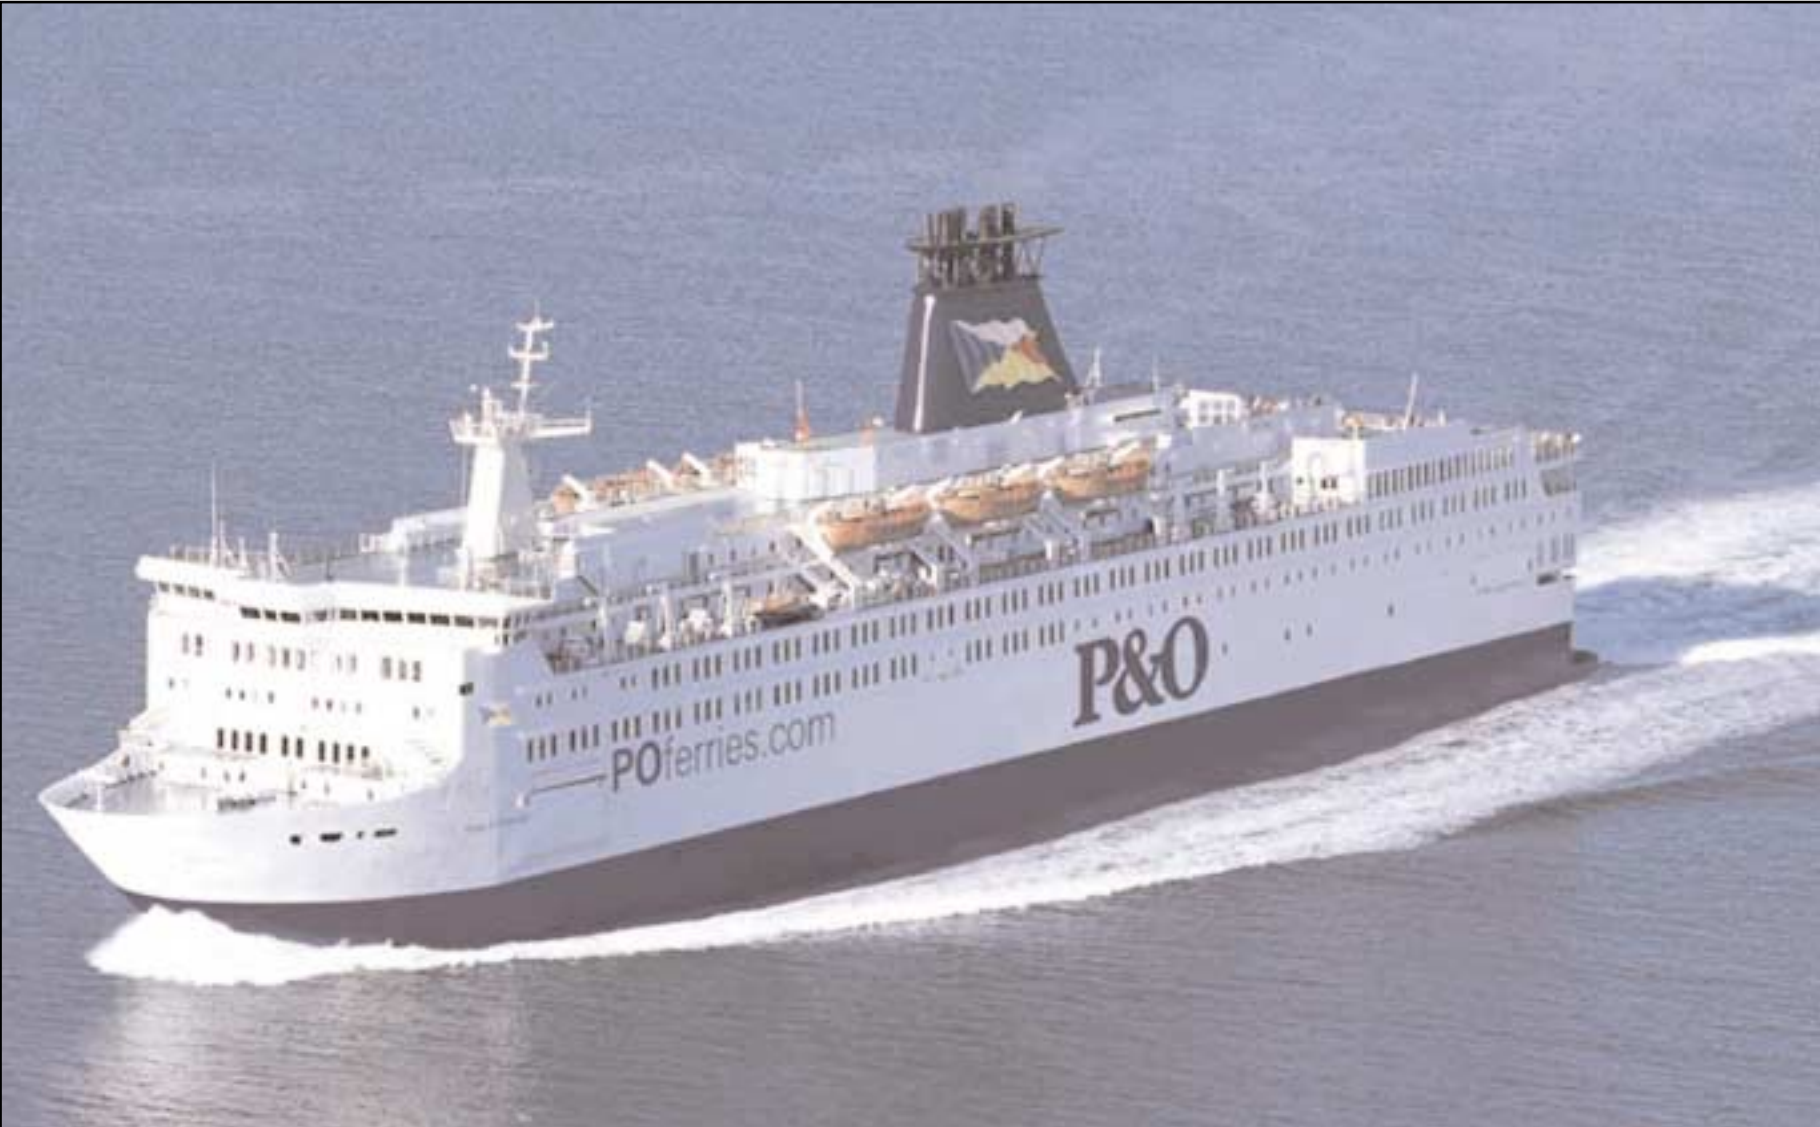
Photograph 1

*Pride of Provence*

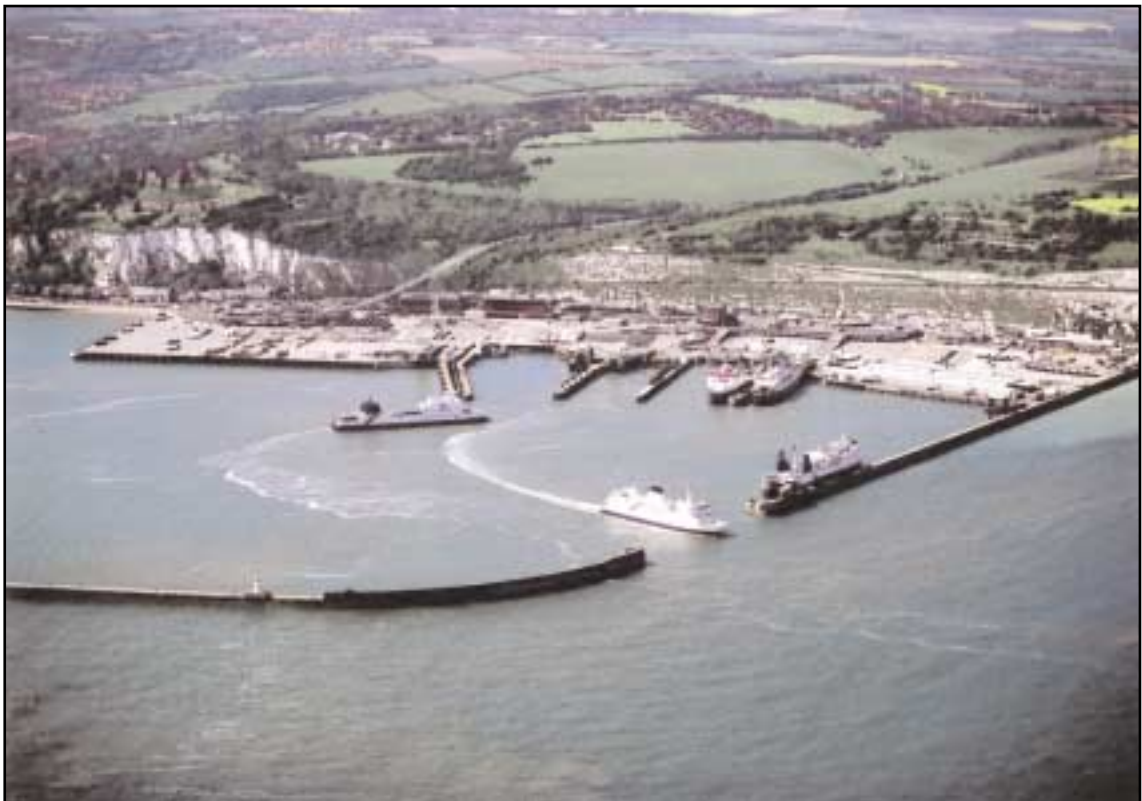
Photograph 2

Dover Harbour showing a ferry departing the eastern entrance

Dover is a busy ferry port with over 130 ferry arrivals and departures through the eastern entrance each day. Fast craft including monohulls and catamarans also use the port, generally through the western entrance. Dover also has commercial dry cargo berths with vessels predominantly using the eastern and western entrances, and it is a popular destination for passenger cruise vessels. In summer it is a base and destination for yachtsmen and pleasure craft, which may use either entrance (**Photograph 2**).
