Report on the investigation of

a fatal accident

during a vertical chute evacuation drill

P&OSL Aquitaine

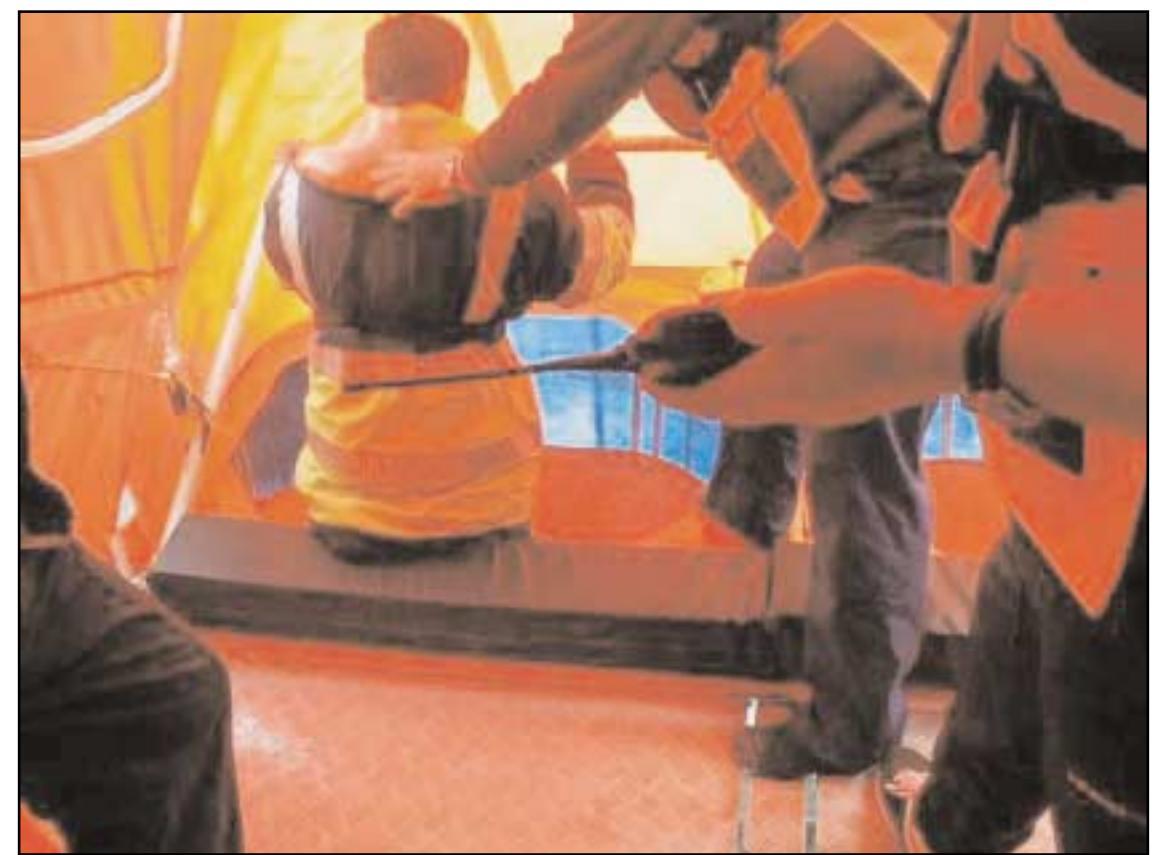
Photograph 2

As well as providing a dry-shod evacuation, the Marin-Ark MES was designed so that evacuees could not see outside the canopy at the head of the evacuation station and during descent **(see photograph 2)**. This was in case they became frightened of the height of the descent, and refused to go down.

An evacuee prepares to descend the left-hand chute

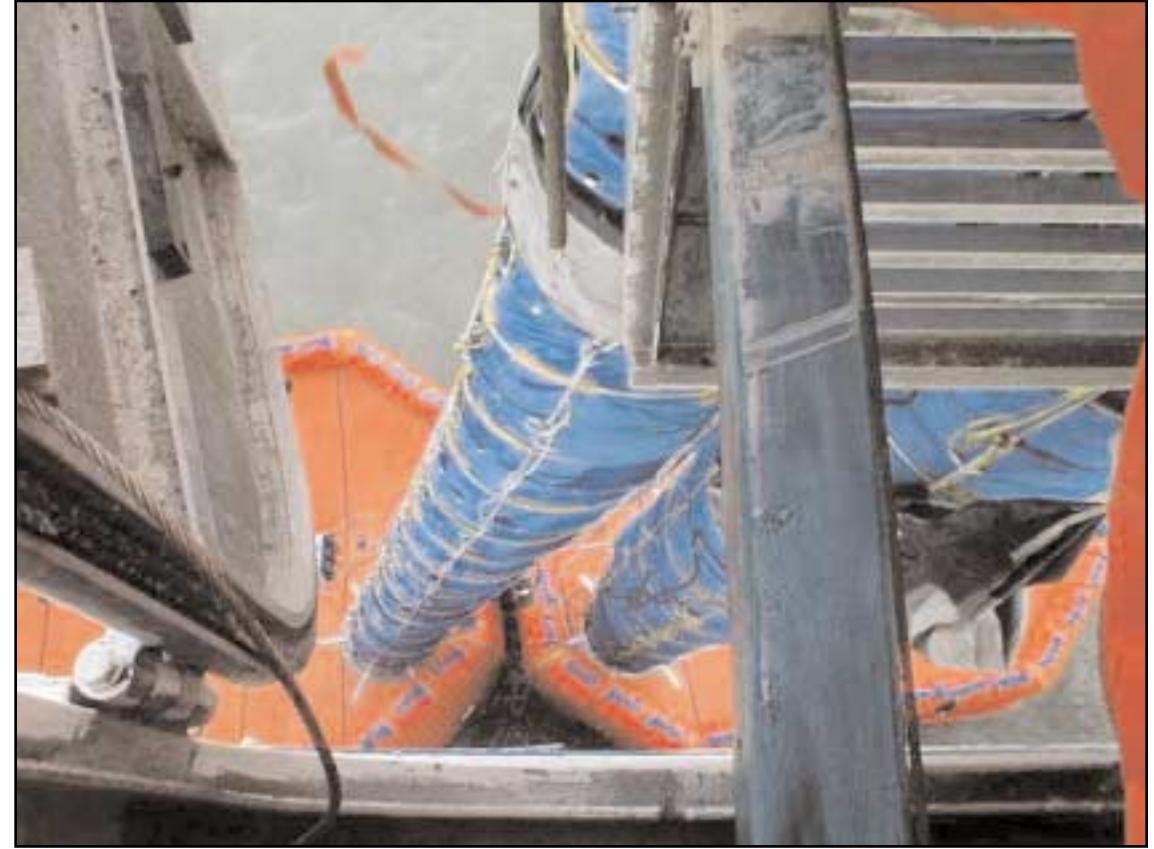
Photograph 4

When the sweeper found Mrs McCabe-Jones again, he looked out through the gaps in the chute's outer wall and saw that they were well down the side of the ship, and near the top of the liferaft **(see photograph 4)**. He called for someone to cut Mrs McCabe-Jones out of the chute.

Looking down from the assembly station to the top of the liferafts

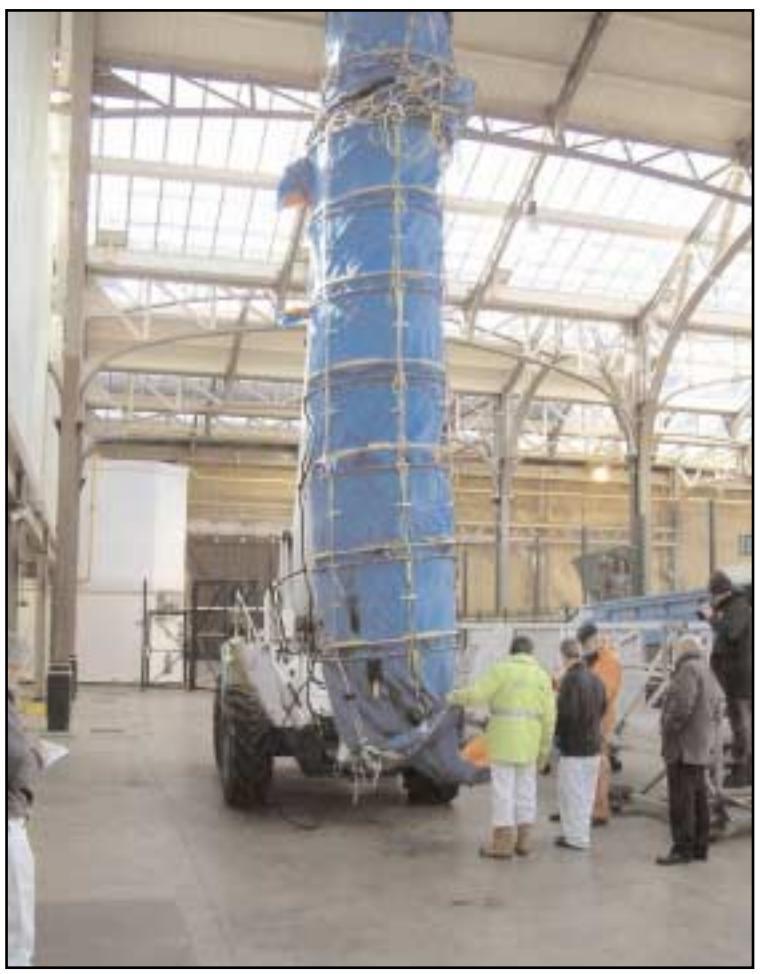
Photograph 6

The chute was laid out on the floor for external inspection. It was then suspended by a crane so that each of the lower cells could be inspected in turn, before and after being detached from the one above (see photographs 6 & 7).

The actual chute used in the drill hoisted up by crane for the inspection

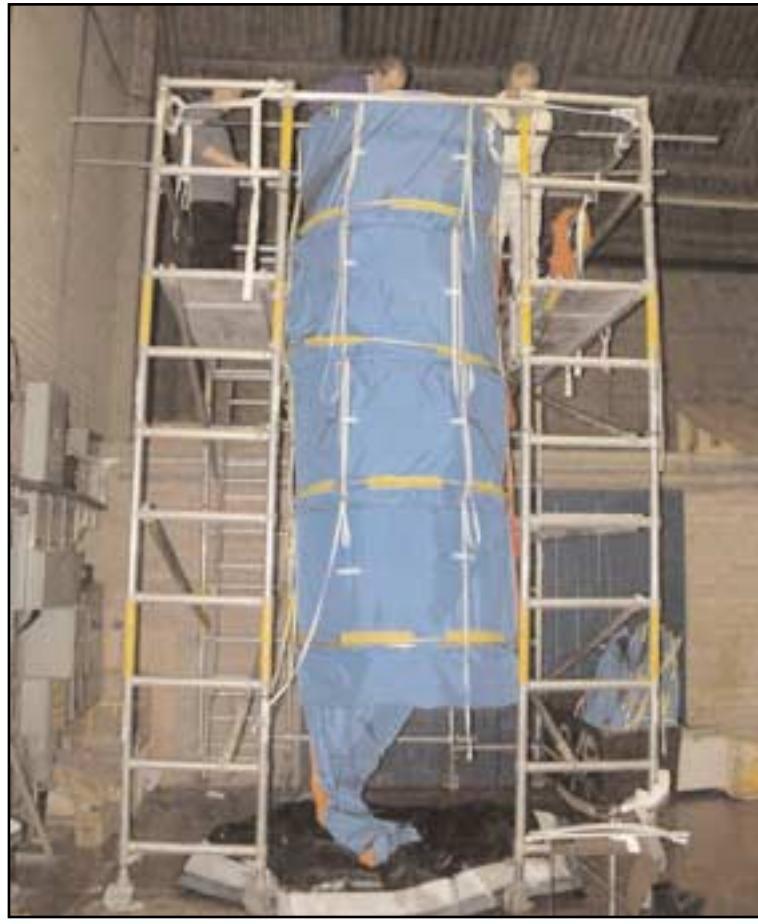
Photograph 8

RFD had created a four-cell section chute suspended from a scaffolding frame. The chute was open at the top so that participants of the reconstruction could see down into the first cell **(see photographs 8 & 9)**.

Four cells rigged up in RFD's factory for the reconstruction

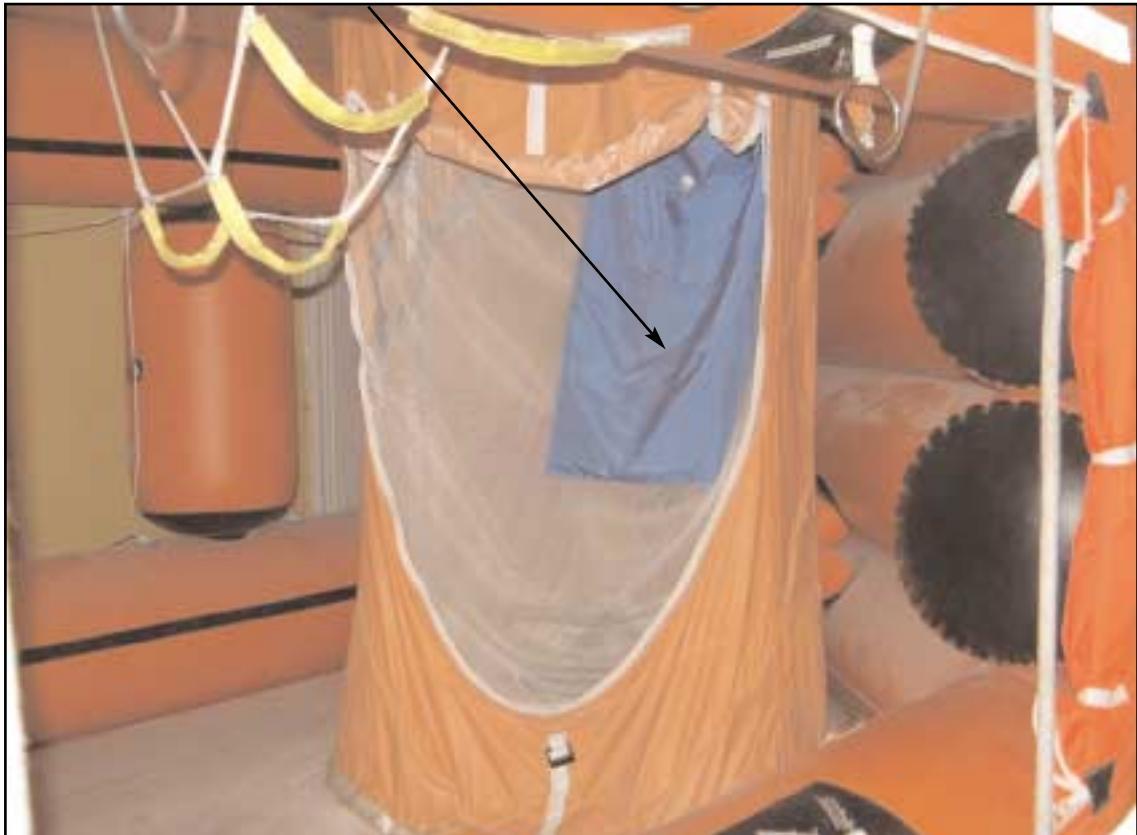
Photograph 11

The analysis showed that 61 evacuees entered the liferaft face-forward, and with the lifejacket in place **(see photograph 11)**. Thirty four exited on their left sides, right sides, with bent knees or backwards but with their lifejacket in place. Therefore, 95 evacuees had their lifejackets in place when they exited the chute, which is 82% of the total. Descent time for these two groups varied from 6 seconds to 26 seconds, with an average time of 11 seconds.

The exit from the chute into the liferaft

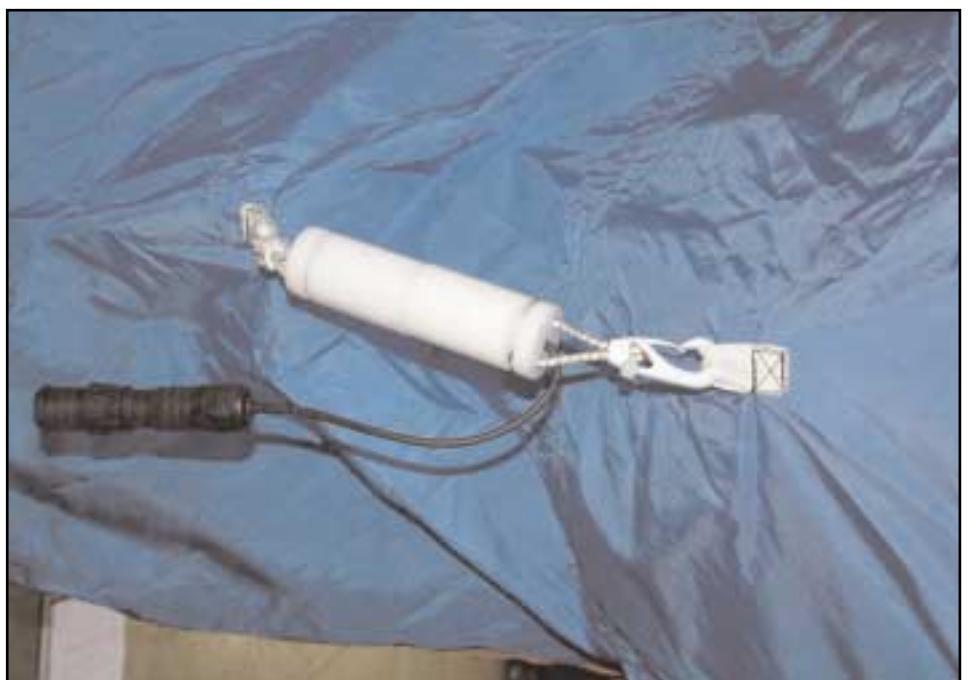
Photograph A1/4

A traffic light system is fitted in the chute. This has sensors in the lower cells, which indicate that the descending evacuee is about to exit the chute. This was not working on the day of the drill **(see photographs A1/4 and A1/5)**; an alternative means of communicating with the top of the chute was being used.

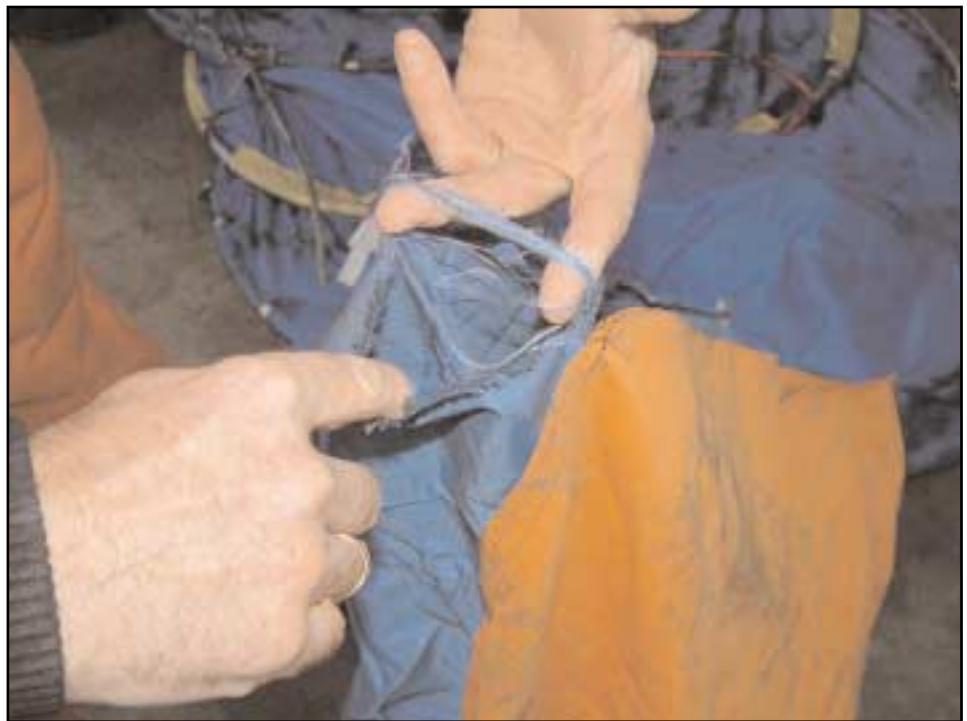
Photograph A1/7

The blue fabric has frayed at the bottom of the sock, with the cross-threads forming a stirrup, and in another area where the threads have possibly formed a stirrup but then parted at one end, **see photographs A1/6 and A1/7.**

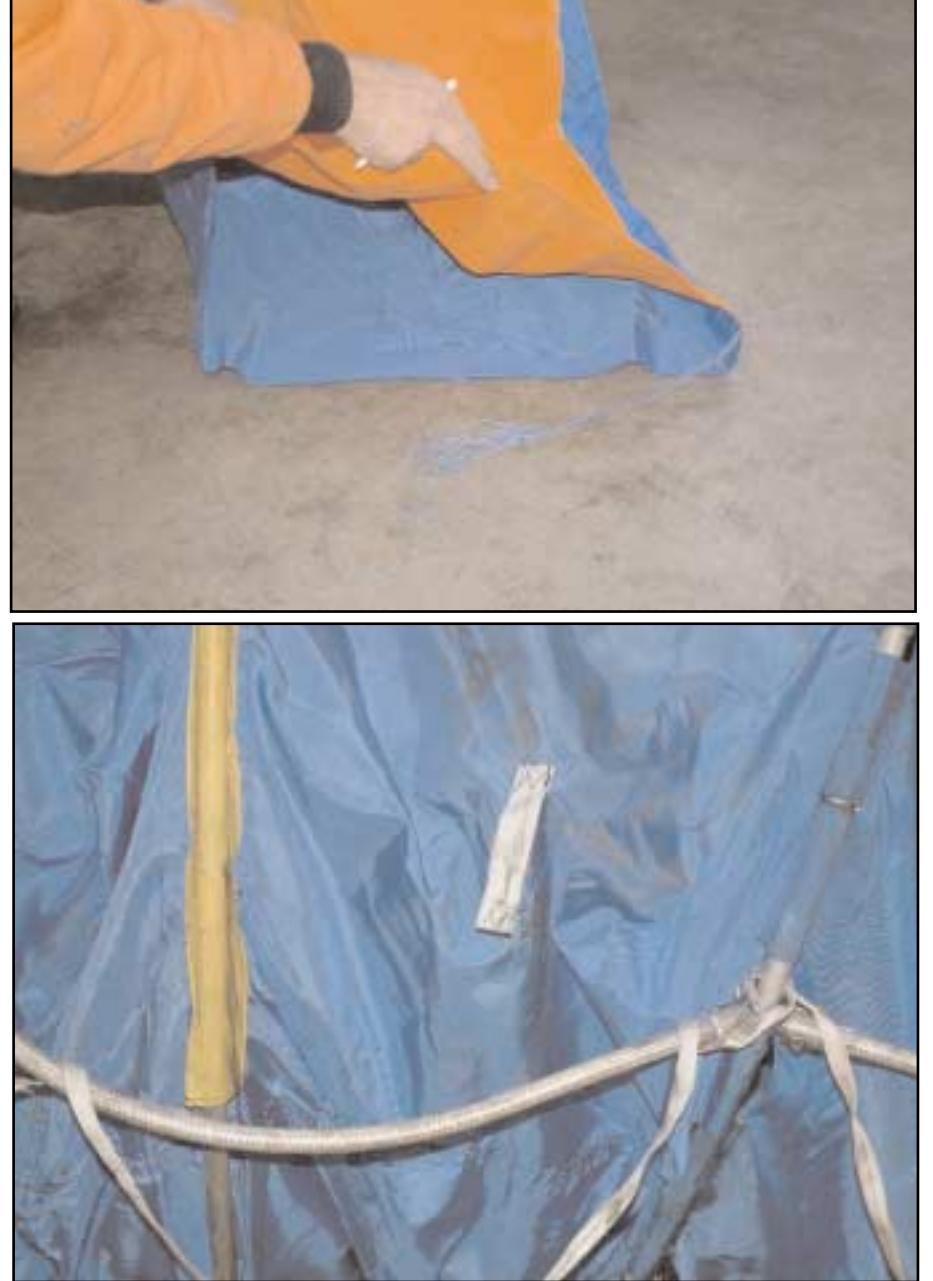
Photograph A1/18

The No. 3 bungee guide loop is detached at one end (see photograph A1/18).

The No. 4 bungee guide loop is detached at one end (see photograph A1/18).

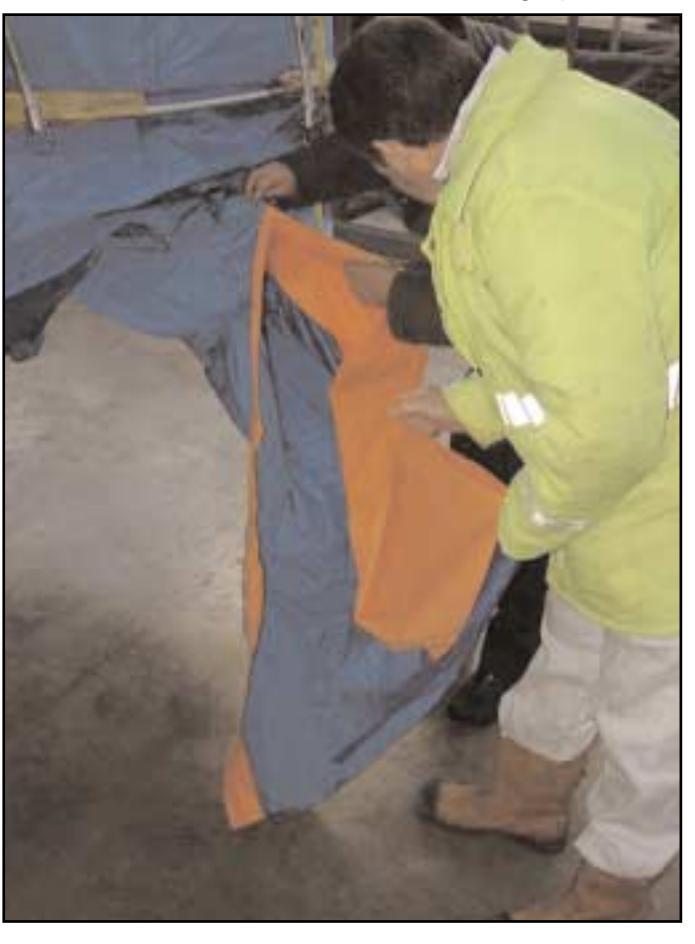
Photograph A1/23

The orange elasticated fabric has a vertical tear 3 to 4 cm from the seam. This starts at the bottom of the sock and extends up its length to a point just below the rounded top of the panel (see photograph A1/22) where there is a jagged sideways tear (see photograph A1/23). It then continues vertically up to, and then follows, the line of stitching (see photograph A1/24).

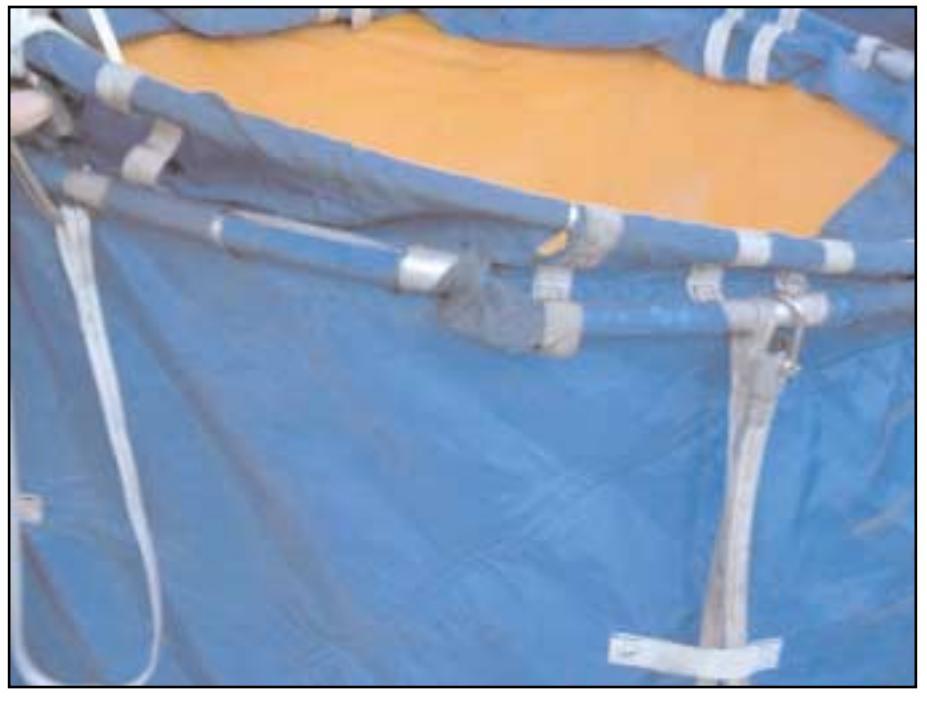
Photograph A1/25

There is fraying at the bottom of the blue fabric restraining panel, fitted over the elasticated panel. This is the only cell fitted with such a panel in the sock, and it is designed to take the initial shock load when an evacuee enters the chute (see photograph A1/25).

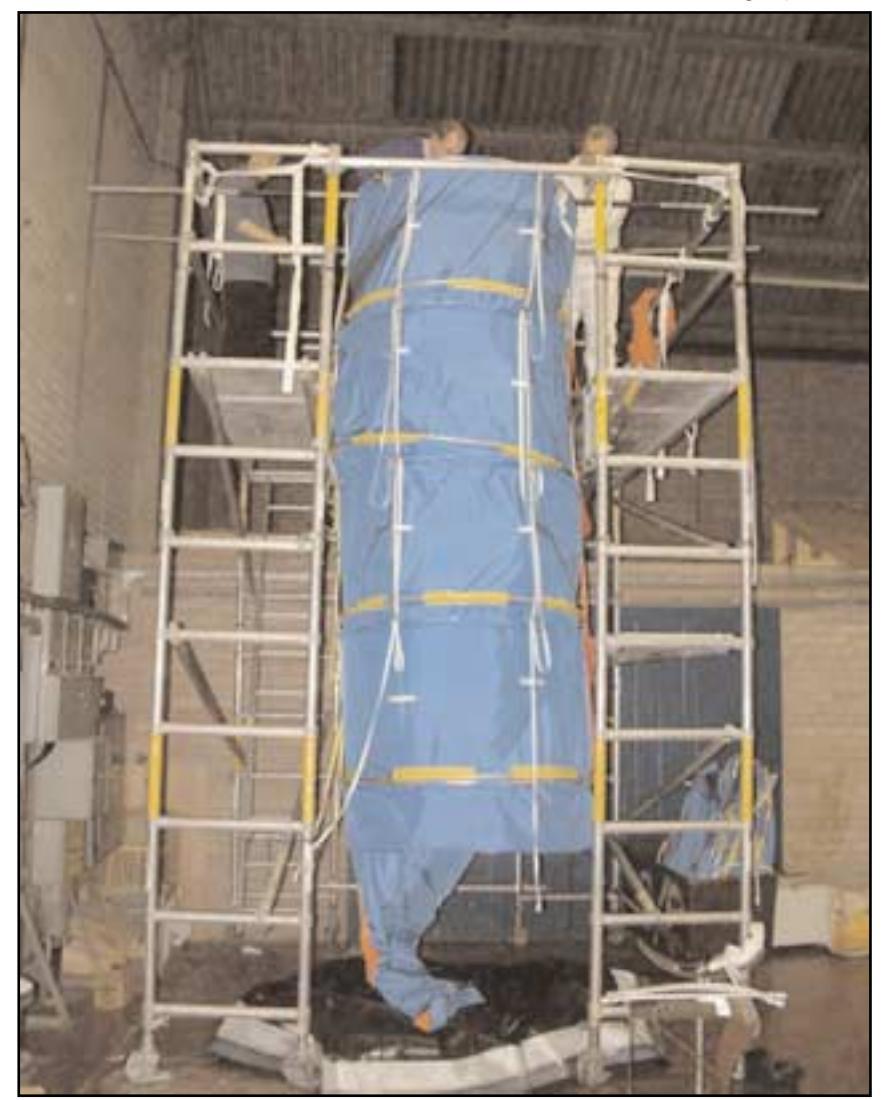
Photograph A2/1

RFD had erected a small section of the escape chute, to enable various scenarios to be explored. **(See photograph A2/1.)** Discussions also took place, including reviewing video footage of the accident, which was taken by MCA on the day.

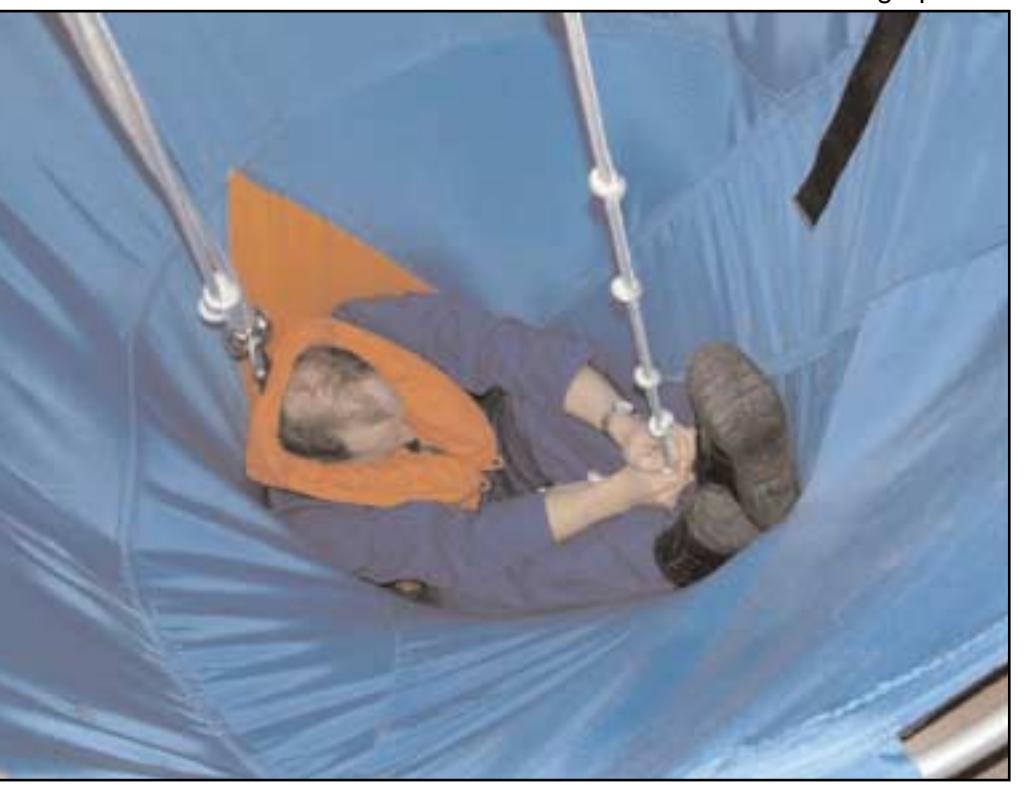
Photograph A2/2

The first task was to recreate the position in which Mrs McCabe-Jones was found. After a couple of positions, the sweeper agreed the most likely position adopted was that shown in **photographs A2/2 and A2/3**, as he could not remember precisely. The sweeper adopted the piked position himself without the safety harness but with the safety rope in position. Although the piked position was uncomfortable, it did not cause any undue concern for those who tried it.

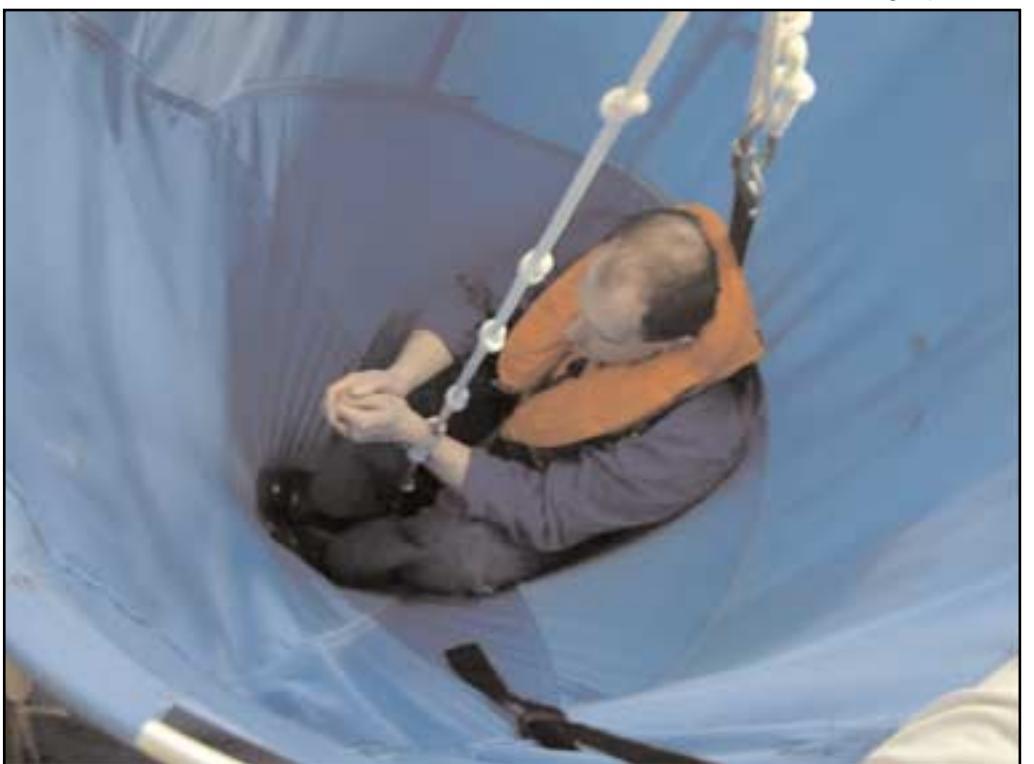
Photograph A2/4

The likely options that would lead to a person assuming the piked position were then pursued. If a person was stuck such that the knees were brought up to the chest, it appeared impossible for the person to move the feet above the waist. **(See Photograph A2/4.)** The person could become stuck in this position but by leaning forward the person starts to slide down feet first.

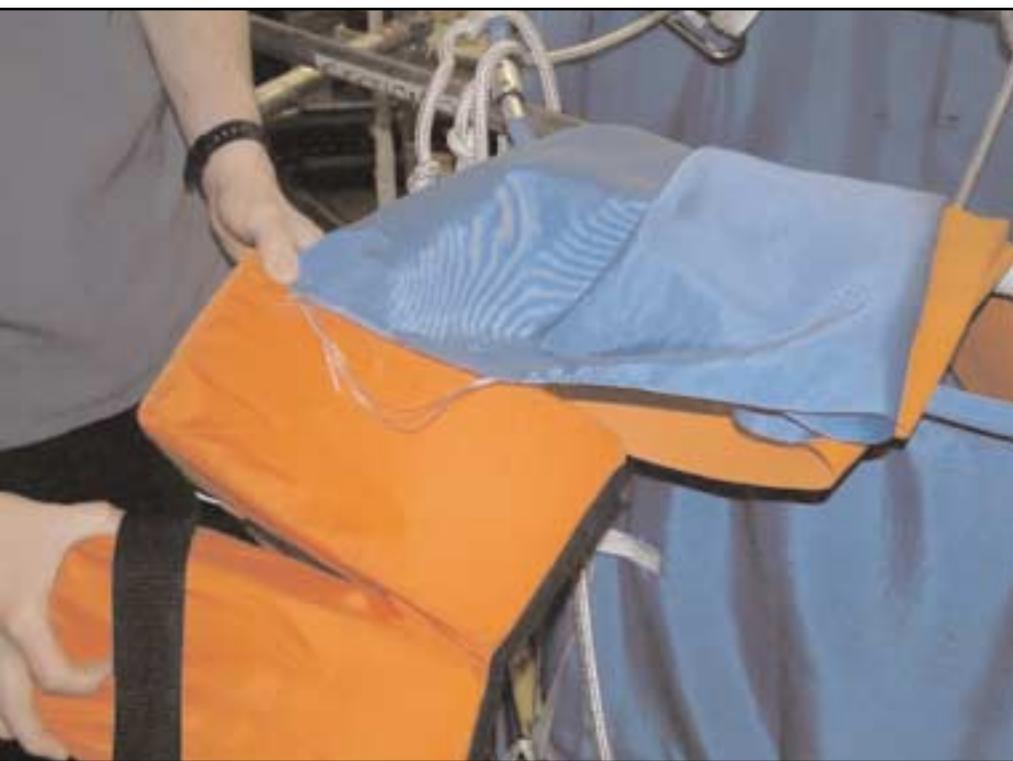
Photograph A2/5

The inspection of the actual escape chute, in Dover, after the accident had highlighted the possibility of stirrups of material threads at the exit of the socks. It may be possible that an evacuee's feet could become stuck in the stirrup. A stirrup of 4 threads was formed in the reconstruction since cell 7 in the inspection had been found with 4 loose threads on it. (See Photograph A2/5.)

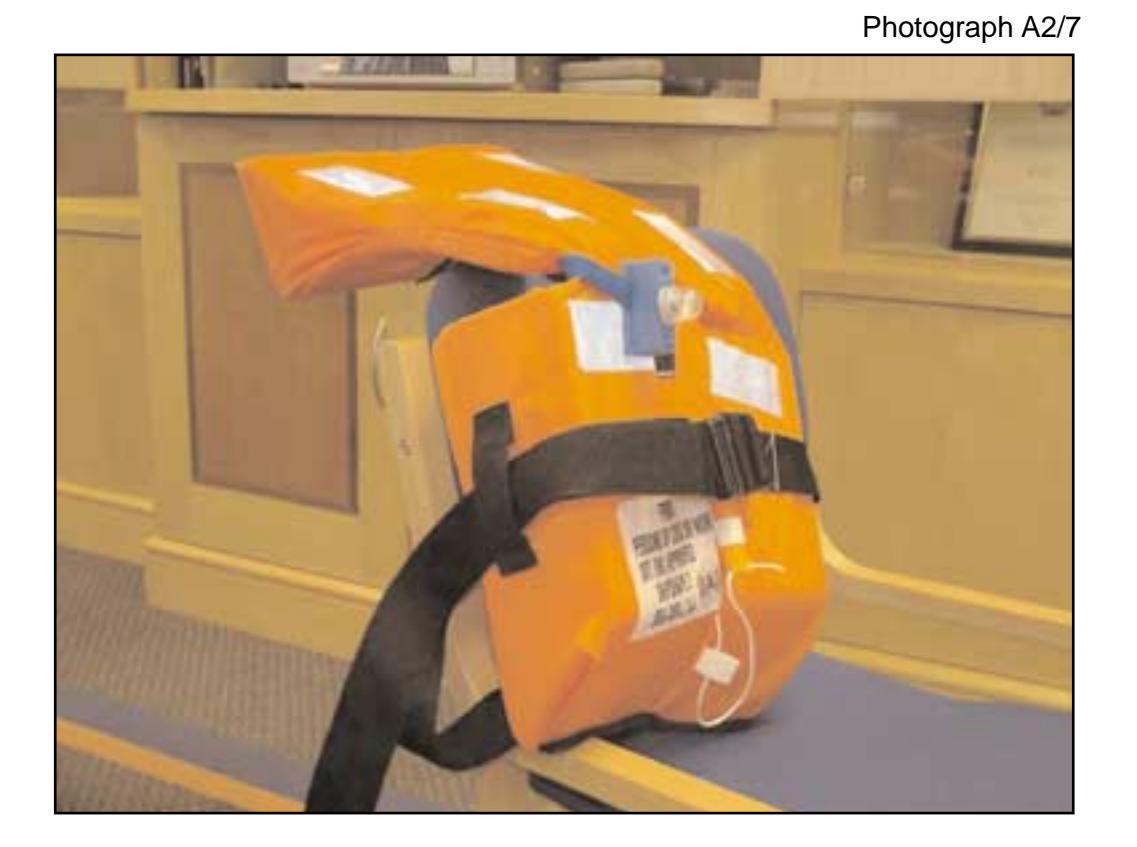
The type of lifejacket used in the evacuation trial had been a 'Seadog Shipshape 2'. P&O Stena Line supplied such a lifejacket for the reconstruction, but it became apparent after studying video footage that it was not identical to those used in the evacuation trial on *P*&OSL Aquitaine. Unlike the lifejacket shown in **Photograph A2/7**, the lifejackets used in the evacuation trial had no webbing guide loops on the side.
