Report on the investigation into a  
wash wave accident involving

***Portsmouth Express***

off East Cowes

**Report No 14/2003  
June 2003**

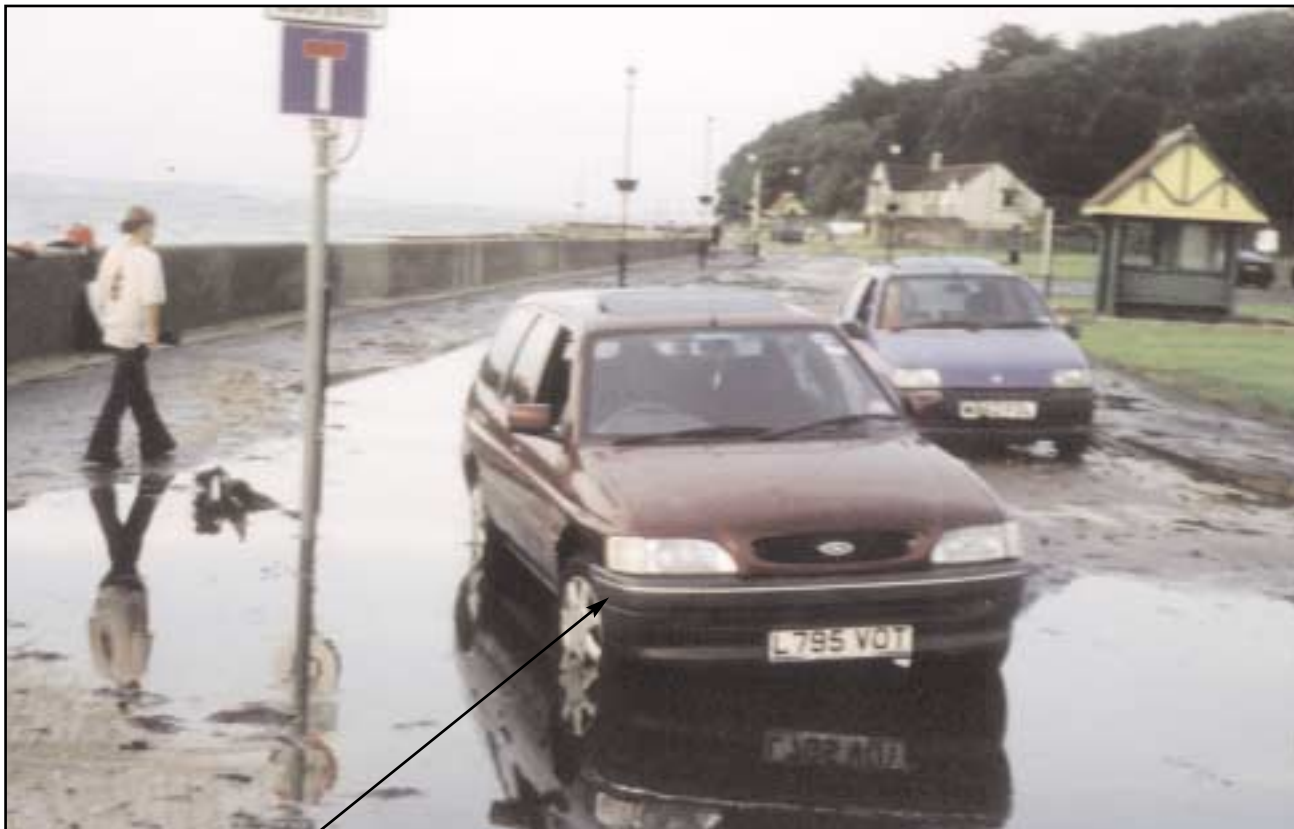
Figure 5

The road and park at East Cowes esplanade were flooded. The floodwater was still quite deep about half-an-hour after the accident (**Figure 5**). One of the waves reached as far as the fence on the far side of the park area (**Figure 6**). Substantial amounts of debris, including seaweed, pebbles and dead fish, were left after the floodwater had drained away. Staff employed by the Isle of Wight Council started clearing this about an hour after the accident.

Floodwater on East Cowes esplanade

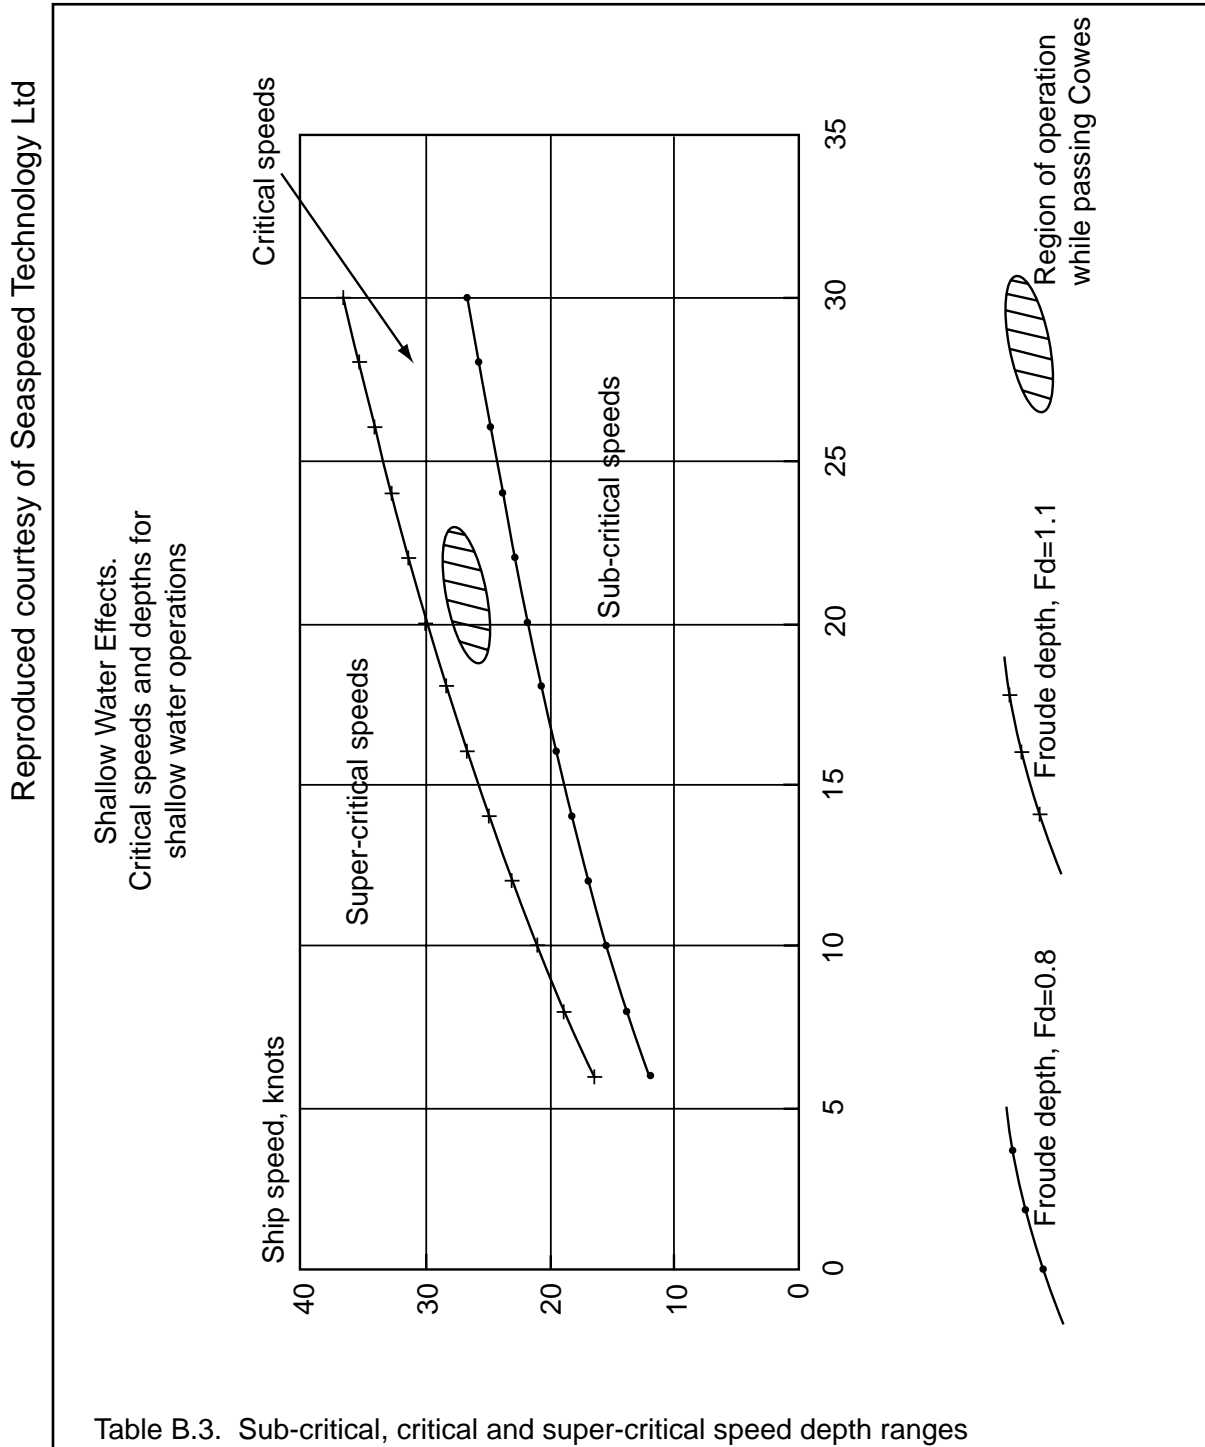
Figure 7

Table B.3. Sub-critical, critical and super-critical speed depth ranges

*Express* was travelling in the critical speed range as she passed Cowes (**Figure 7**). A vessel produces the greatest wash when travelling in the critical speed range. *Portsmouth Express* was using all her available power, so going faster to get out of the critical speed range was not an option; therefore she should have passed Cowes at sub-critical speed. Going faster would, in any case, have been unwise bearing in mind the confined nature of the channel. In summary, the speed of *Portsmouth Express* in the channel past Cowes was too high.

The item in the RAPP that illustrates the problem most clearly is the graph (**Figure 7**). The graph is easy to use, and the critical speed range to be avoided is shown. The master had read the RAPP, and he knew that the vessel should not be in the critical speed range near to land. He assumed that the vessel could not reach the critical speed range in the water depths in the Solent, because only three engines were available. However, had he used the graph in conjunction with the charted depths and expected speeds, it would have been apparent that there was a danger of reaching the critical speed range.

A RAPP should be prepared for all HSC voyages. A document similar to the RAPP prepared for *Portsmouth Express*, should be compiled for the normal ferry route. However, such a comprehensive piece of work is unnecessary for a one-off voyage, when intending to operate at sub-critical speed. For such a voyage, an acceptable RAPP would be to find the depths of water along the proposed track from charts and tidal information, and then apply this to a graph such as that shown in **(Figure 7)**.

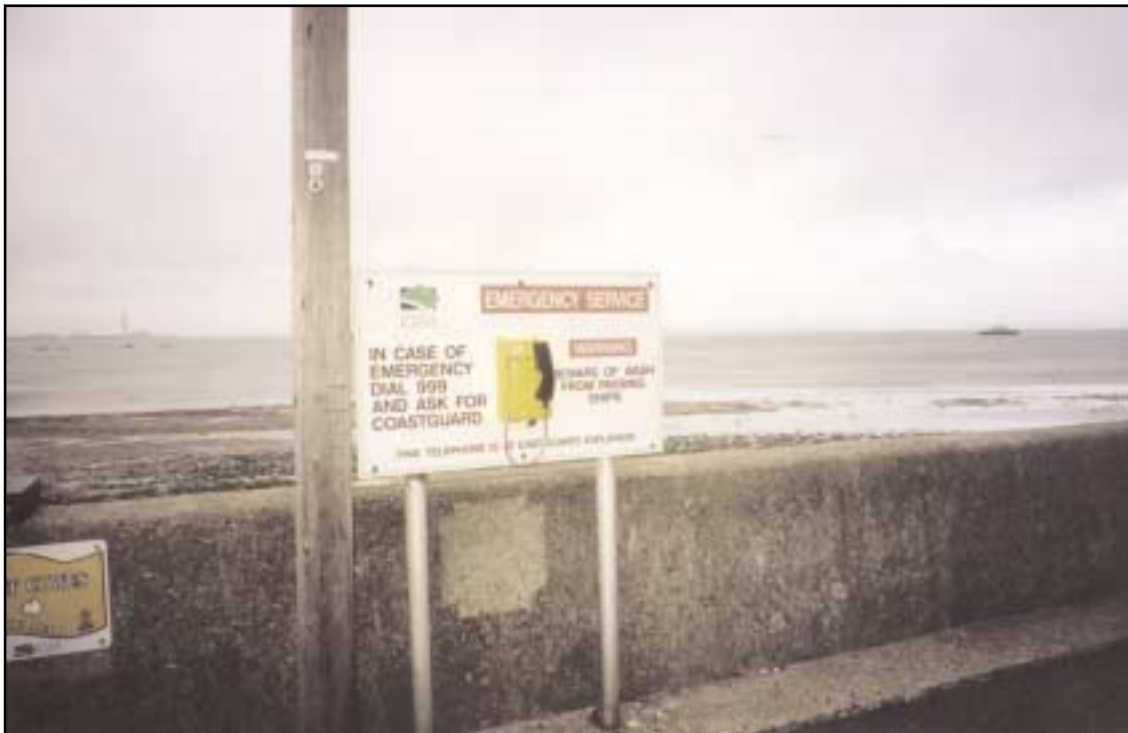
Sign at East Cowes point
