Report on the investigation  
of the capsizing of  
***fv Flamingo***  
East of Harwich  
on 7 July 2002  
with the loss of four lives

Marine Accident Investigation Branch  
First Floor  
Carlton House  
Carlton Place  
Southampton  
United Kingdom  
SO15 2DZ

**Report No 15/2003  
June 2003**

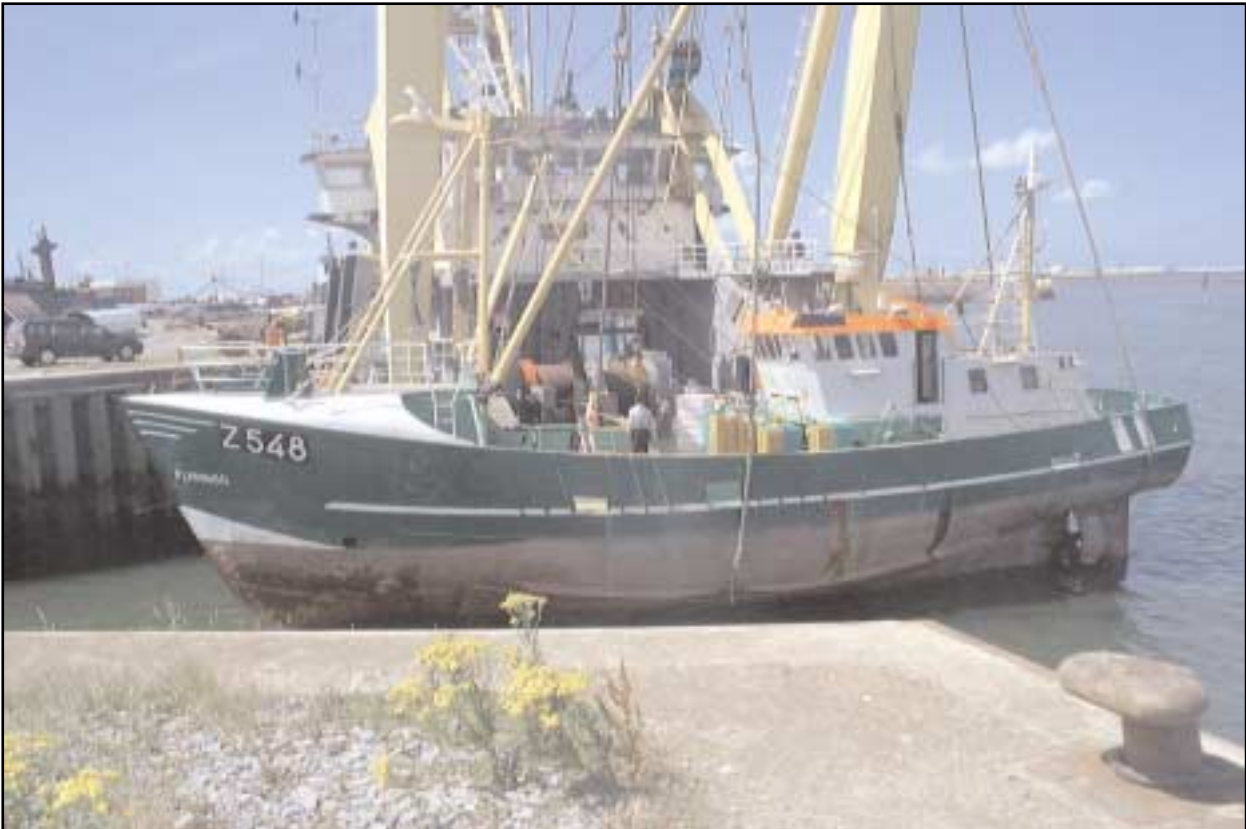
*Flamingo* being examined in Zeebrugge

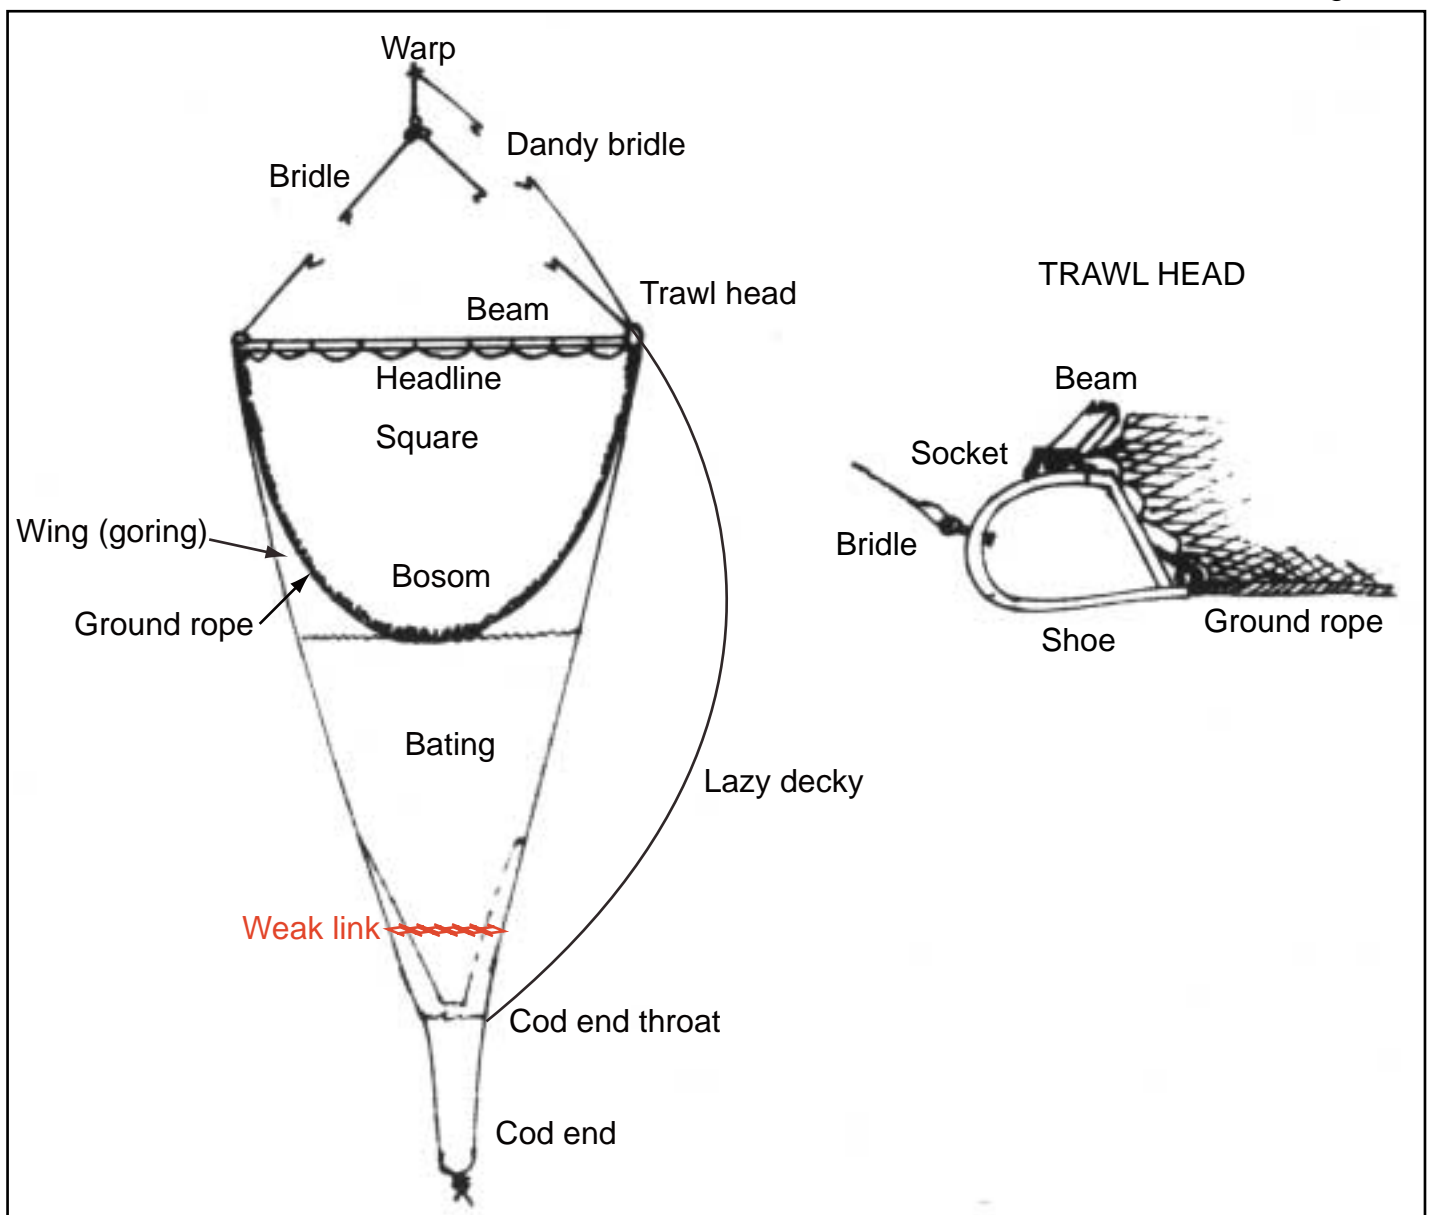
Figure 15

Once within the net's mouth, fish migrate through a converging section of the net, known as the belly, towards the net's closed end, known as the cod end. The cod end is that part of the net which is hauled on board by a simple lifting arrangement known as the gilson, when connected to a line called a "lazy decky". This line is attached to the shoe of the beam. The other end leads to the cod end's entrance and to a line which encircles its throat. When the gear reaches the surface, weight is taken on the "lazy decky" using the gilson (**see Figure 15**).

On occasions, before lifting the catch on board, it is necessary for a beam trawler to wash her nets to clear out sand and shells and other fine debris, and also to move the catch to the aft section of the cod end. This is to avoid excess weight while lifting the catch on board, and to save time while sorting the catch. The nets are washed by topping the derricks to about 45° and steaming ahead

Beam trawl

With the weak link parted, the weight is expelled from the trawl. The main part of the trawl can then be retrieved back on board along with the cod ends using the “lazy decky”, with the catch intact. In this scenario, the “weak link” has had the desired effect; no loss of gear, an easily manageable trawl and no loss of catch (**see Figure 15**).

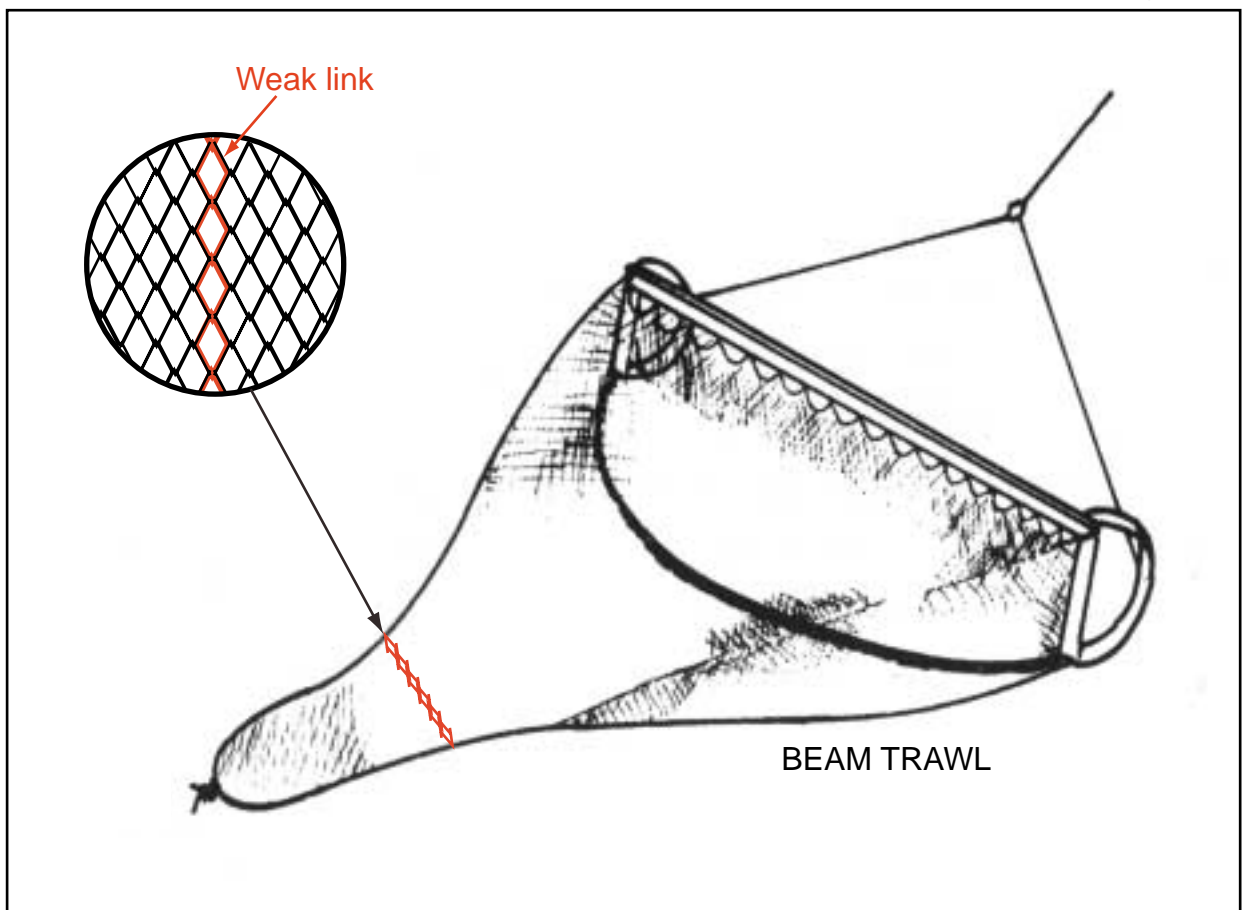
Figure 16

*Flamingo's* gear on each side weighed about 3 tonnes and consisted of a beam chain, chain mat and net. The “weak link” consisted of one single band of mesh around the circumference of the trawl, positioned above the cod end. The “weak link” was of smaller diameter line than the net, consisting of 3mm 3-stranded polypropylene, at about 6 metres from the cod end (**see Figure 16**).

With this in mind, operators of beam trawlers are reminded of the inherent dangers of the “weak link” design.

Beam trawl
