Report of investigation
into flooding of aft engine room
of passenger cruise ship
Queen Elizabeth 2

21/22 May 2002

Report No 9/2003
March 2003

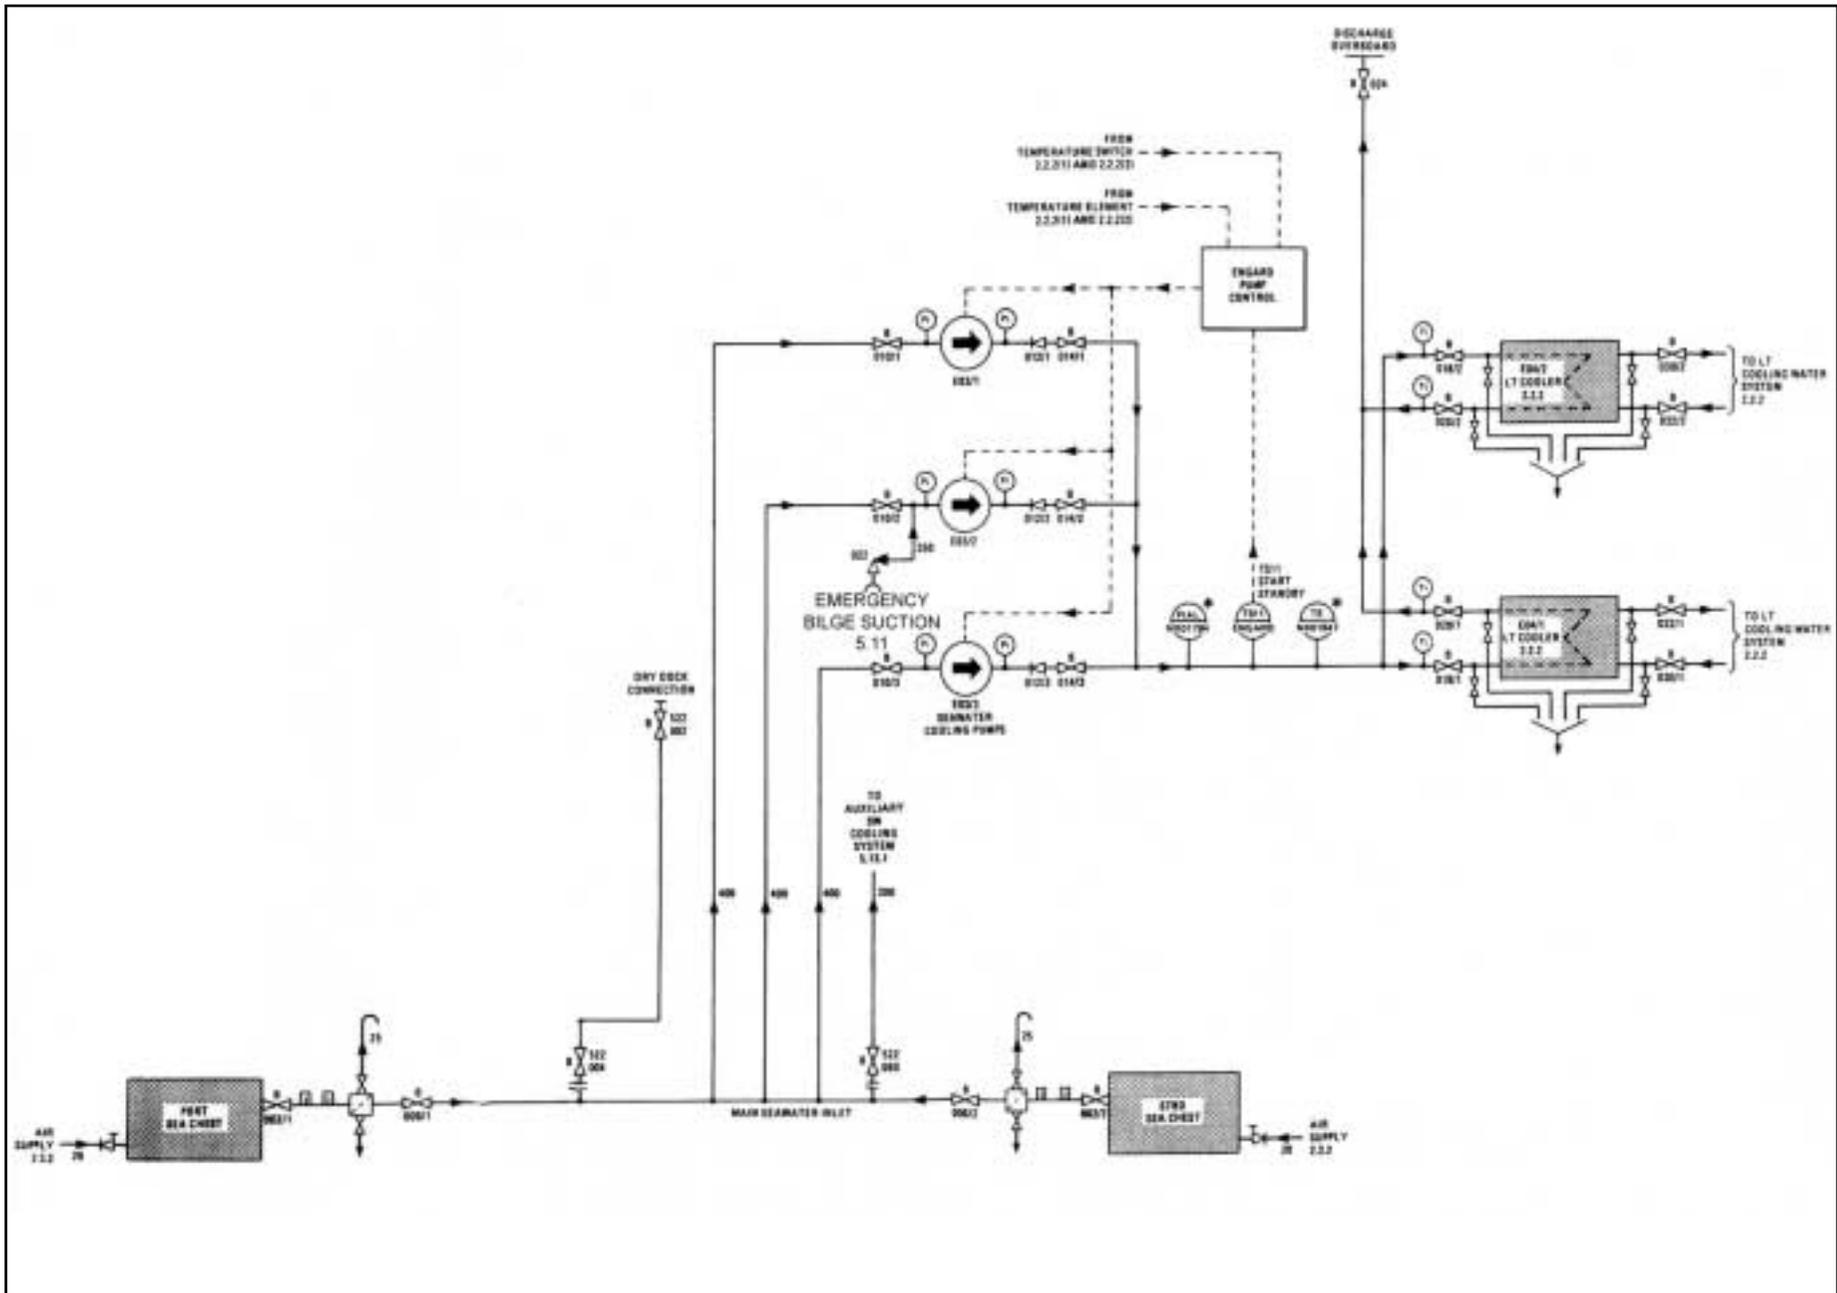
Figure 12

Emergency direct bilge suctions or injections, of 350mm diameter, and having no connection to the bilge main, are provided in the forward and aft engine rooms by one of the three sea water pumps in each space. These pumps normally supply sea water to the low temperature (LT) coolers for the main engines, and are intended for use as bilge pumps only as a last resort. Their drive motors are about 2m above engine room floor plate level and about 3m above the inner bottom of the vessel. All output from these pumps passes through one or other of two heat exchangers before going overboard (**Figure 12**).

Main SW circulating system and bilge injection
