Report on the investigation of
the grounding of
mv *Lysfoss*
Sound of Mull, Scotland
7 May 2001

Marine Accident Investigation Branch
First Floor
Carlton House
Carlton Place
Southampton
United Kingdom
SO15 2DZ

**Report No 23/2002
July 2002**

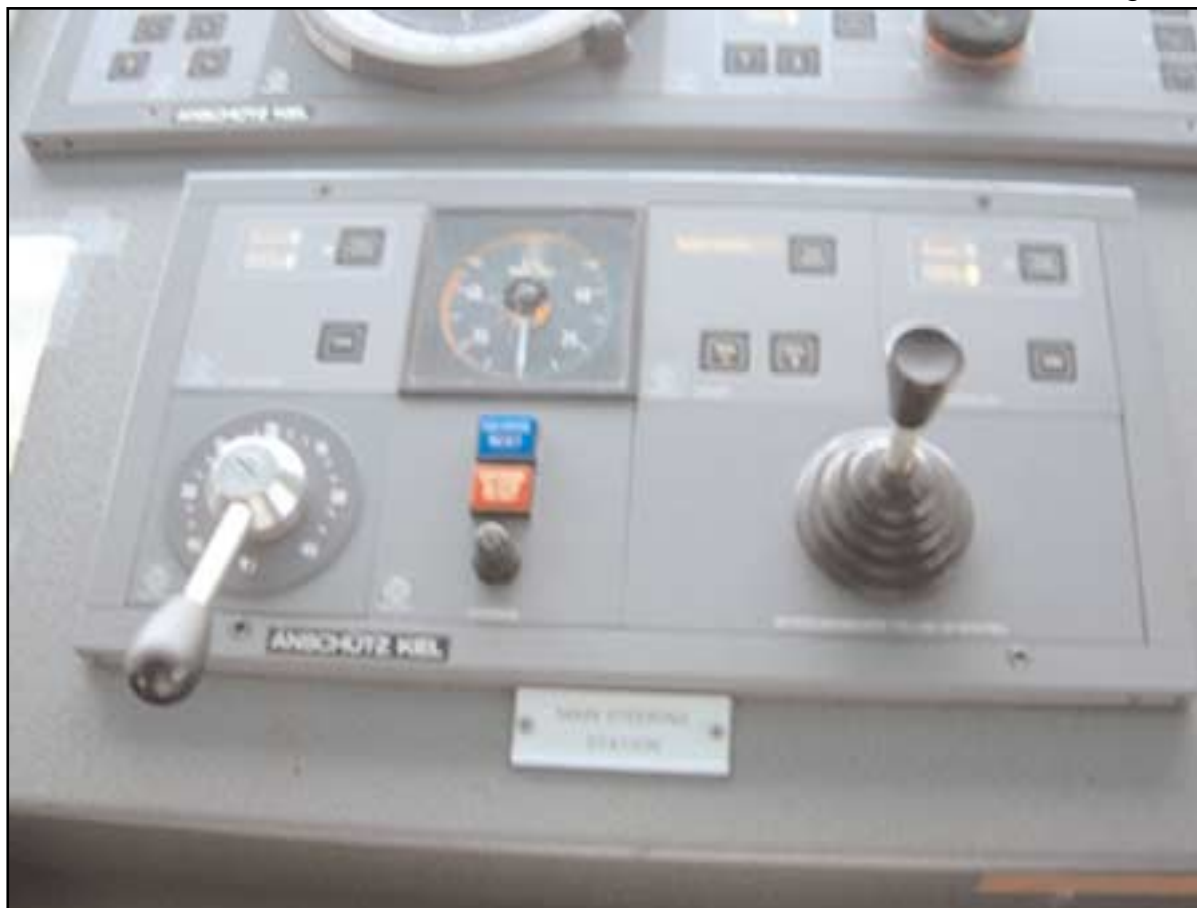
The main steering console

A watch alarm was fitted, which had to be reset at 12-minute intervals. After 12 minutes a light illuminated for 30 seconds, followed by a buzzer sounding for 2 minutes. If the alarm was not reset during this period, an alarm sounded in the engineer's cabin and engine room. The time interval on the watch alarm could be reduced to 6 minutes. It was possible to disable the watch alarm by removing its power fuse which was located in an unlocked cabinet on the bridge.
