Report on the investigation of
the capsizing and foundering of

Radiant PD298

10 April 2002

**Report No 2/2003
January 2003**

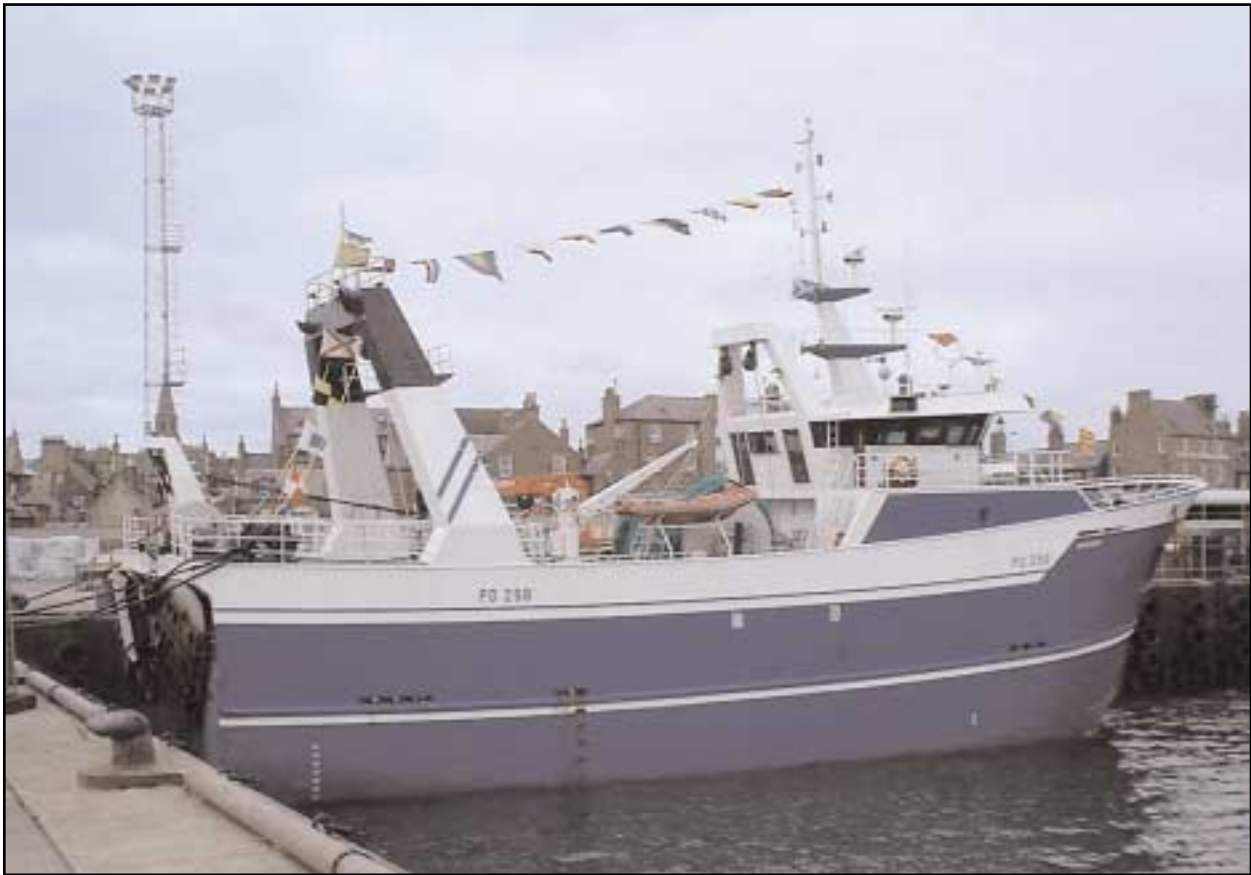
Figures 1 and 2 - General views of *Radiant*

Scupper adjacent to
port engine air intakes

Radiant's sister vessel *Resplendent* is fitted with port engine air intakes in a similar position. A recommendation has therefore been made to her owner to consider raising them and/or moving them further inboard.

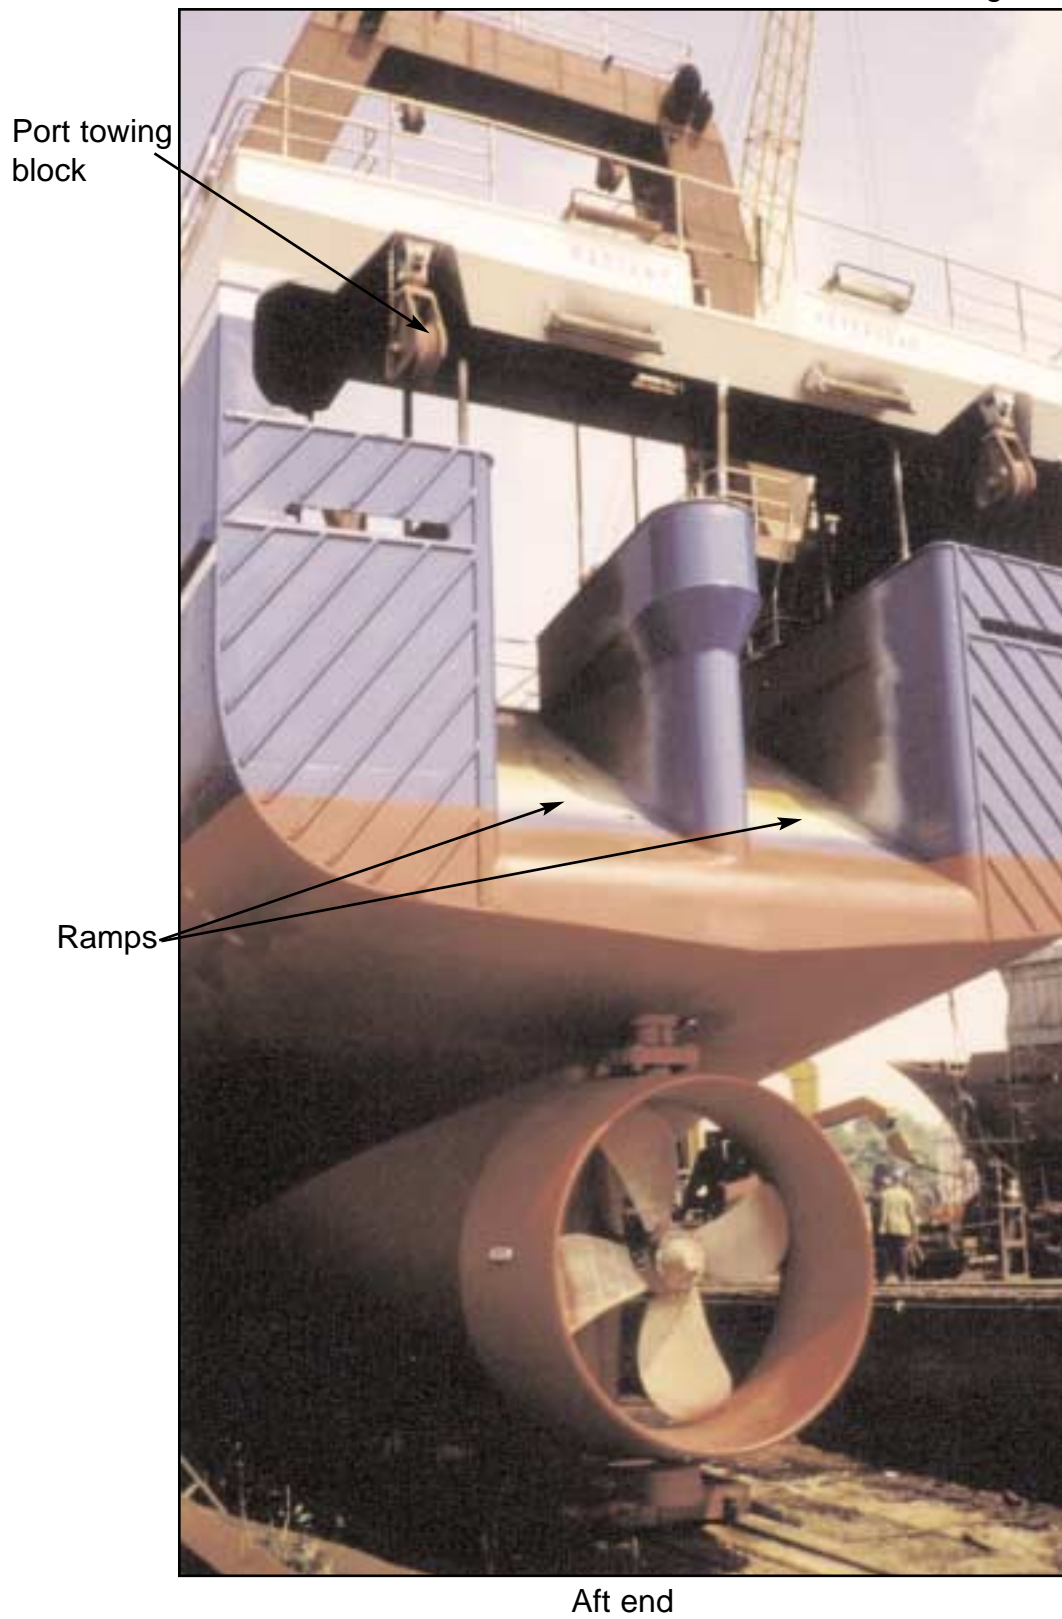
Figure 7

To begin shooting the gear, two trawls were pulled from their stowed positions aft along the working deck, until the cod ends slid down the ramps (**Figure 7**) into the water. Once the drag of the water was pulling the trawls out, the lines to the outhaul winches were removed. Shortly after, the trawl doors were attached, and the clump weight was deployed. The trawl doors were attached to warps, wound around the trawl winches situated below the working deck. The clump weight was attached to a warp, which was wound around a winch on the port side of the shelter deck. These three winches controlled the gear during trawling operations. The port and starboard trawl winches were contained in their own compartments, and small hatches were provided for the warps to pass through. The warps then ran to the towing blocks, which were positioned at the extreme aft end over the ramps.

A stability case was run where *Radiant* was in Condition 6 and 36 tonnes was loaded on the port towing block (**Figure 7**). In this situation, the steady angle of heel was 21° and the angle at which the port engine air intakes started to immerse was 37.5° (**Figure 12**). These angles were calculated on the basis that there was no shift of loose gear. At such large angles of heel/list the shift of some gear is likely. This would degrade the stability even further. William Ritchie recalls that all the loose gear on the chart table fell on the deck when a large list developed. This would have happened in other spaces as well. The wind on the starboard side of the vessel would also have increased the list to port, but this was not considered in the calculations.

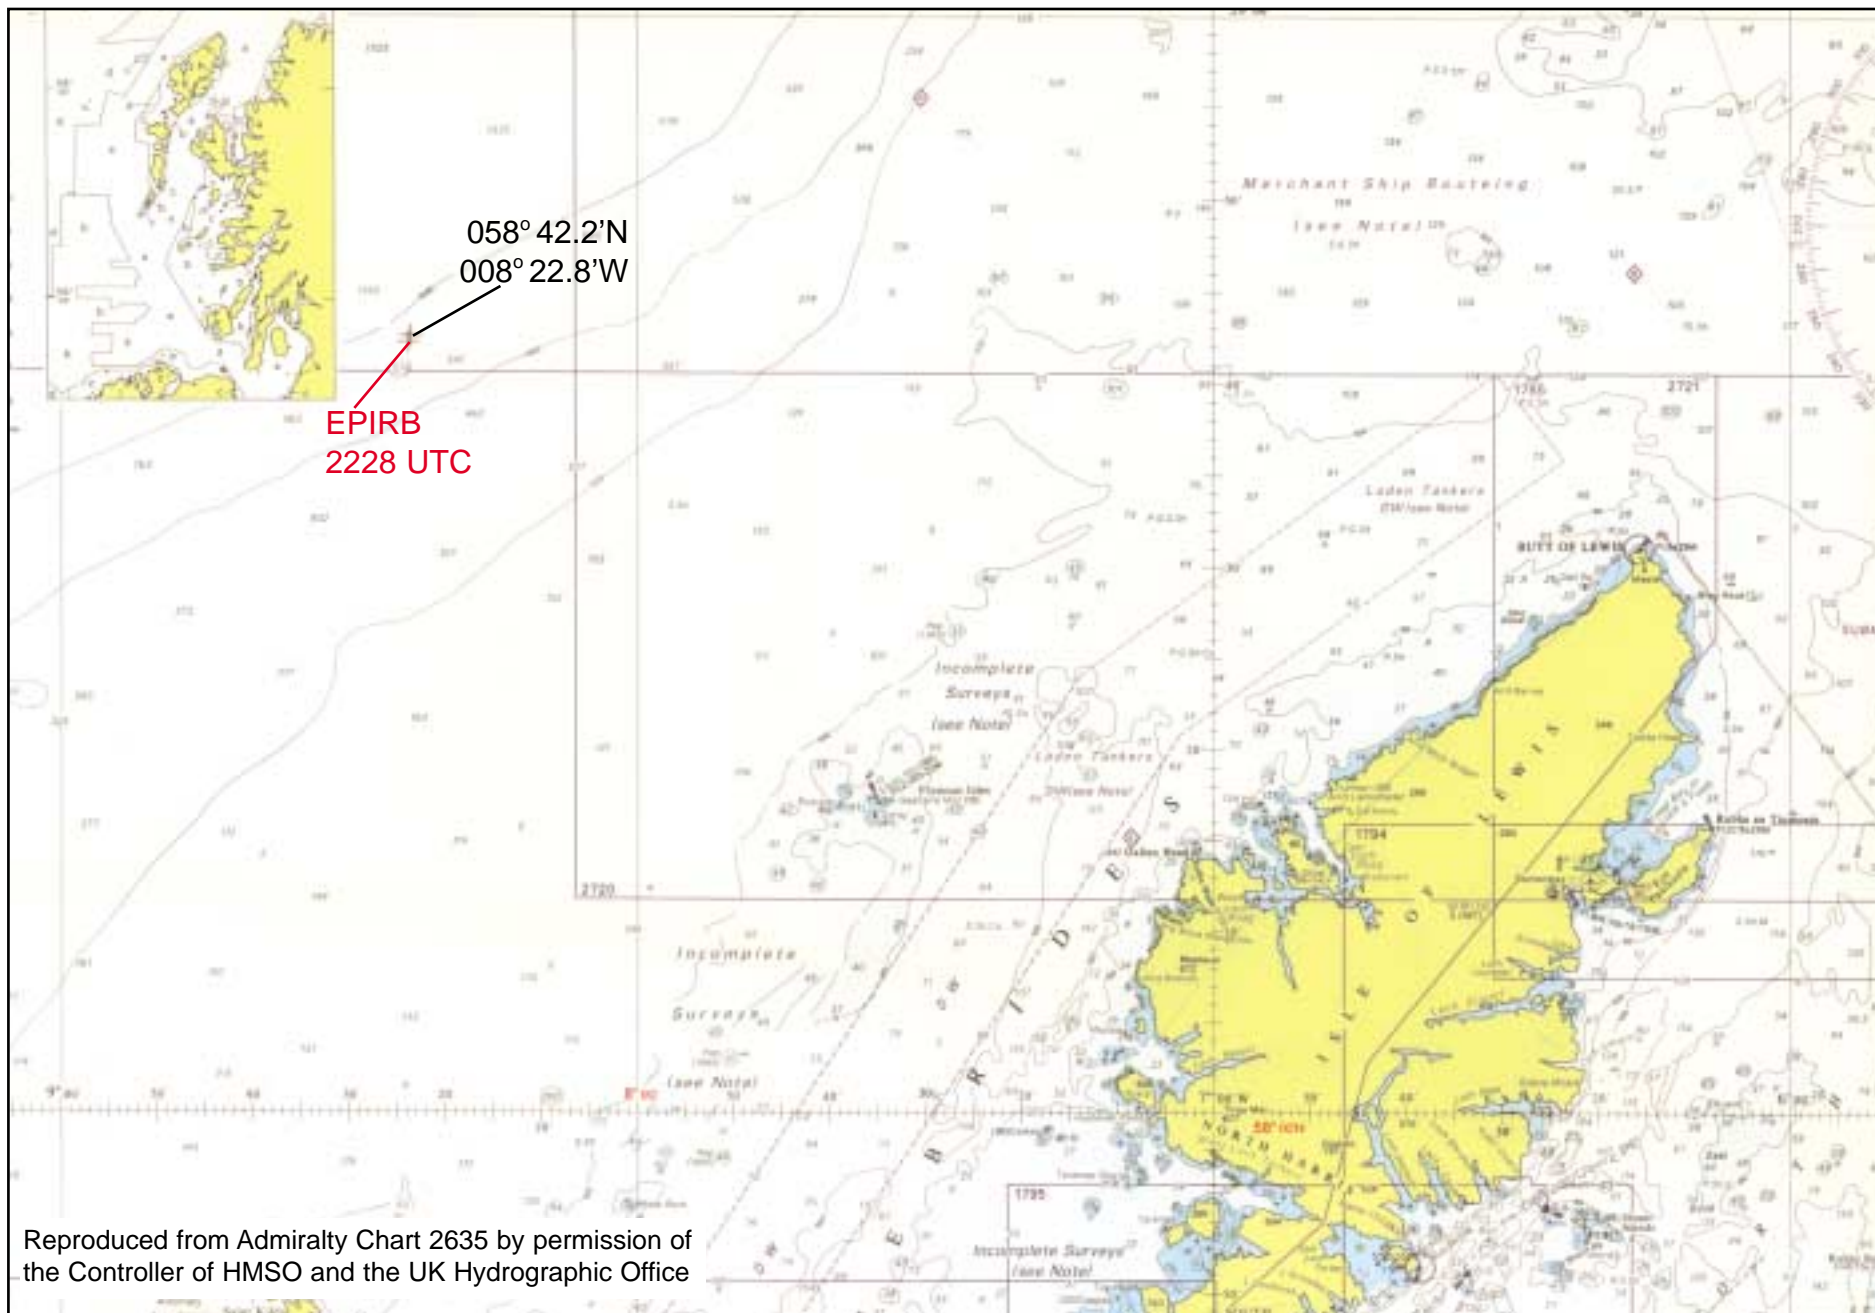
Figure 9

The crew of the fishing vessel *Crystal River* located the wreck of *Radiant* on the seabed at position 058° 42.2' N and 008° 22.8'W using sonar equipment (**Figure 9**). This was just to the north-east of the sinking position used by the coastguard. There was a small current to the north-east, and this would have carried the vessel in that direction as she sank.

Radiant was having great difficulty breaking free, this indicates that the fastener was something else, possibly a wreck. The French fishing vessel *Le Parrain* was lost in the area a couple of months before. *Le Parrain* had broken down and was being towed, while unmanned. The tow parted at night and she was never seen again, so it is believed that she sank. *Crystal River's* skipper did not locate another wreck close to *Radiant*, however, he did say that he, too, had come fast in this position, before *Radiant's* loss. The chart (**Figure 9**) does not show any wrecks in the area where *Radiant* sank.

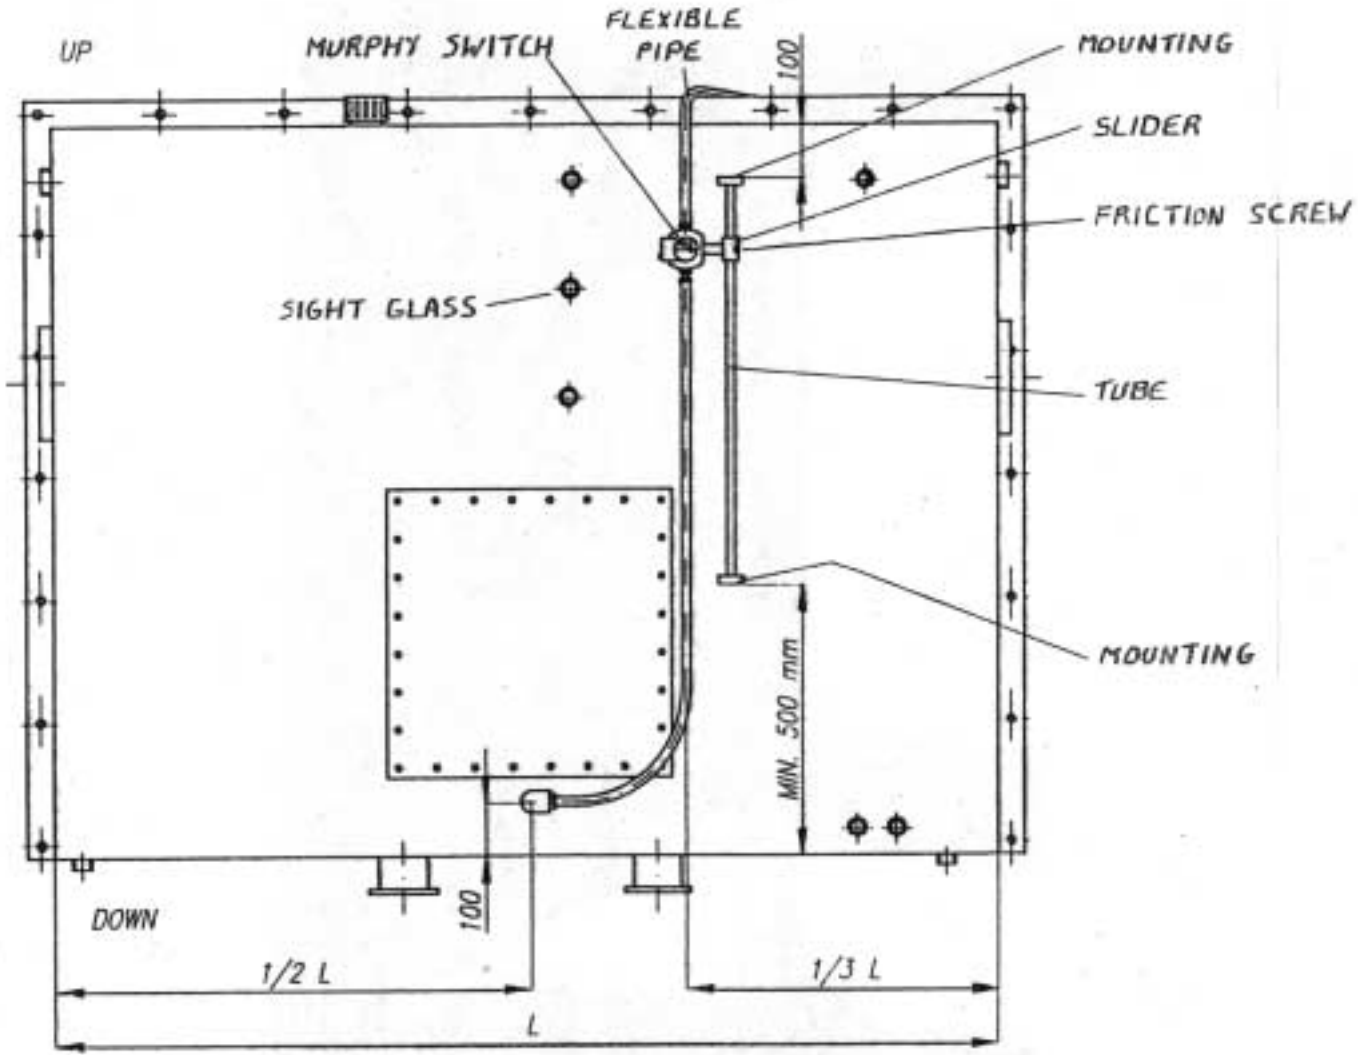
Figure 10

The hydraulic tank was at the forward end of the hydraulic space with the six main pumps. The tank was fitted with an oil level alarm/cut out switch referred to as a "Murphy switch", which could be moved up and down (**Figure 10**). On *Radiant*, the switch was set between the upper and middle sight glasses. The upper sight glass was level with the surface of the hydraulic oil, which was about 0.2m above the Murphy switch.

If there was an oil leak and the level fell below the Murphy switch, an audible alarm sounded, and the six main pumps cut out, effectively disabling all the hydraulics. However, there was a hydraulic emergency start switch (**Figure 11**) on the winch control panel. A plastic cover, to prevent inadvertent use, protected

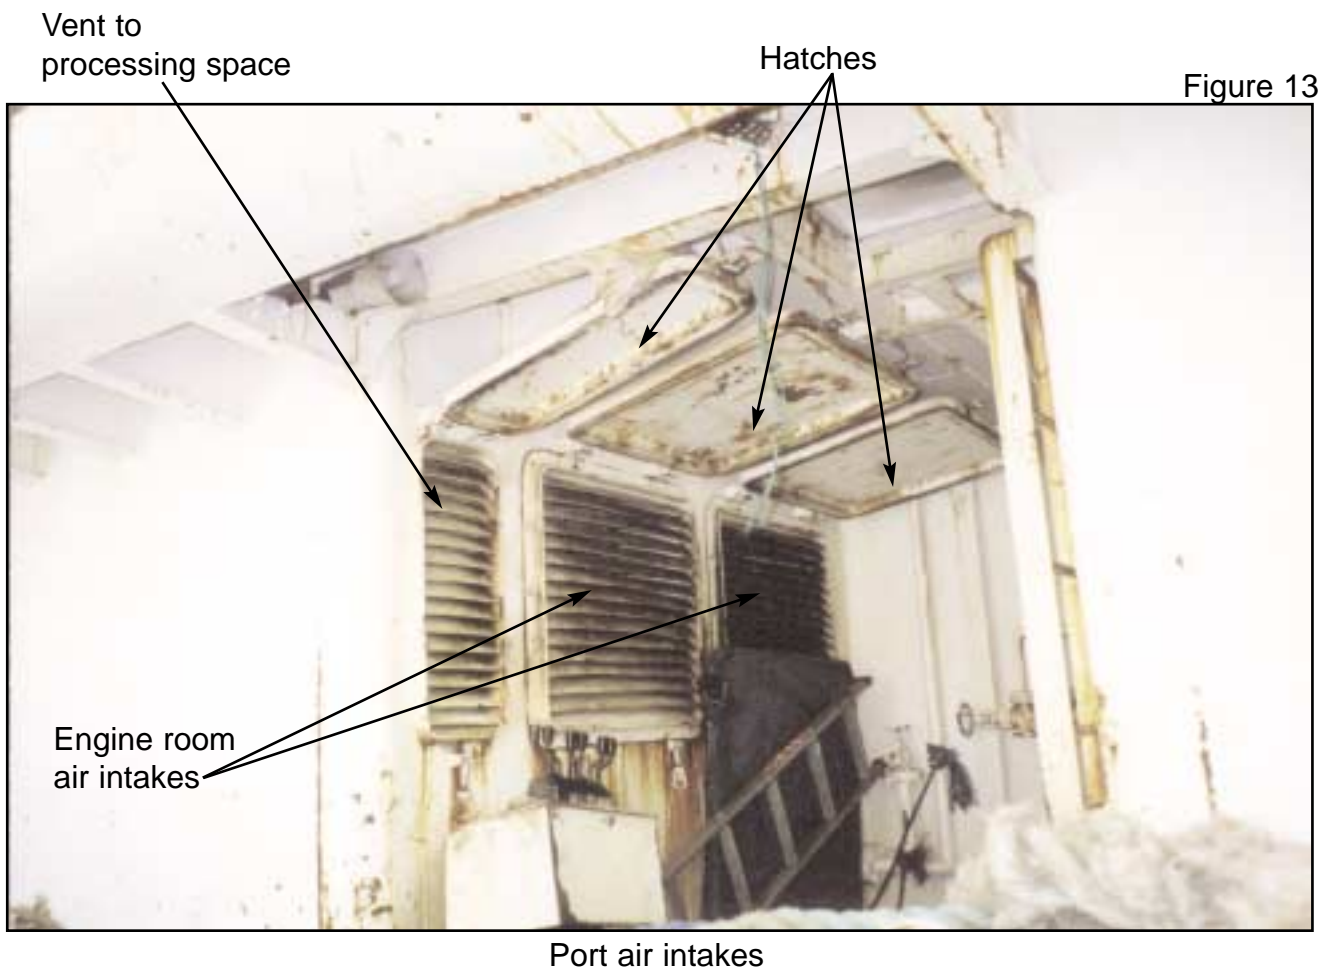
Figure 13

The stability book showed that *Radiant* met the stability requirements of the regulations. The MCA was in the process of checking the stability book to confirm this when the vessel was lost. The port engine air intakes were not considered to be a downflooding point, because the openings could be closed with hatches (**Figure 13**). However, the intakes had to be open to supply air to the main engine, generators, and for engine room ventilation, when the vessel was fishing. There was a scupper (**Figures 14 & 15**) adjacent to these intakes, which was low on the port side (**Figure 2**). If the vessel was heeled to a large angle to port, water could flood in through this scupper on to the working deck, and then down into the engine room via the intakes.

The vent opening to the processing space was inboard of the port engine air intakes (**Figure 13**). This was the next downflooding point after the port warp opening, but it did not immerse until the angle of heel was about 51°.

The port engine air intakes were not taken as a downflooding point when assessing the vessel's stability. For operational reasons this is not considered practical, so a recommendation on this has been made to the MCA. *Radiant* was fitted with powerful winches, which were capable of seriously compromising stability if fishing gear became snagged. For similar vessels, a notice should be shown in bold print, near the front of the stability book, warning skippers of this danger. A recommendation has been made to the MCA addressing this point.
