Report on the investigation of the  
collision between the ro-ro ferry  
***Stena Gothica***  
and the eastern approach jetty at  
Immingham on 2 April 2002

Marine Accident Investigation Branch  
First Floor  
Carlton House  
Carlton Place  
Southampton  
United Kingdom  
SO15 2DZ

**Report No 39/2002  
December 2002**

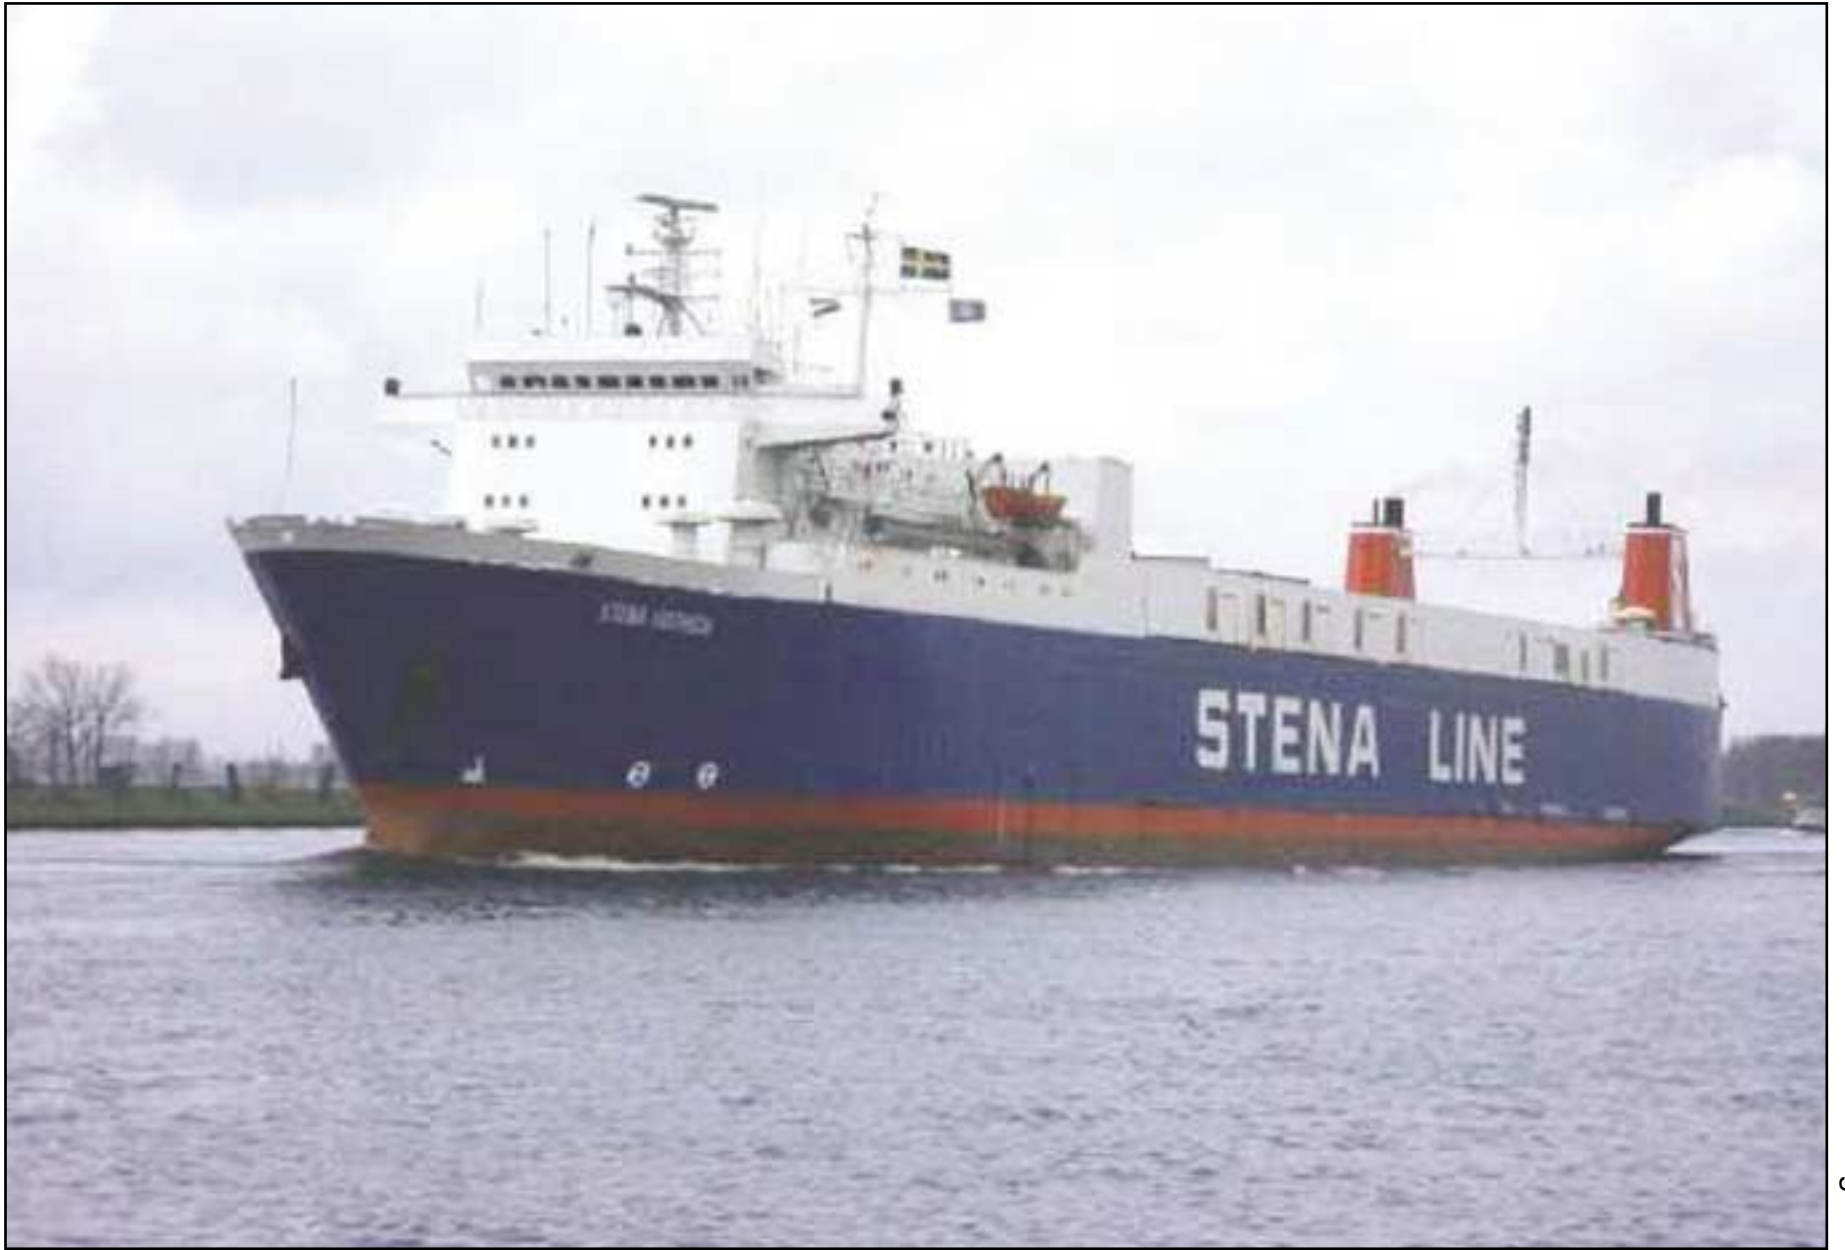
Figure 1

*Stena Gothica*

*Stena Gothica* (see Figure 1) was a ro-ro cargo vessel owned and operated by Stena Line. She was on a regular schedule trading between Gothenburg and Harwich, with occasional visits to Ghent and Immingham. She could carry up to 11 lorry drivers as passengers. As she was not a regular visitor to Immingham none of her masters held a PEC for the port.

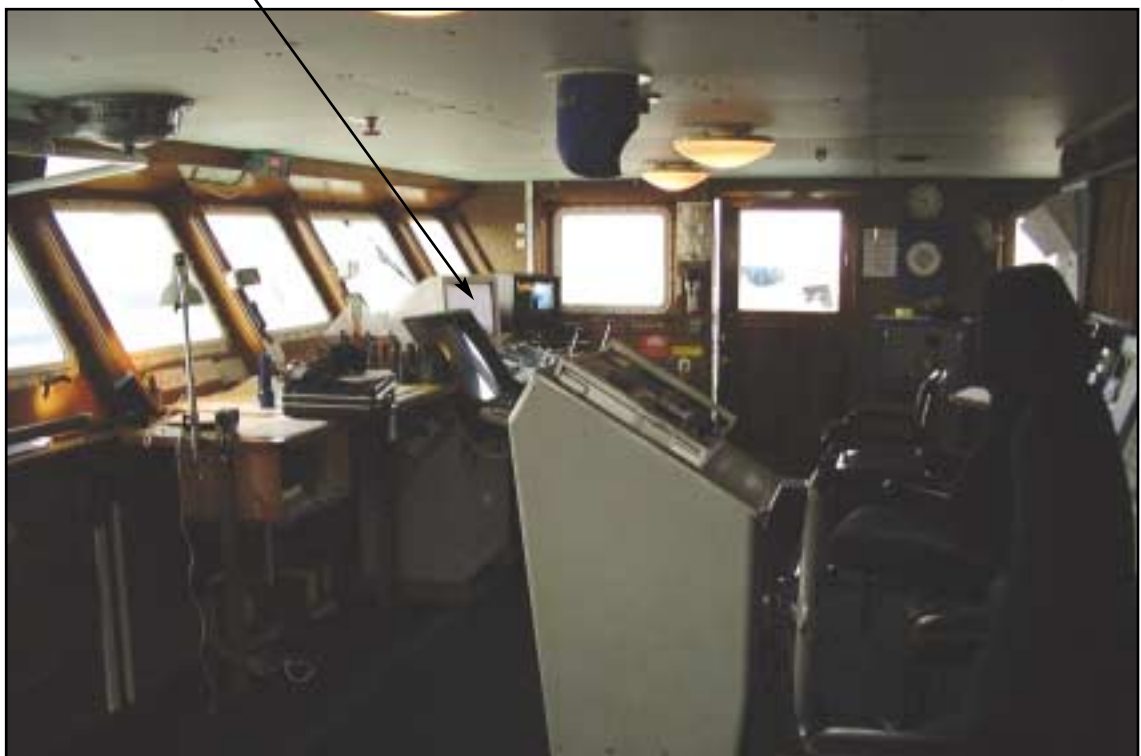
Figure 2

Bridge layout

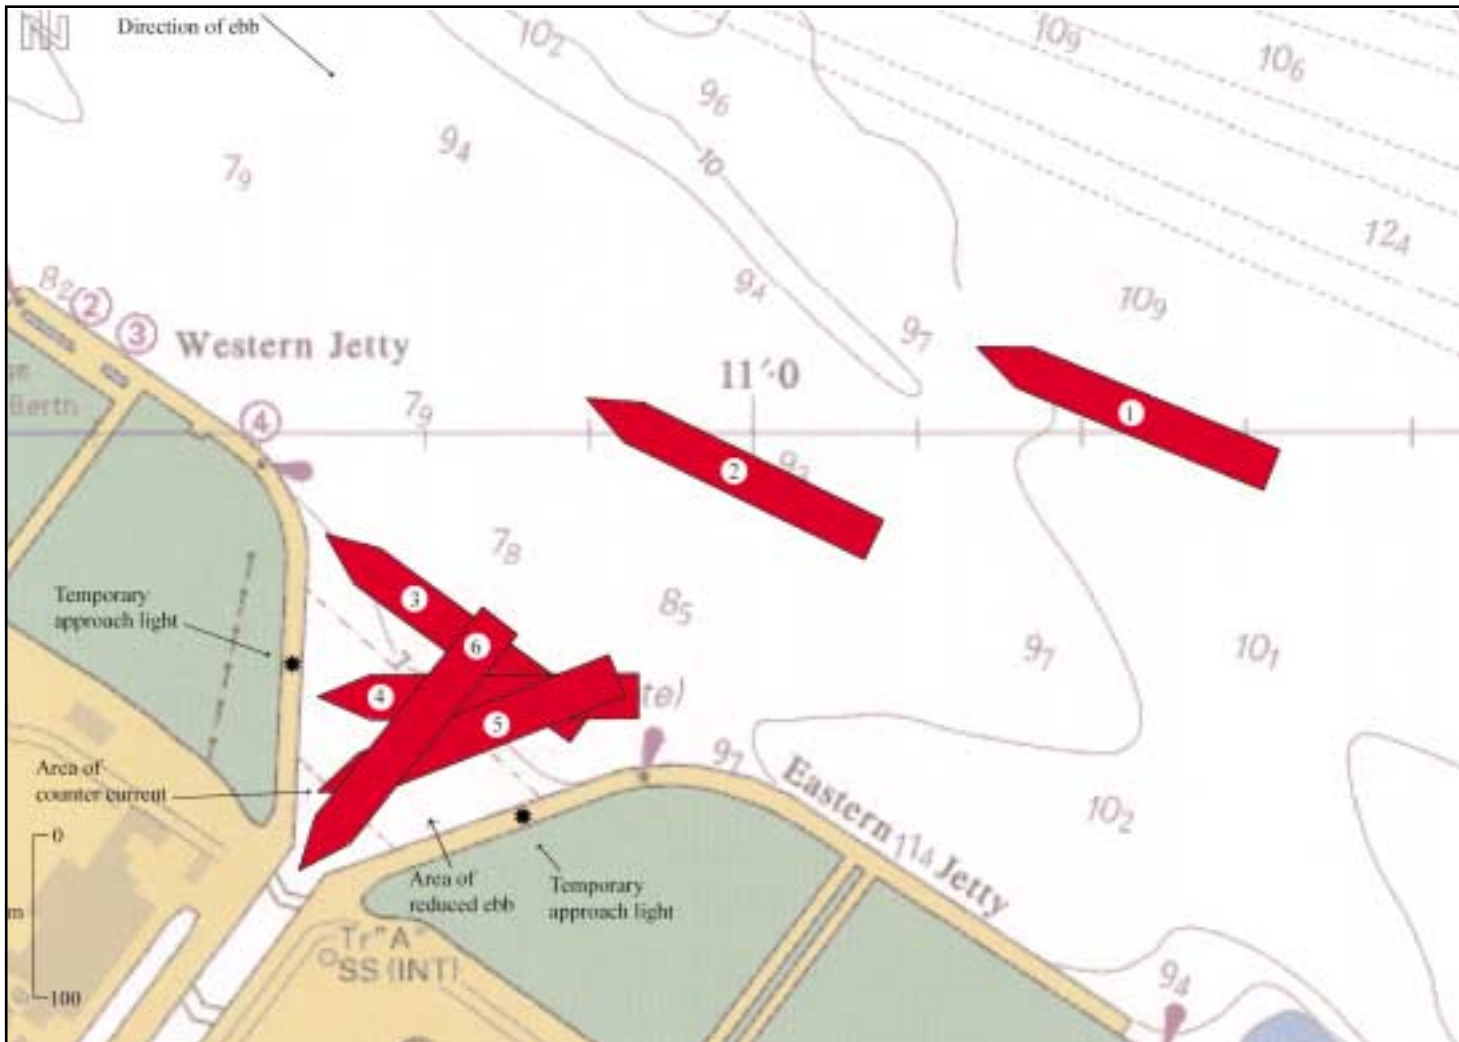
Figure 6

The normal procedure for entering the lock entrance, on an ebb tide, is to stem the tide and then “crab” the vessel slowly over the ground to a position where the bow is very close to the western jetty (**see Figure 6**).

Normal approach during ebb
