Report on the investigation of the collision between the ro-ro ferry

Stena Gothica

and the eastern approach jetty at Immingham on 2 April 2002

> > Report No 39/2002 December 2002

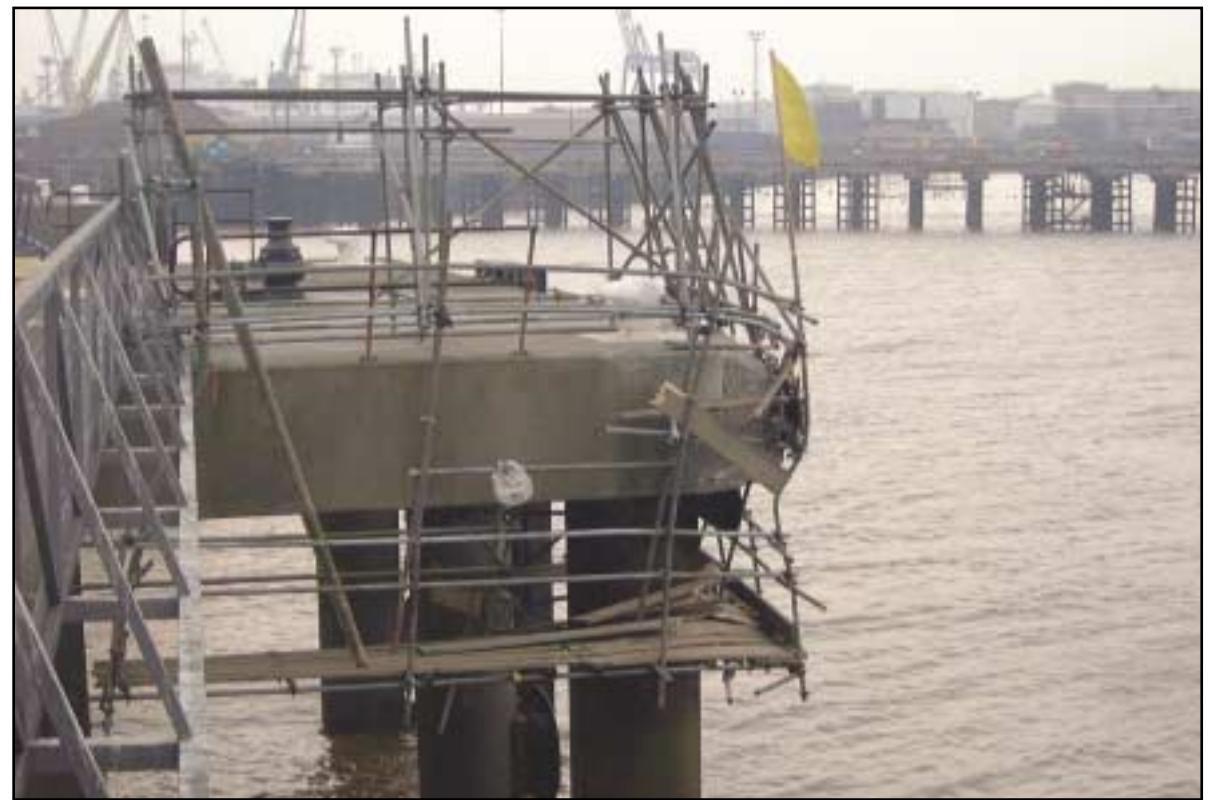
Figure 11

At the time of the incident the outermost fender on the second dolphin (No 24) from the lock was under repair and missing due to an earlier incident. The missing fender had scaffolding around it and was marked by a flag. The pilots had been informed.

Fender 24

Since the incident, the fendering has been fully repaired (see Figure 8).
