Report on the investigation of
the collision between
the Saint Vincent and the Grenadines registered
general cargo ship
Aroid
and the Antigua and Barbuda registered
general cargo ship
Anjola
in the River Trent
on 25 February 2002

Report No 30/2002
October 2002

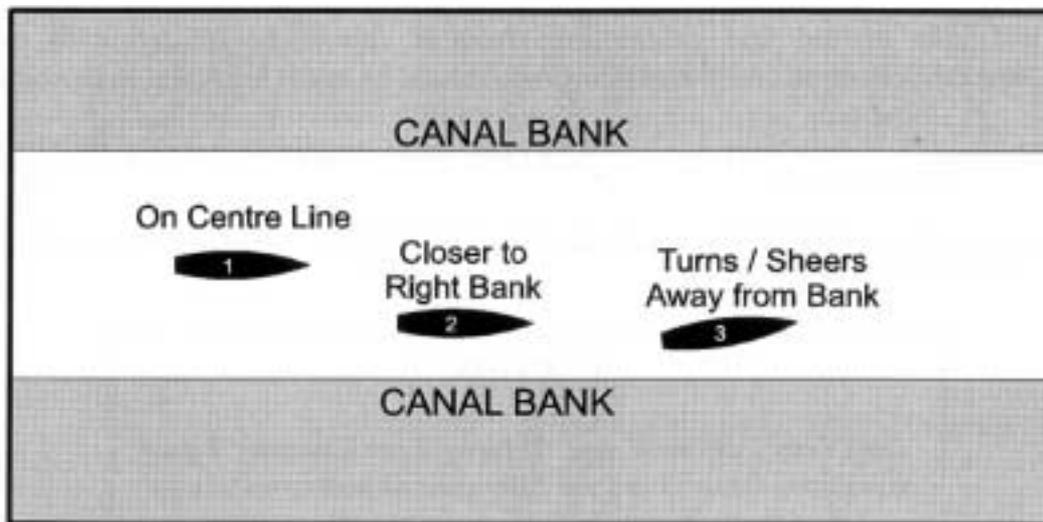
Figure 2-7 Bank Effect - (Suction Aft of C of G) Turning Ship Away from Bank

- b. **Bank Effect in Canals.** Consider a vessel which moves off the centre line of a canal (Fig 2-7 Position 1) and towards the right hand bank.(Fig 2-7 Position 2) The flow of water between its starboard side and the nearer bank becomes confined and, from the *Bernoulli Phenomenon*, it will be seen that the *Velocity* of the water flow will be greater on the starboard side than on the port side, and thus lower *Pressure* (greater *Suction*) will occur on the starboard side. This *Suction* will tend to pull the ship to starboard towards the nearer bank. However, the *Suction* forces are not uniformly distributed along the ship's length, and their resultant acts somewhere abaft amidships. This is equivalent to a force acting aft of the *Centre of Gravity* which also creates a *Turning Moment*, deflecting the ship's head away from the bank – in this case to port (Fig 2-7 Position 3). In practice this *Turning Moment* overrides bodily *Suction* towards the bank and the ship will start moving away from it – sometimes so violently that a sheer towards the opposite bank is generated. A ship being deflected away from a solid bank or wall is sometimes said to be being 'pushed off by the bow *Pressure Zone*'. A convenient analogy but not an exact description of the cause of this phenomenon.
