Report on the investigation of

the cargo shift, abandonment, and grounding of

mv Kodima

> Report No 1/2003 January 2003

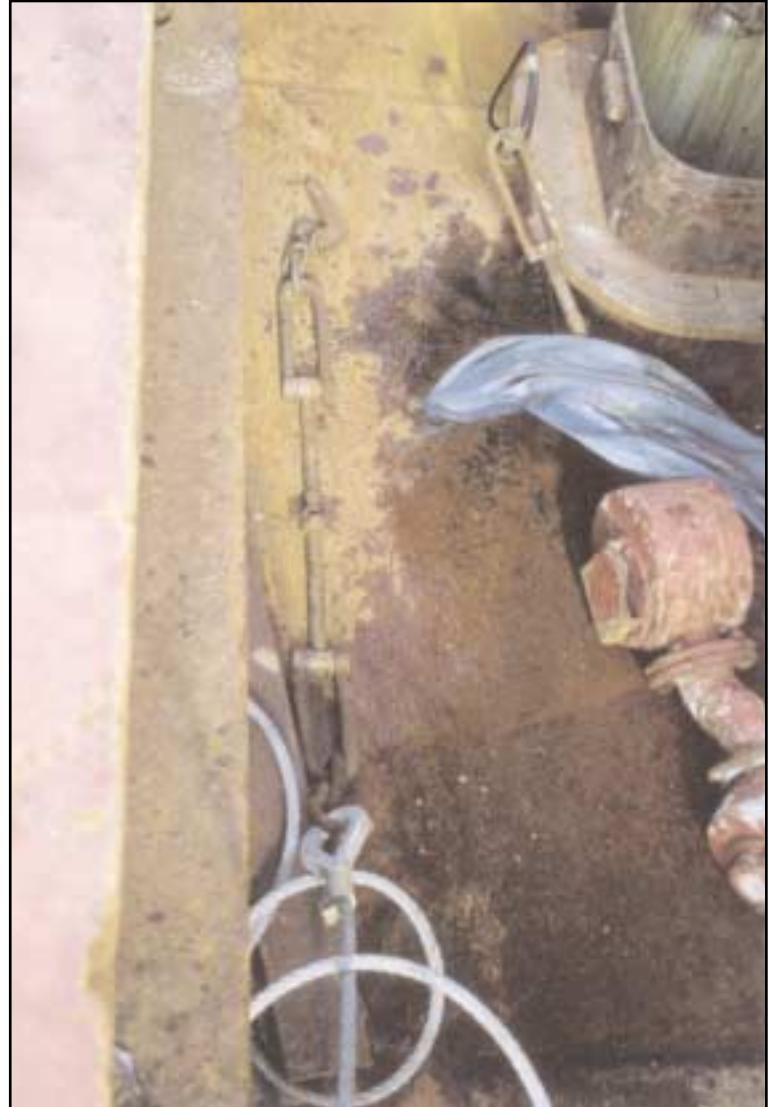
Figure 4

Forty-four lashing wires, secured to strong points on the deck at intervals of about 1.5m, were fitted. The wires were of 16mm diameter and were tested and certified in 1997 by the Russian Register of Shipping. Integral to the wire lashings were a turnbuckle to allow tightening, a pelican hook for quick release, and chain for adjustment of length (Figure 4).

Photograph showing wire lashing with turnbuckle and pelican hook

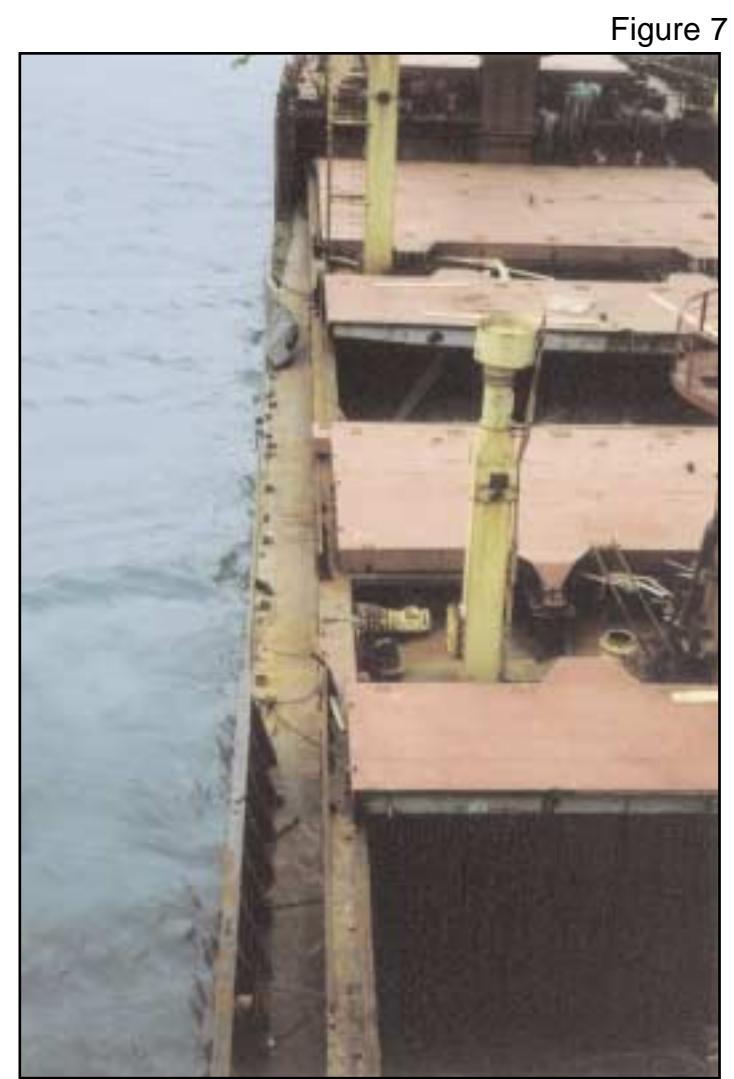
Two gangs of stevedores were used, one starting at the forward end of No 2 hold hatch cover, and the other starting at the aft end of No 4 hold hatch cover. Both worked towards each other. Packages were packed around obstructions on the deck, including hold air vents (Figure 7), over sounding pipes (Figure 8), and dunnage was placed on top of the packages located between the hatch coamings and ship's-side bulwarks to keep the stow level. Other than in the wells between the hatches, all of the timber packages were stowed longitudinally and, after the first tier had been loaded, the stevedores placed 5cm thick dunnage along the outer edge of the stow in order to angle the outer packages inboard slightly. Three tiers of timber packages were stowed on the hatch cover to hold No 2, and four tiers on the hatch covers to holds No 3 and No 4, with fewer packages being used on the uppermost tiers. The chief officer estimated that the height of the deck cargo was slightly less than 4m above the hatch covers. The length of the stow was about 66m, being from immediately forward of the main superstructure, to aft of the forecastle housing.

Photograph showing hold air vents

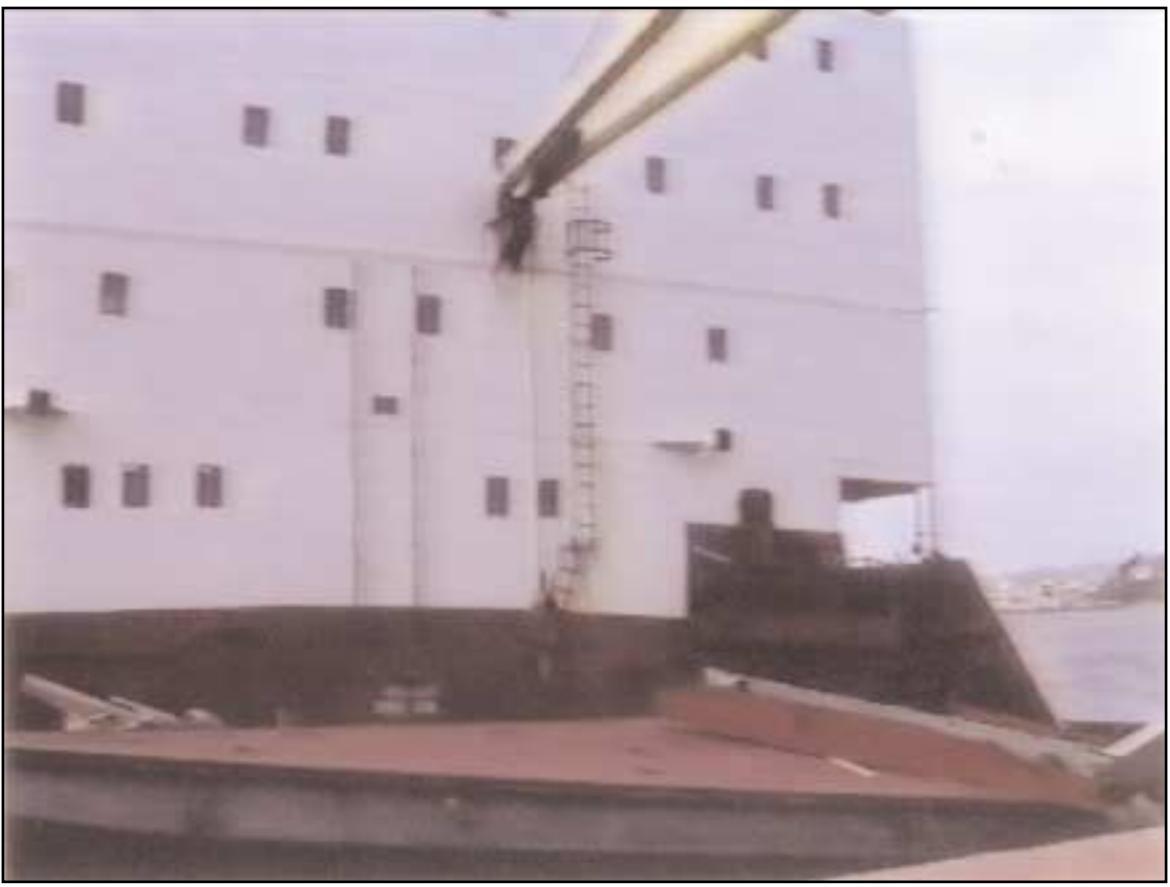
Photograph showing ladder used to access the top of the timber deck cargo
