Report on the investigation of the
grounding of the passenger ro-ro ferry

Sardinia Vera

off Newhaven on

Report No 32/2002
October 2002

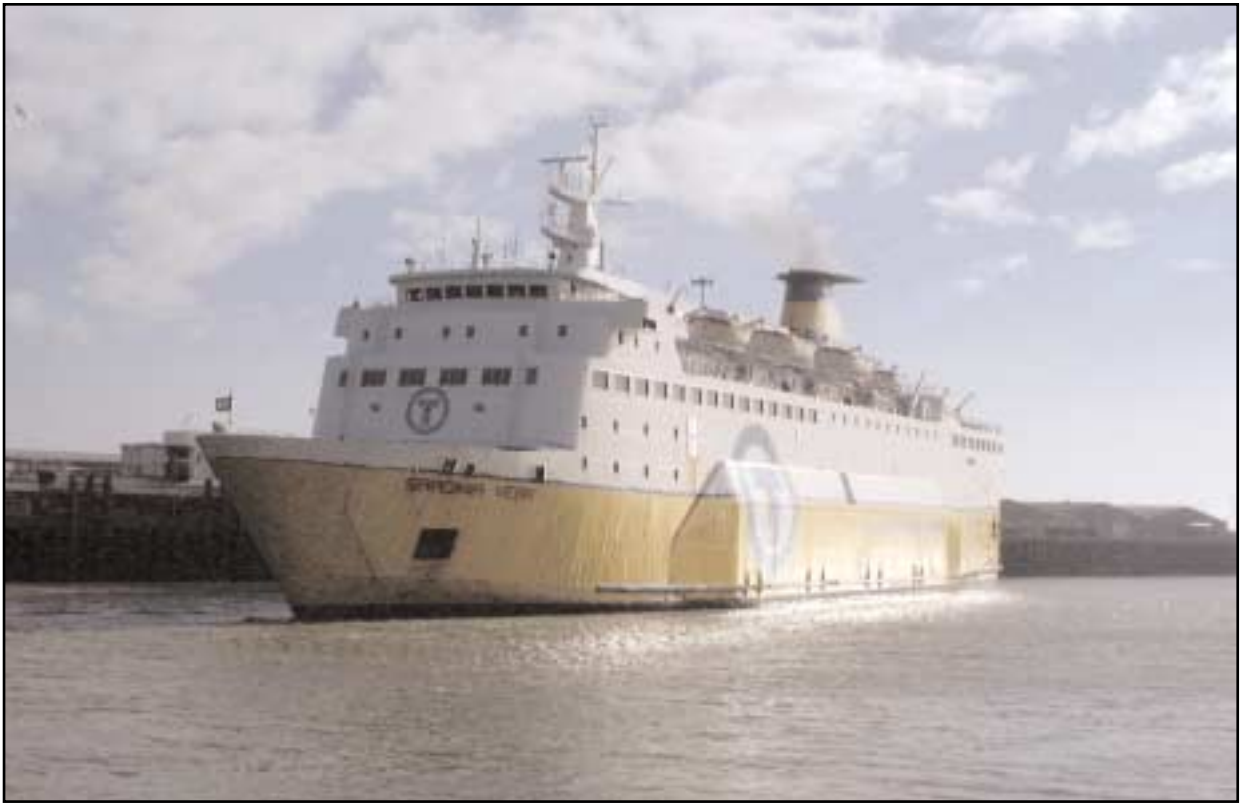
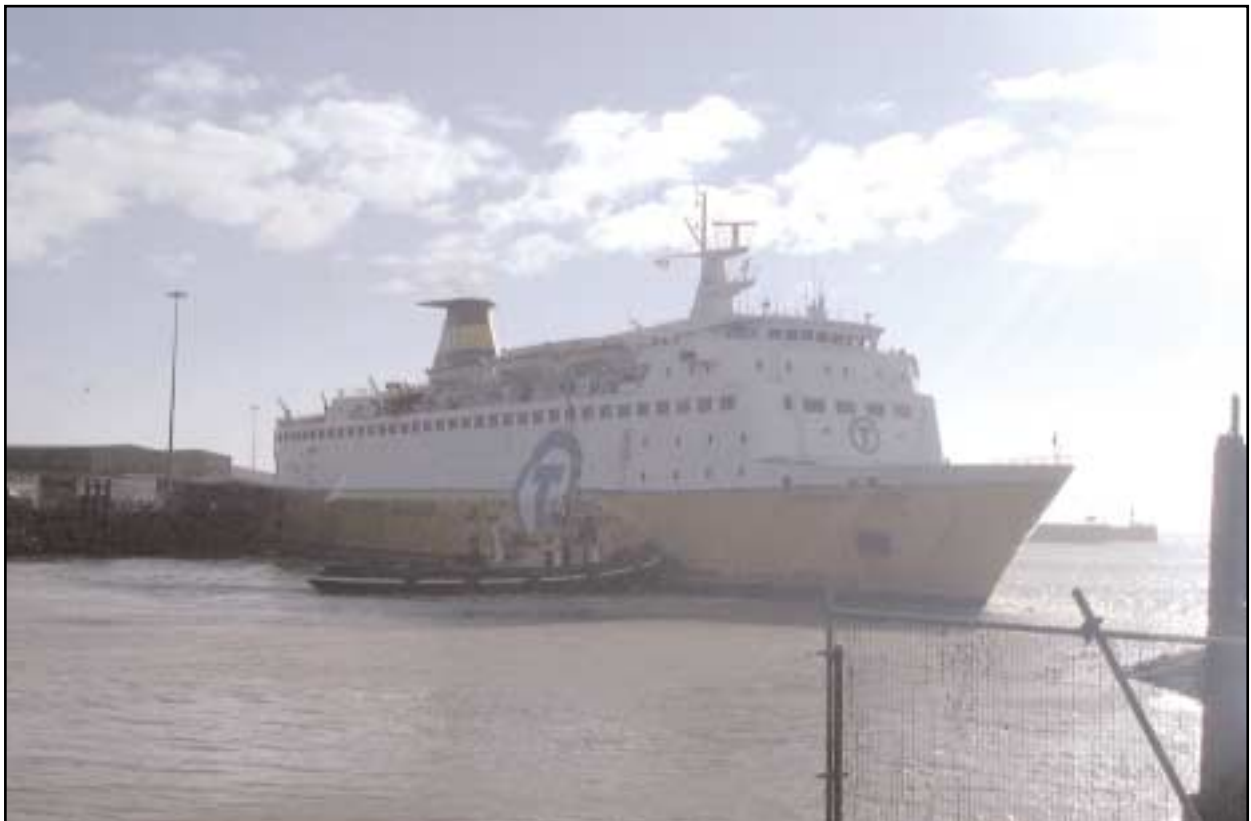
Figures 1 and 2 - *Sardinia Vera*

Sardinia Vera is a high-sided ro-ro vessel and has a considerable area of windage (**see Figures 1 and 2**). She is therefore very susceptible to the effects of the wind and attracts considerable leeway.

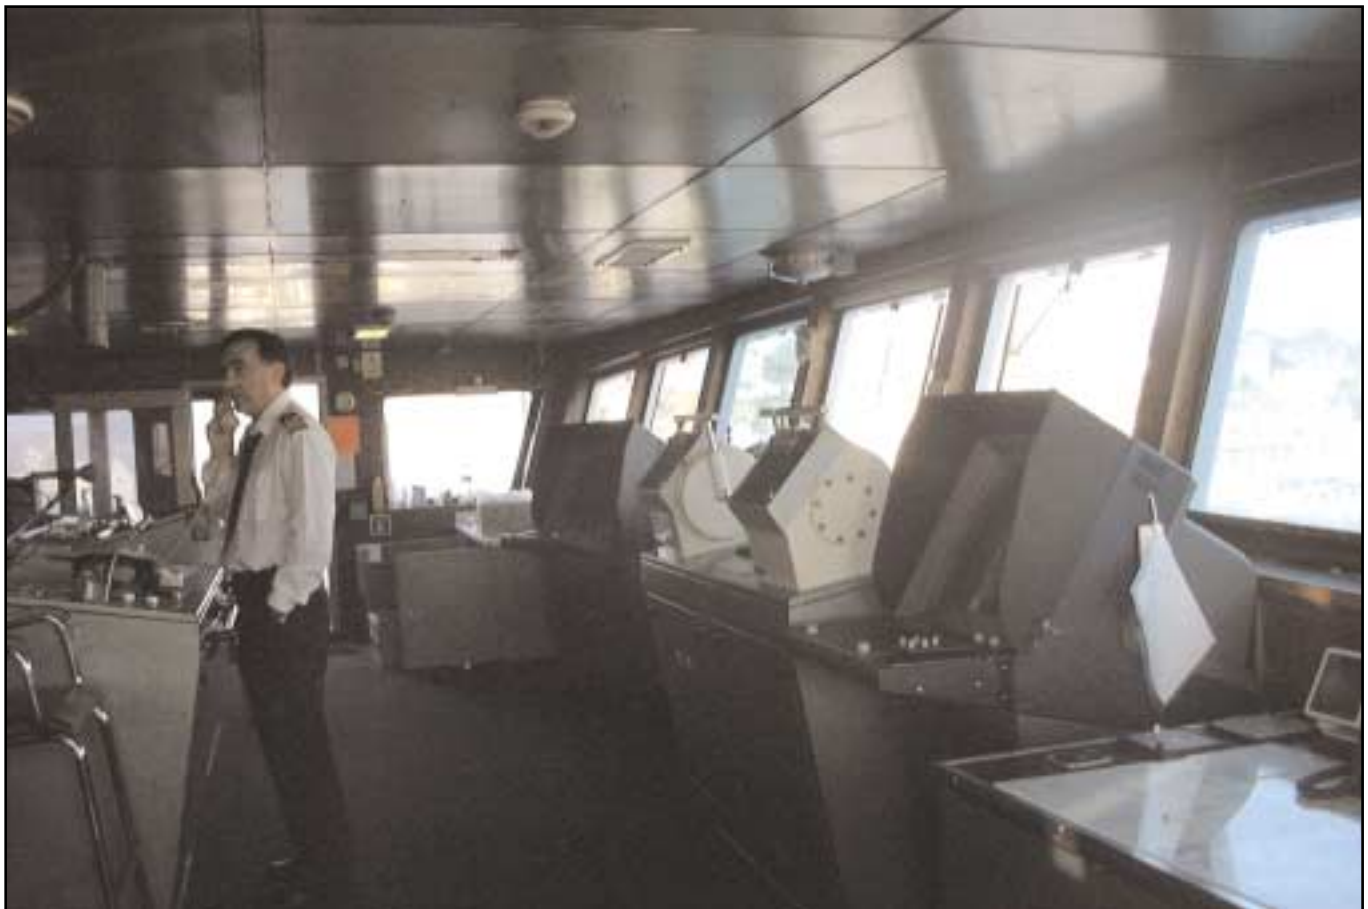
Figure 12

No defects were found with any bridge, machinery or steering equipment.
