Report on the investigation of the
grounding of the passenger ro-ro ferry

Sardinia Vera

off Newhaven on

Report No 32/2002
October 2002

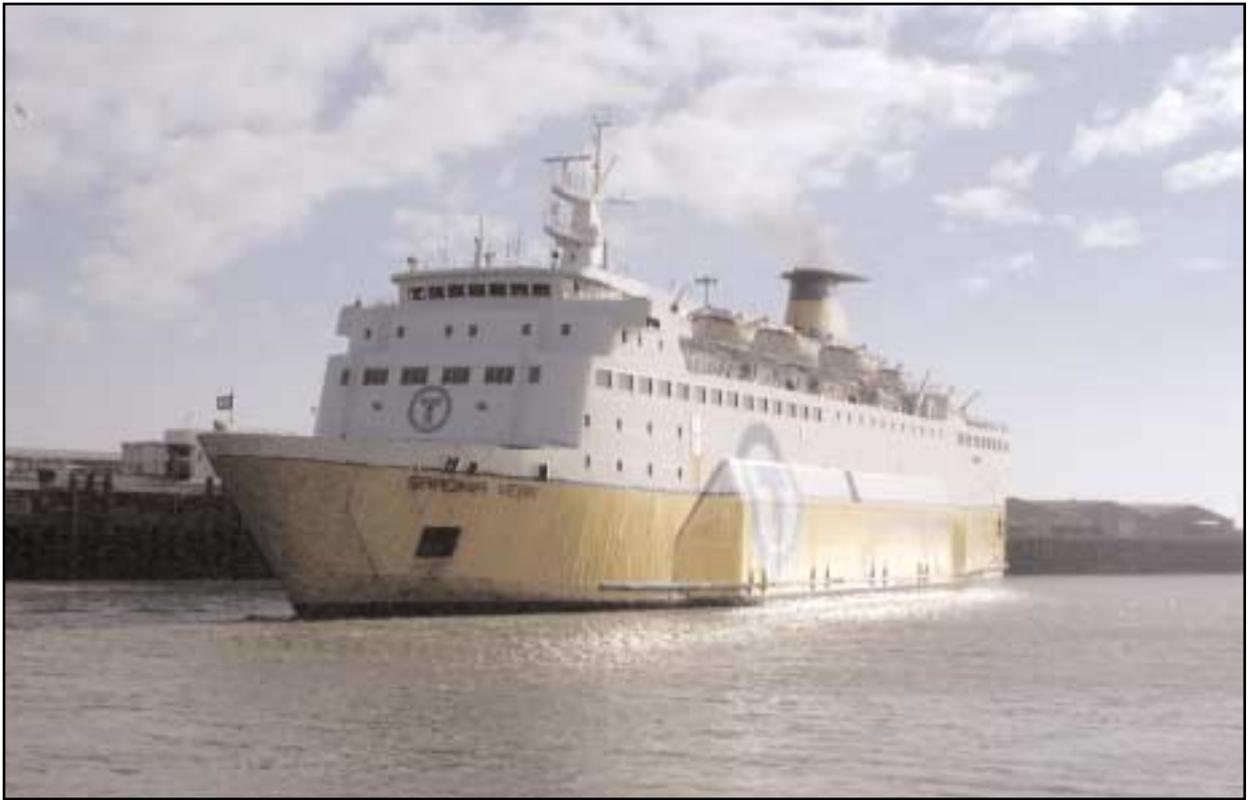
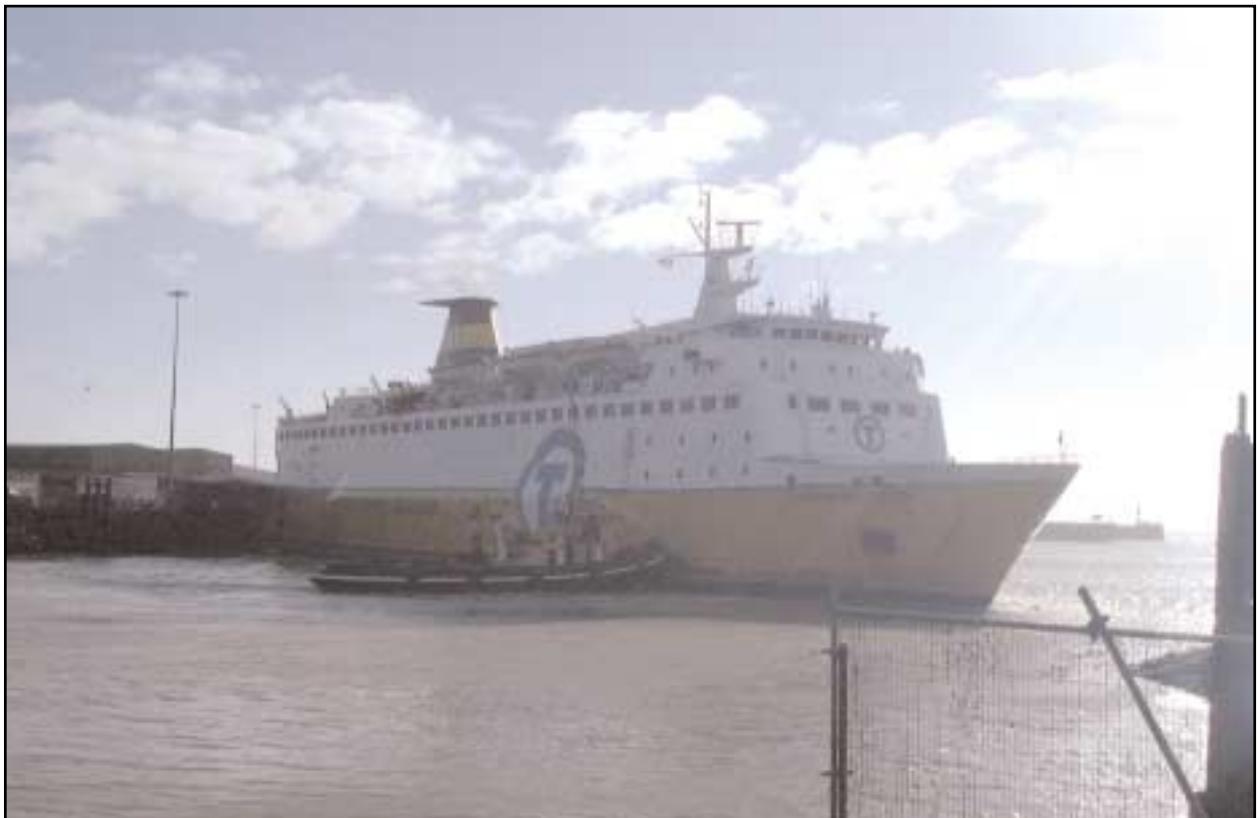
Figures 1 and 2 - *Sardinia Vera*

Sardinia Vera is a high-sided ro-ro vessel and has a considerable area of windage (**see Figures 1 and 2**). She is therefore very susceptible to the effects of the wind and attracts considerable leeway.
