Report on the investigation of
the capsizing of the fishing vessel

Charisma (OB588)

30 January 2002

**Report No 38/2002
November 2002**

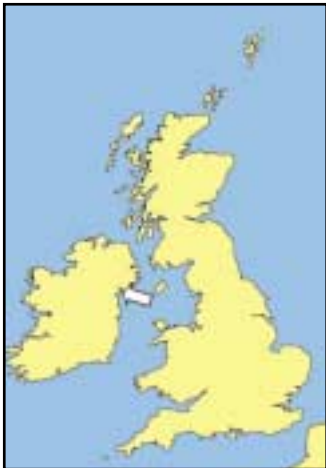
Charisma, a 9.68m GRP vessel built in 1989, was dredging for mussels in Rostrevor Bay, Carlingford Lough on 30 January 2002. She had a crew of three. The weather was described as ideal for mussel fishing with light winds and a calm sea. A substantial catch of mussels had been caught the previous day and this had been left stacked on deck overnight.

It is concluded that the ultimate capsizing of *Charisma* was caused by the effect of undetected flooding, probably via the manual bilge discharge pipe, in combination with the heavy load of mussel bags on deck.
