Report on the investigation of
the collision between
Diamant/Northern Merchant
3 miles SE of Dover
on
6 January 2002

Marine Accident Investigation Branch
First Floor
Carlton House
Carlton Place
Southampton
United Kingdom
SO15 2DZ

Report No 10/2003
April 2003

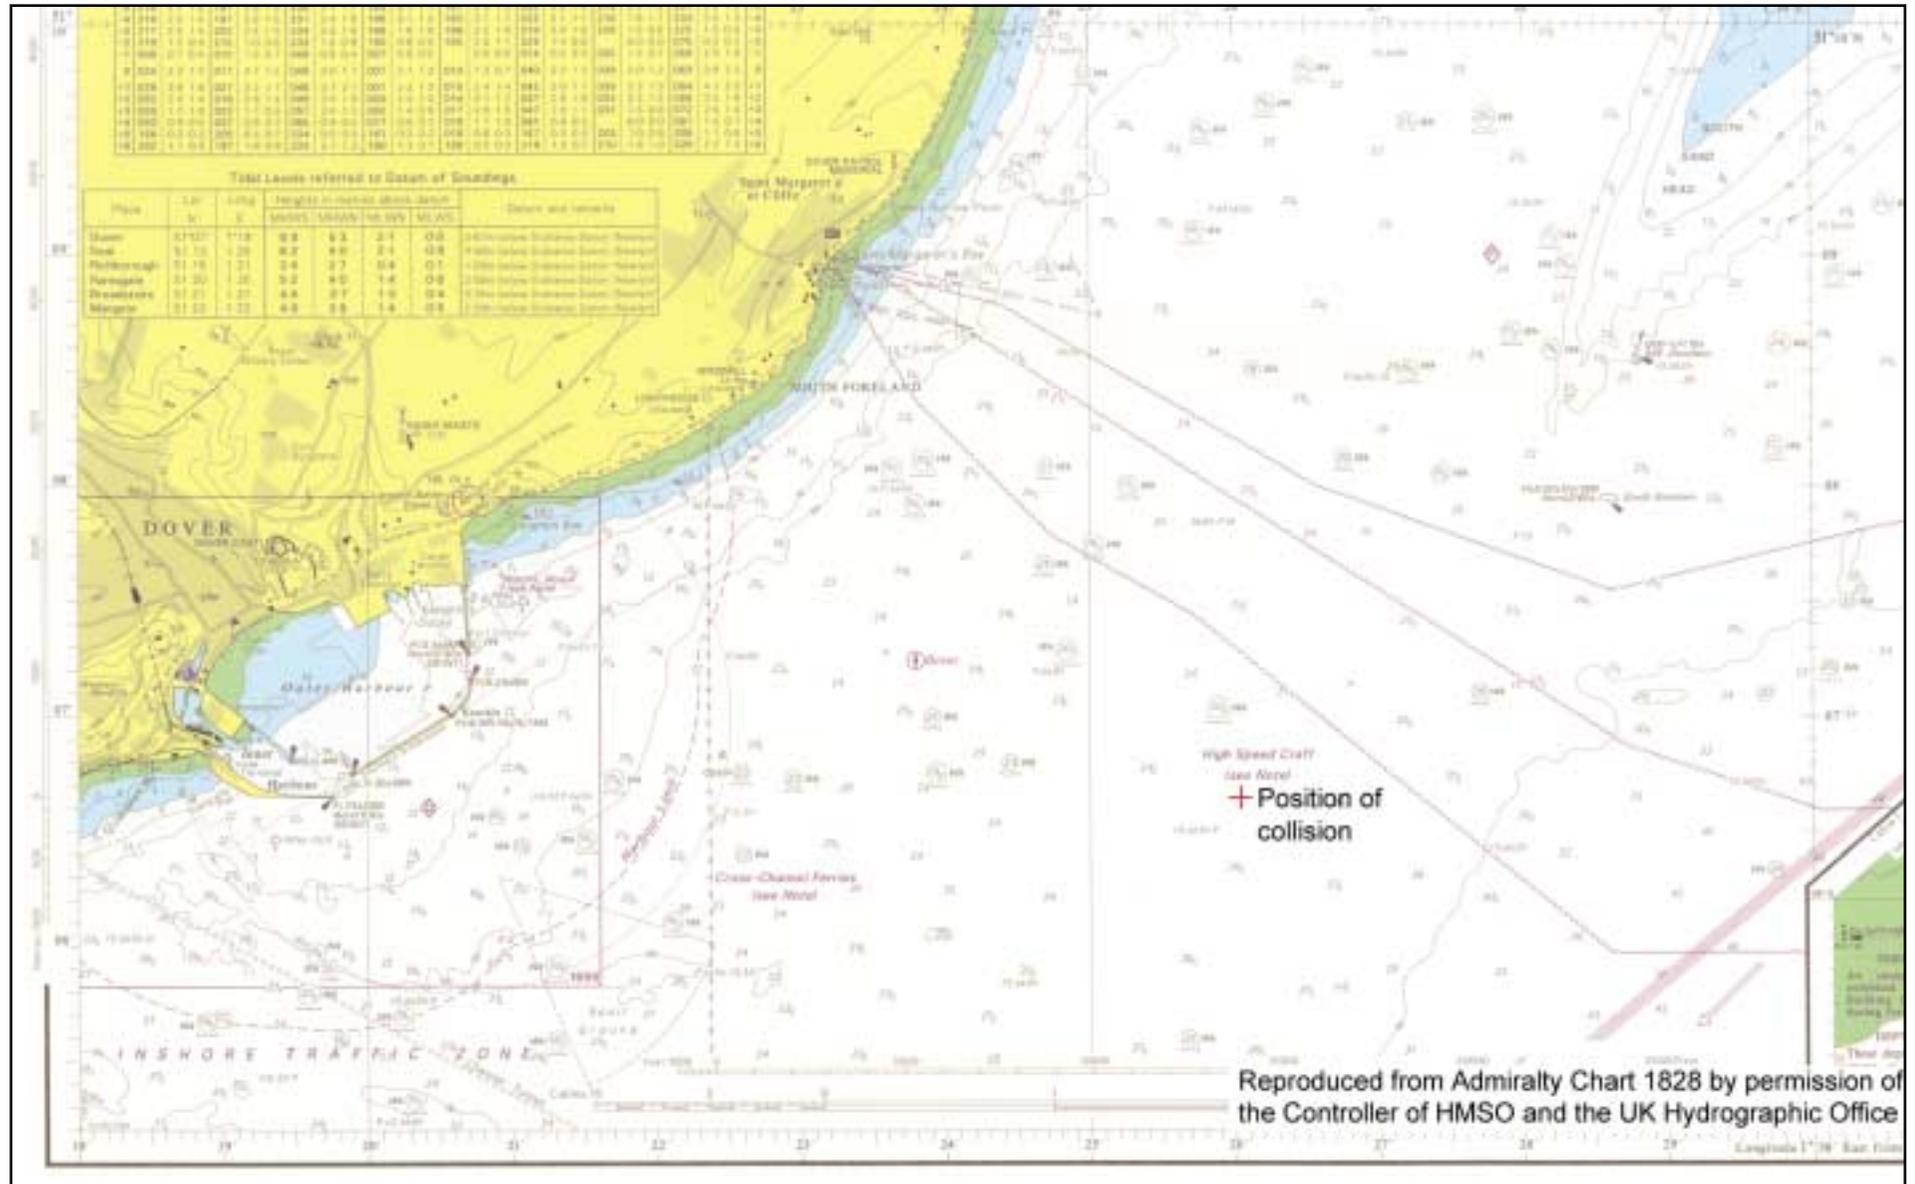
Chart extract showing position of collision

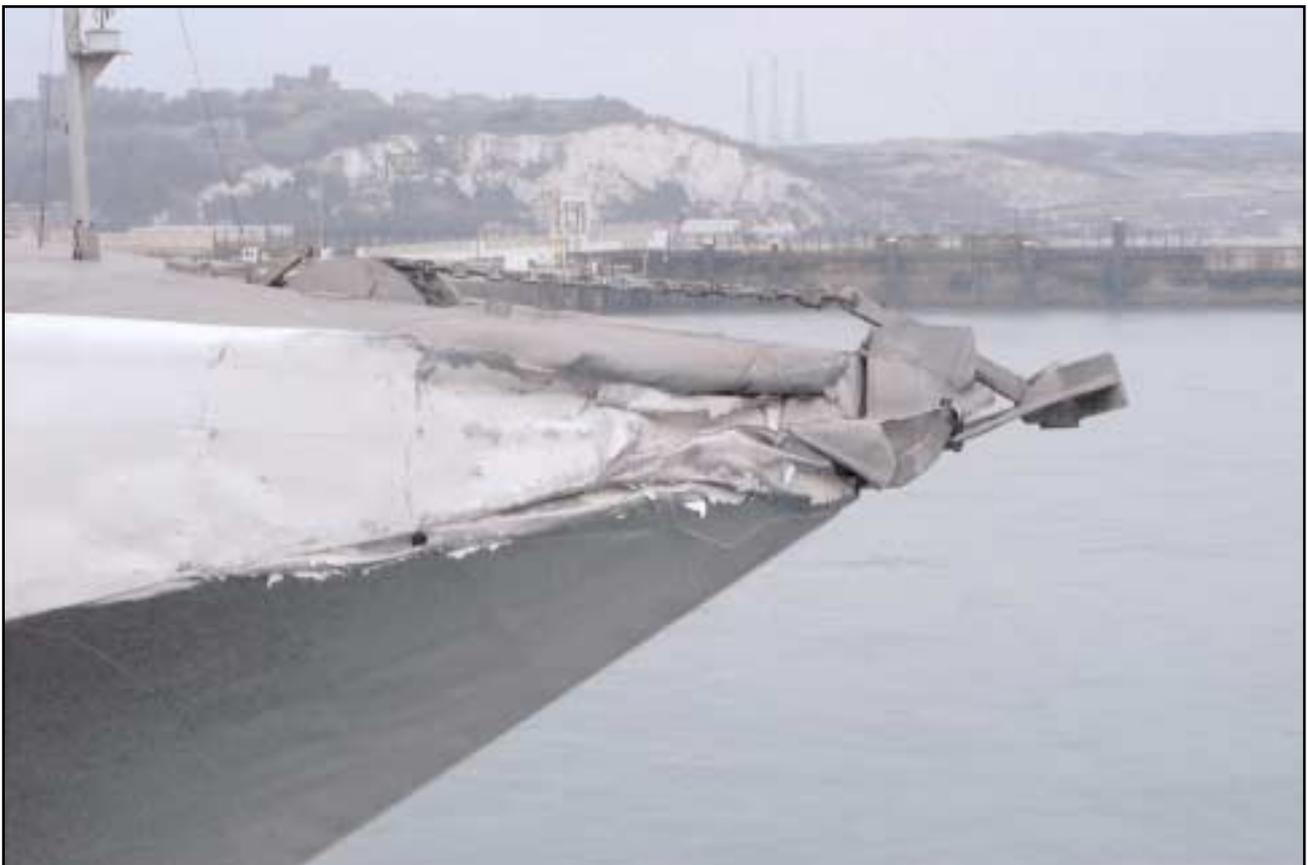
Figure 6 - damage to *Diamant*

After soundings and checks were made, it was reported that there was substantial damage to No.1 void space in the starboard hull (**Figure 6**) with ingress of water, but the bilge pumps were coping. Damage to some cars was also reported. Ten minutes after the collision, the master made a further announcement to the passengers to inform them the vessel would be continuing to Dover at slow speed.
