Report on the investigation of
the grounding of
mv Willy
Cawsand Bay, Plymouth Sound
1 January 2002

Marine Accident Investigation Branch
First Floor
Carlton House
Carlton Place
Southampton
United Kingdom
SO15 2DZ

Report No 31/2002
October 2002

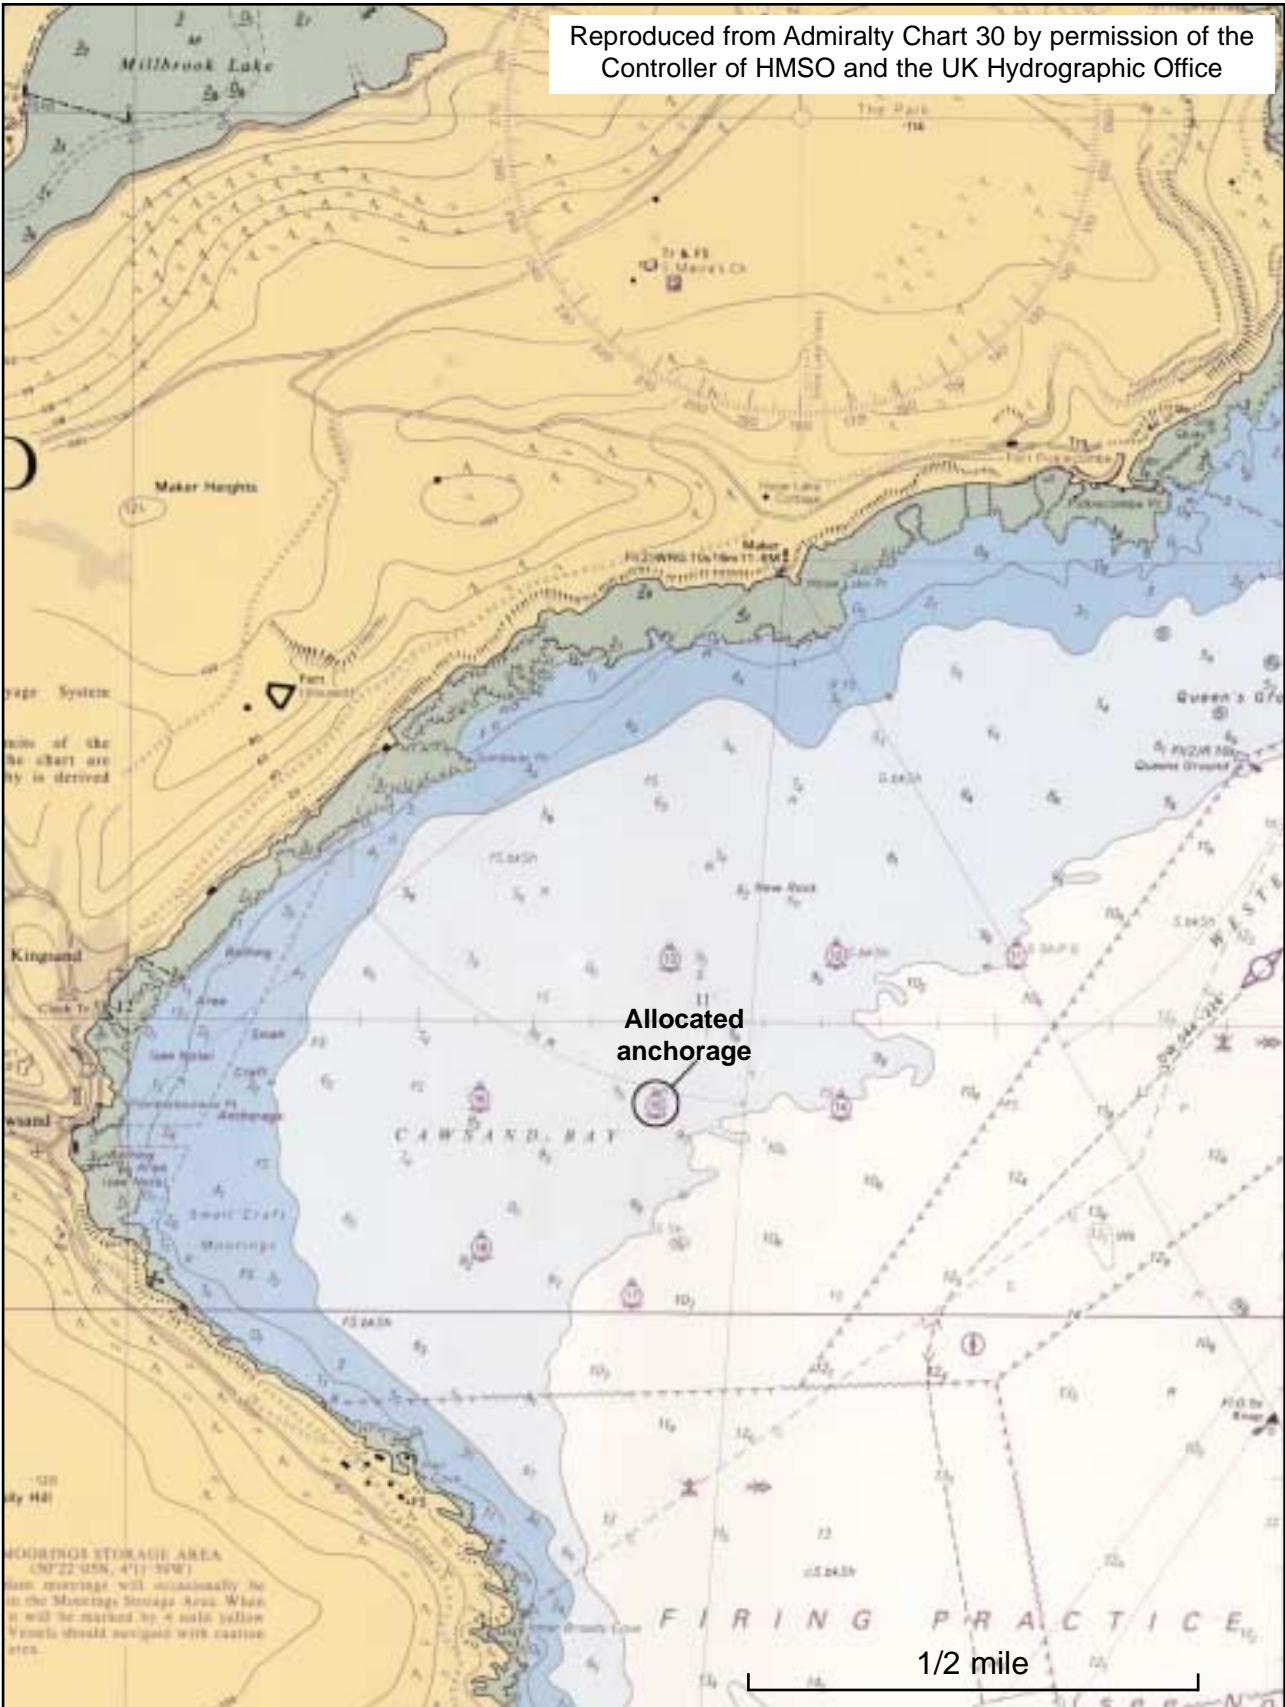
Figure 1

Cawsand Bay lies within the limits of the Dockyard Port of Plymouth, and ships are allowed to anchor in the designated berths when authorised to do so by the Queen's Harbour Master. No dues are charged for ships anchoring within the limits of the Dockyard Port. There are eight designated anchorage berths within Cawsand Bay – numbers 11 to 18 (**Figure 1**). Anchorage No. 15 has a charted depth of between 9.6 and 9.7m, and the sea bottom in its vicinity is a mixture of sand and shells.
