Report on the investigation of an
accommodation fire on

mv Rosebank

14 December 2001

**Report No 28/2002
August 2002**

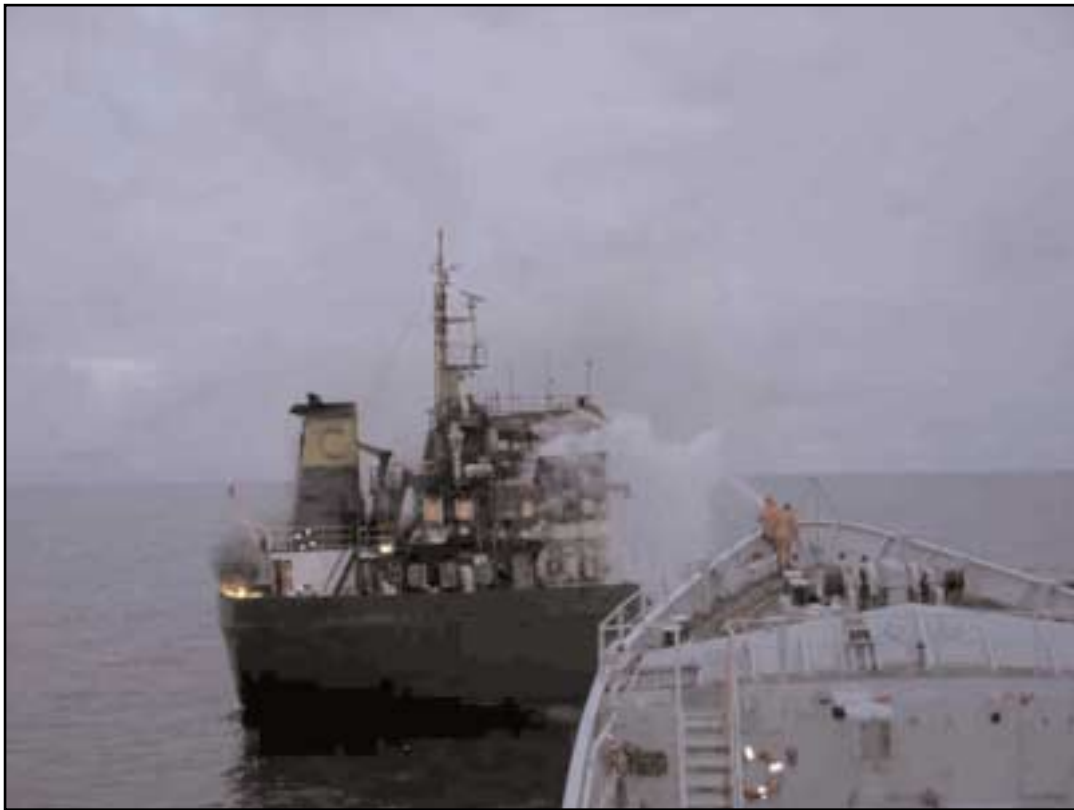
Figure 4

1.3.9 At 0036, *HMS Anglesey* arrived on scene with fire-fighting equipment, and attempted to contain the situation (**Figures 4 and 5**). All other vessels were therefore released and the incident was downgraded to a “Pan-Pan” situation. A 4-mile exclusion zone was established around the burning vessel and negotiations took place between the owners, insurers and pollution control officers as to what should be done about her.
