Report on the investigation of  
the failure of a warp block  
on board the UK registered fishing vessel

***Ocean Star***

north of the Shetland Islands

**Report No 13/2003  
May 2003**

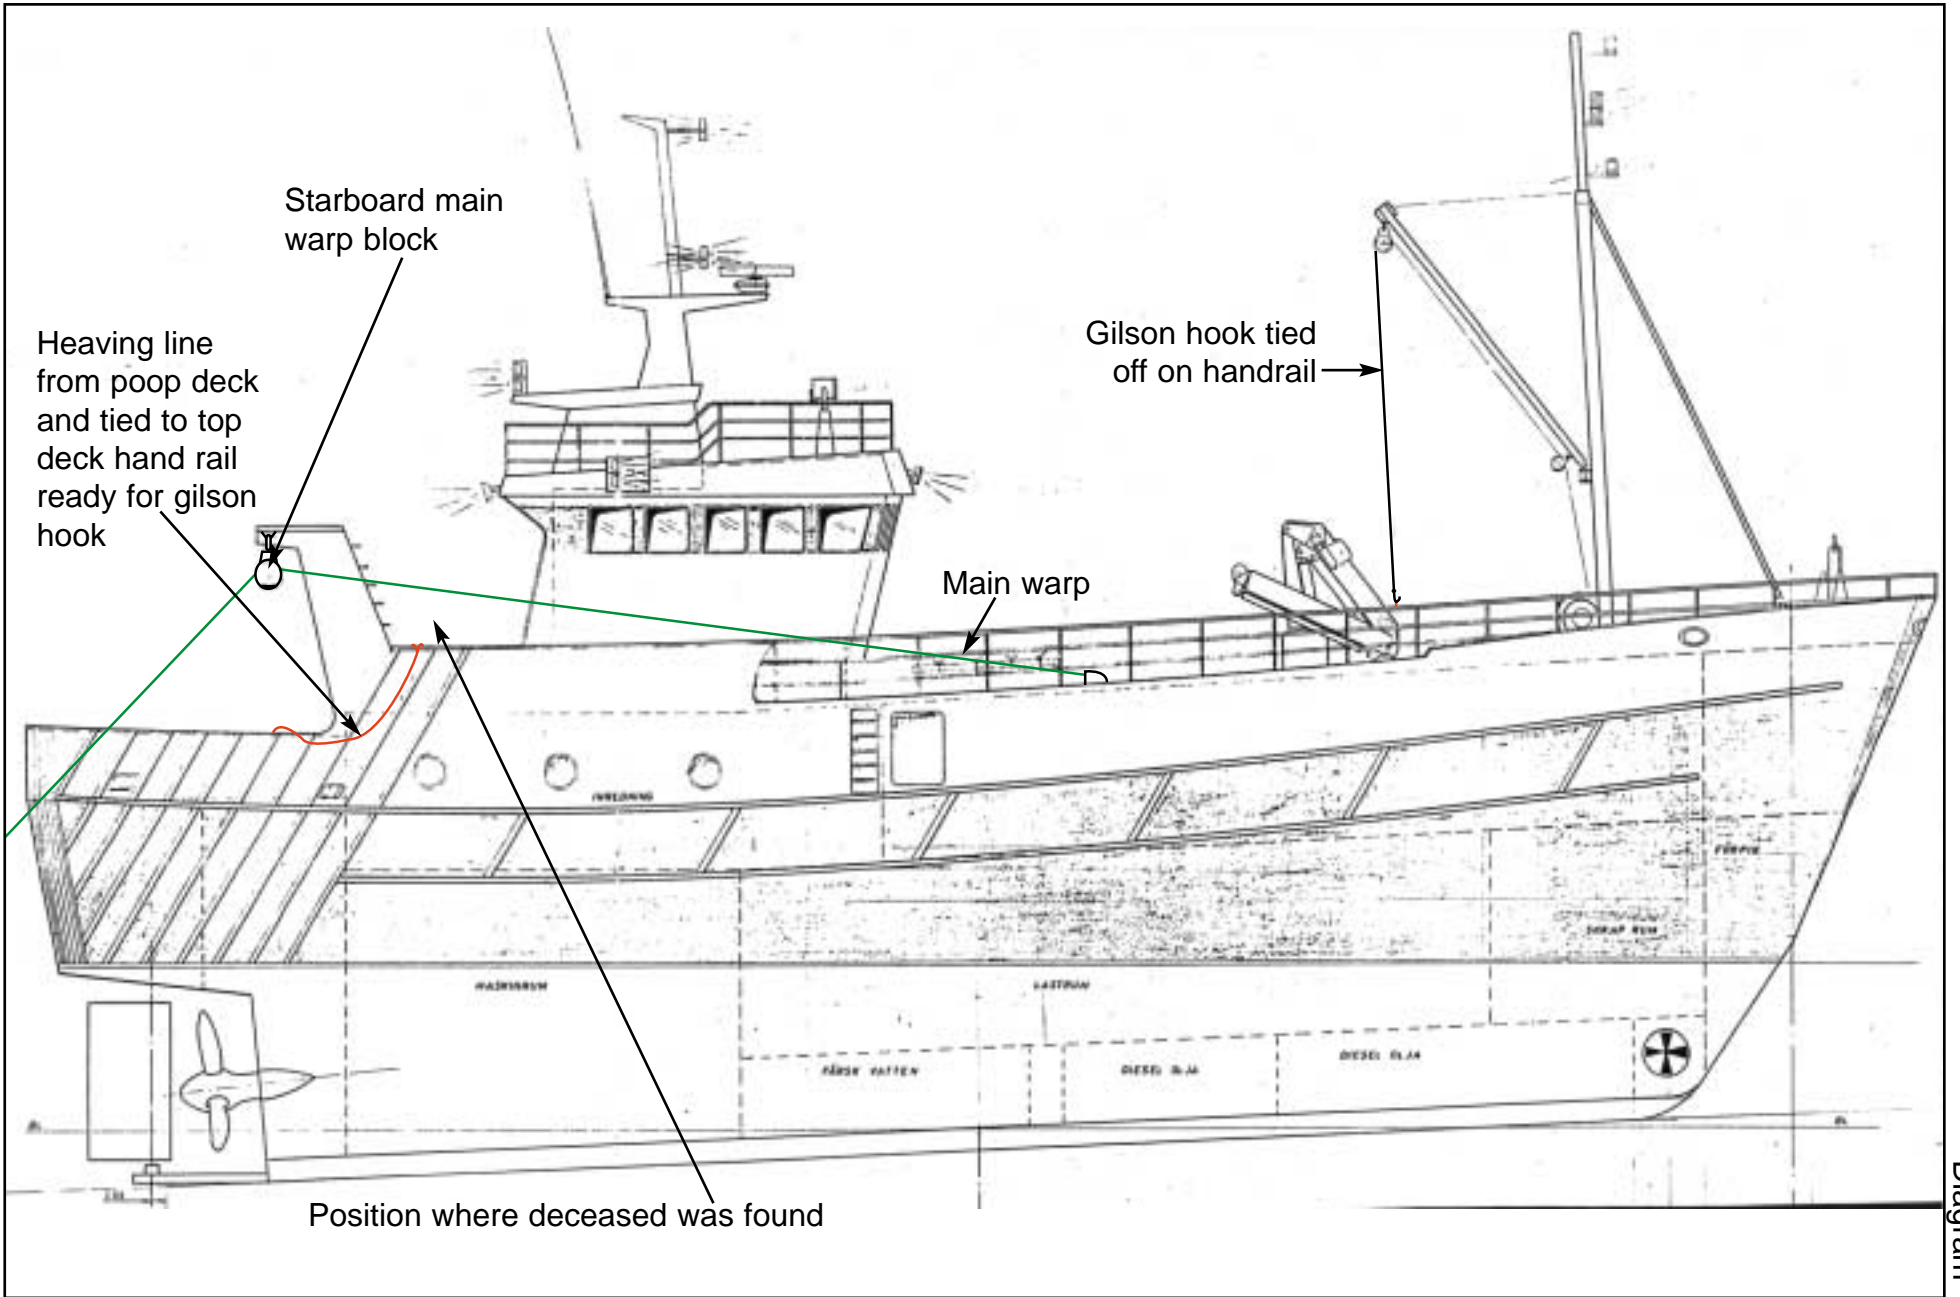
A deckhand on the poop deck took the heaving line off the cleat and threw it up and around the base of the gallows to the second deckhand, without sighting him. As he turned away, he heard a loud noise and thought one of the main warp wires had parted. He looked up and saw that the starboard main warp block had broken (**see photograph 2**) and that the heaving line was trailing astern of the vessel. He retrieved the line and threw it back up to the other deckhand. The line was not caught. He called a warning to him and then to the skipper, that the block had come apart.

A view of *Ocean Star* and of the broken starboard main warp block
