Report on the investigation of  
a fatal accident on board  
***Gemma Fidelis (GY 419)***  
9 miles east of the River Tees  
on  
23 October 2001

Marine Accident Investigation Branch  
First Floor  
Carlton House  
Carlton Place  
Southampton  
United Kingdom  
SO15 2DZ

**Report No 24/2002**  
**July 2002**

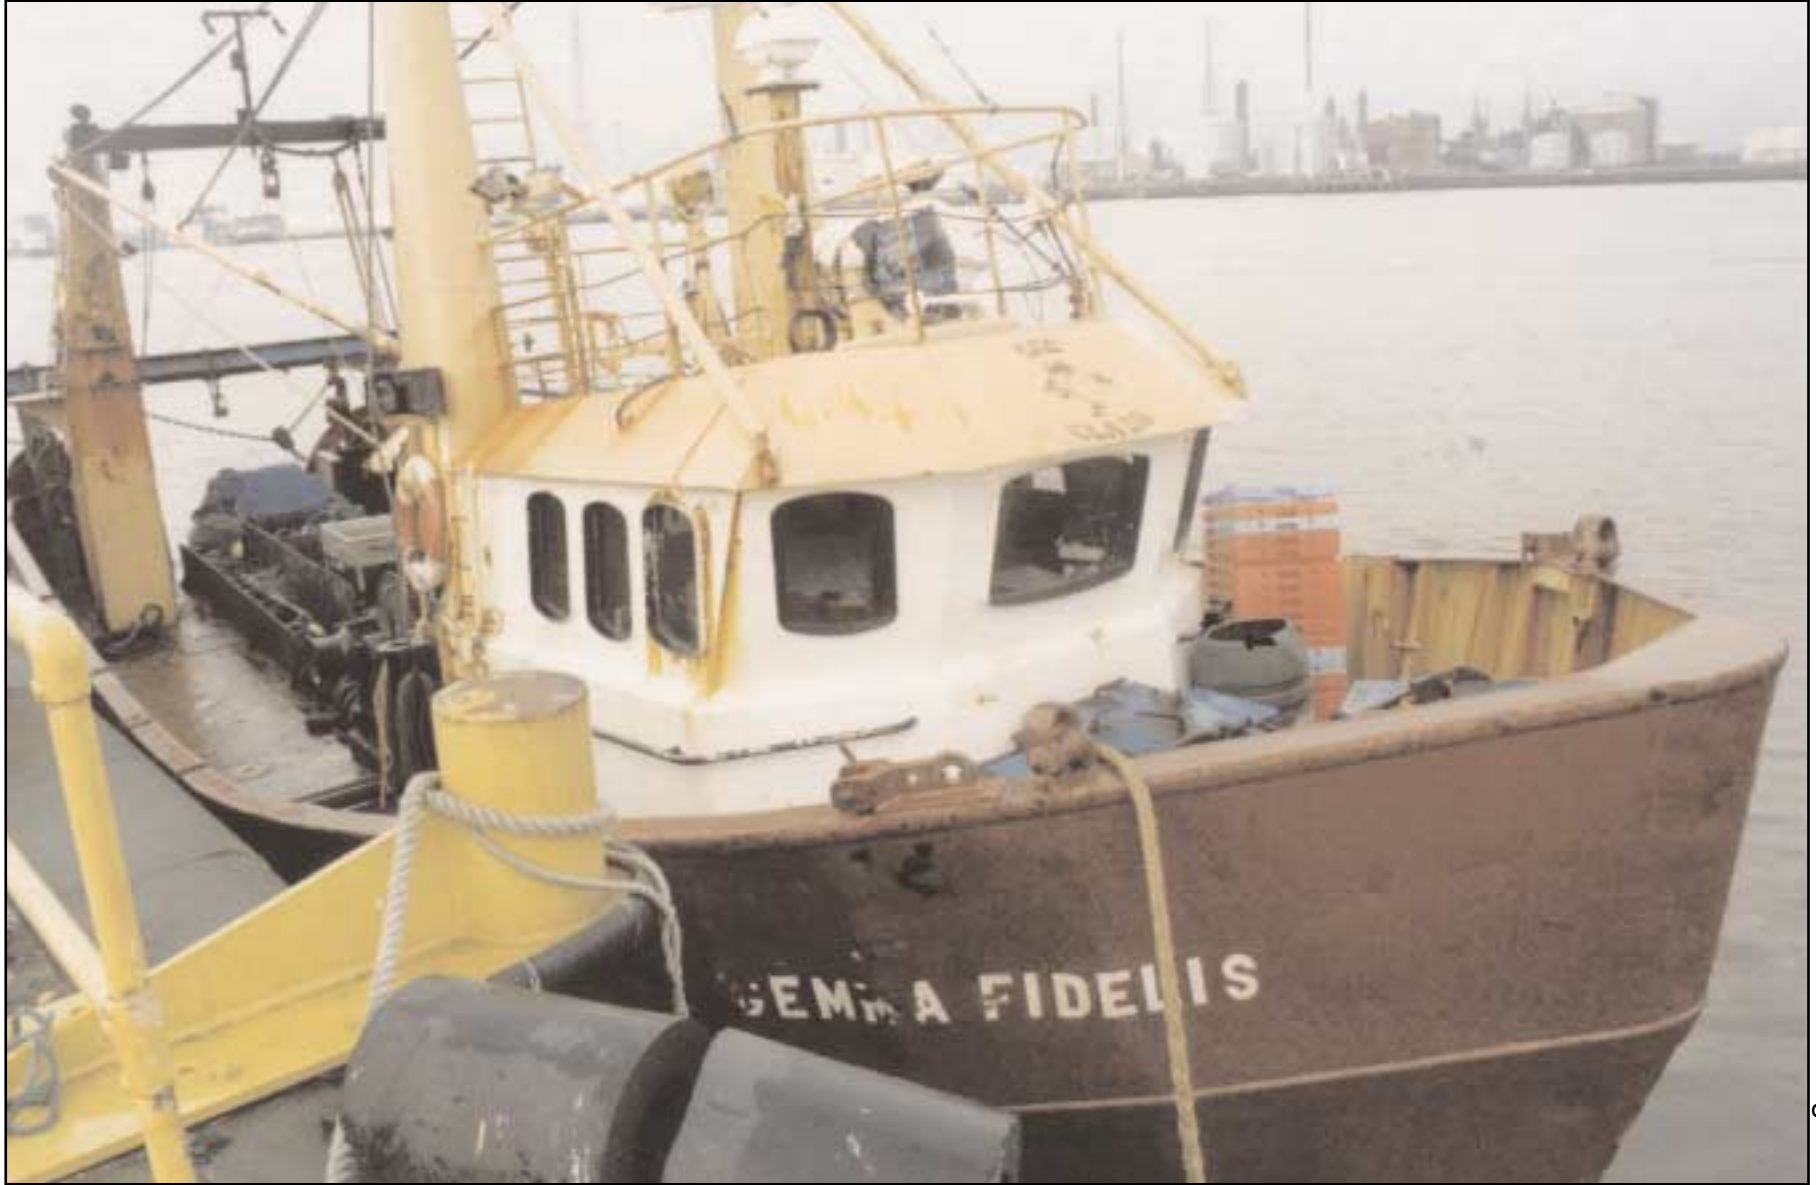
Figure 1

*Gemma Fidelis*

Her design incorporated one deck above the waterline (**Figure 1**). Below deck the accommodation was forward. The fish room and engine room were aft of the accommodation, separated by watertight bulkheads.

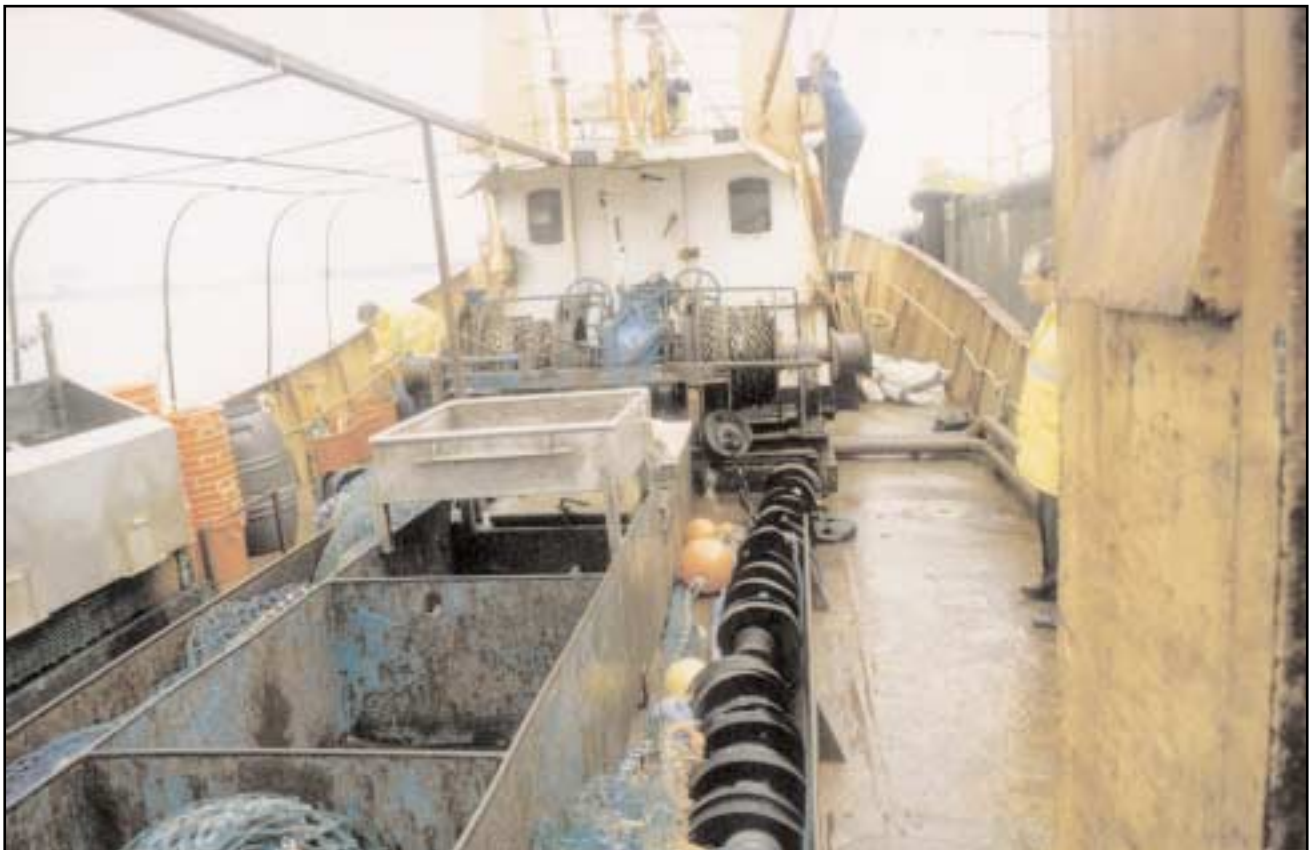
Figure 2

On the main deck the wheelhouse was situated forward. Immediately aft of the wheelhouse was the main trawl winch and working deck, which incorporated centre pounds and longitudinal channels for storing the trawl and ground gear when in the hauled-on-deck position (**Figure 2**).

Aft deck
