Report on the investigation of the fire on board

HSS Stena Explorer

entering Holyhead

**Report No 5/2003
February 2003**

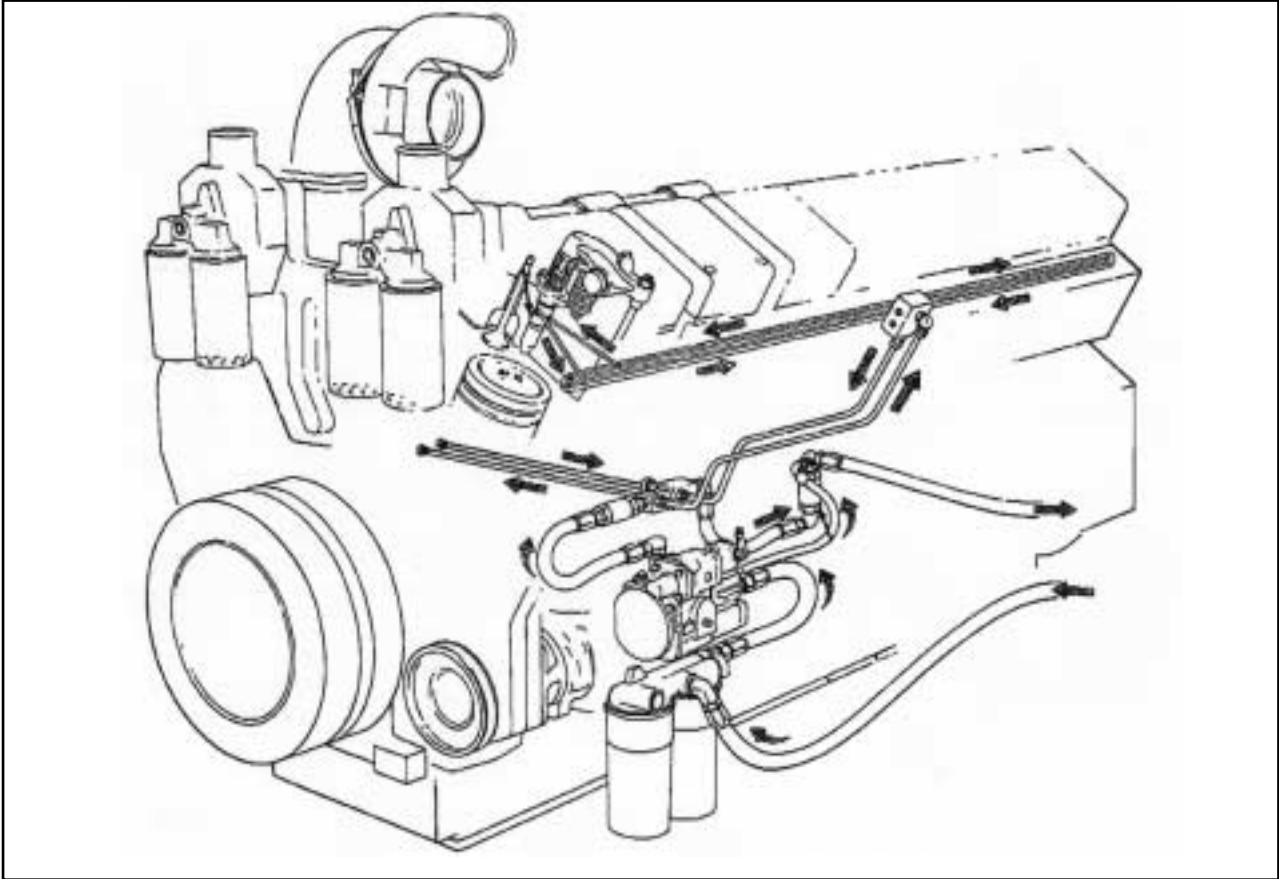
Figure 6

The diesel generator fuel oil system arrangement is illustrated in **Figure 5**. The high and low pressure pipes of the system, between the booster pump and fuel injectors, are joined together by flange or compression type fittings. The fitting which failed, resulting in leakage of oil, was a compression fitting on what is known as a pig-tail pipe, see **Figure 6**. The pipe was on the low pressure side, between the booster pump and high pressure pump, and was one of four connecting the forward and aft, upper and lower, fuel rails for each bank of cylinders in the 'V' configuration engine. This is shown in **Figure 7**.

Engine fuel oil system arrangement

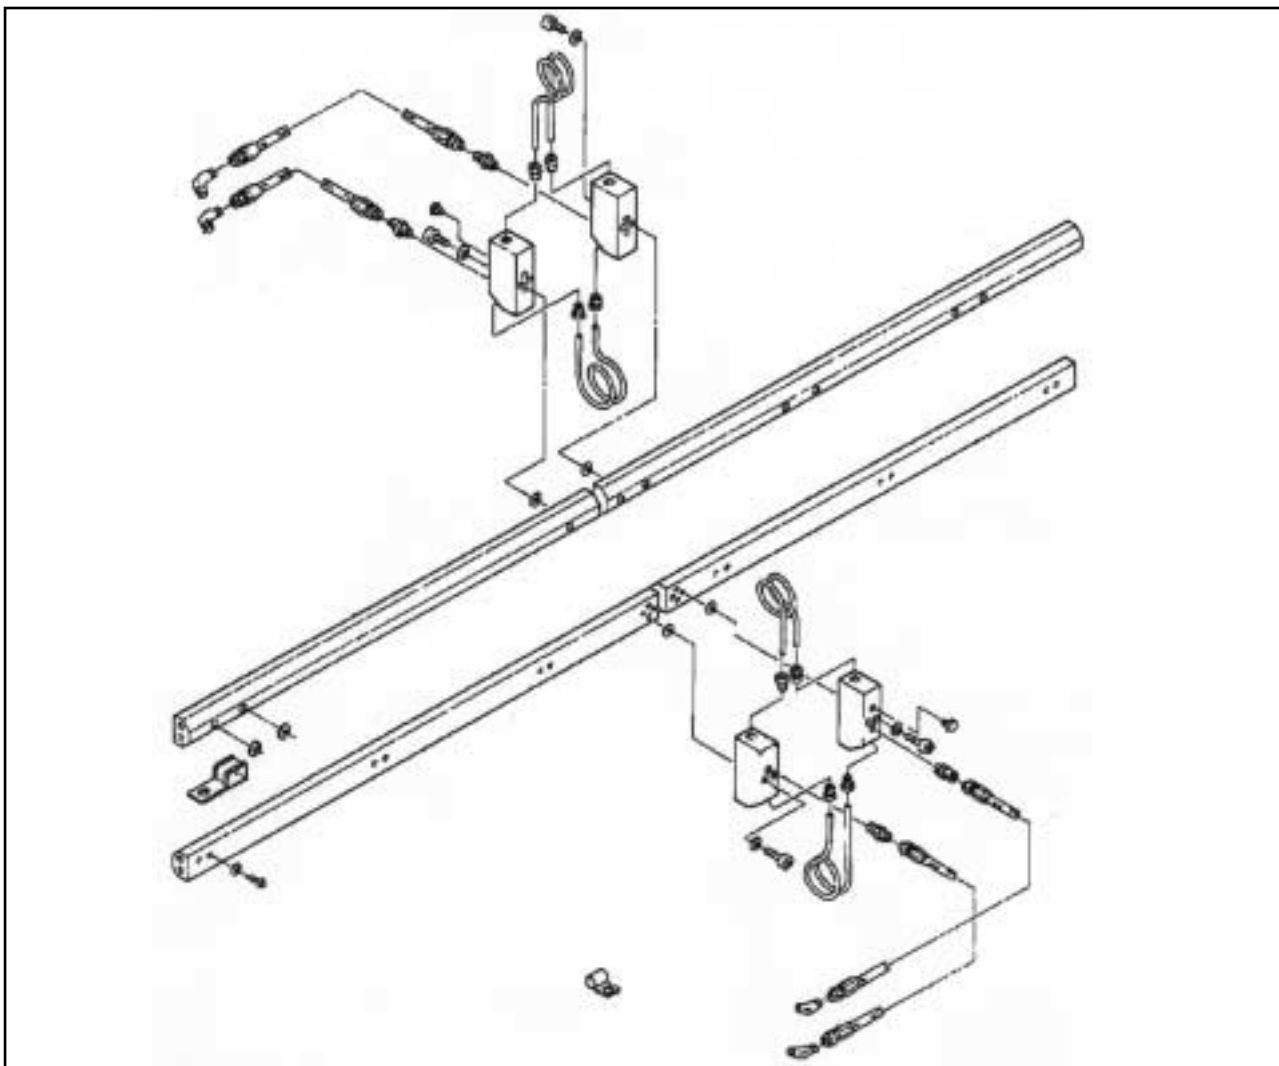
Figure 15

In the second quarter of 1994, Cummins introduced a change to the design of the fuel plumbing on all engines using the upper and lower pig-tail pipe connection system. *Stena Explorer* was fitted with the pre-1994 designed arrangement, and this is shown in **Figure 15**.

Current fuel plumbing

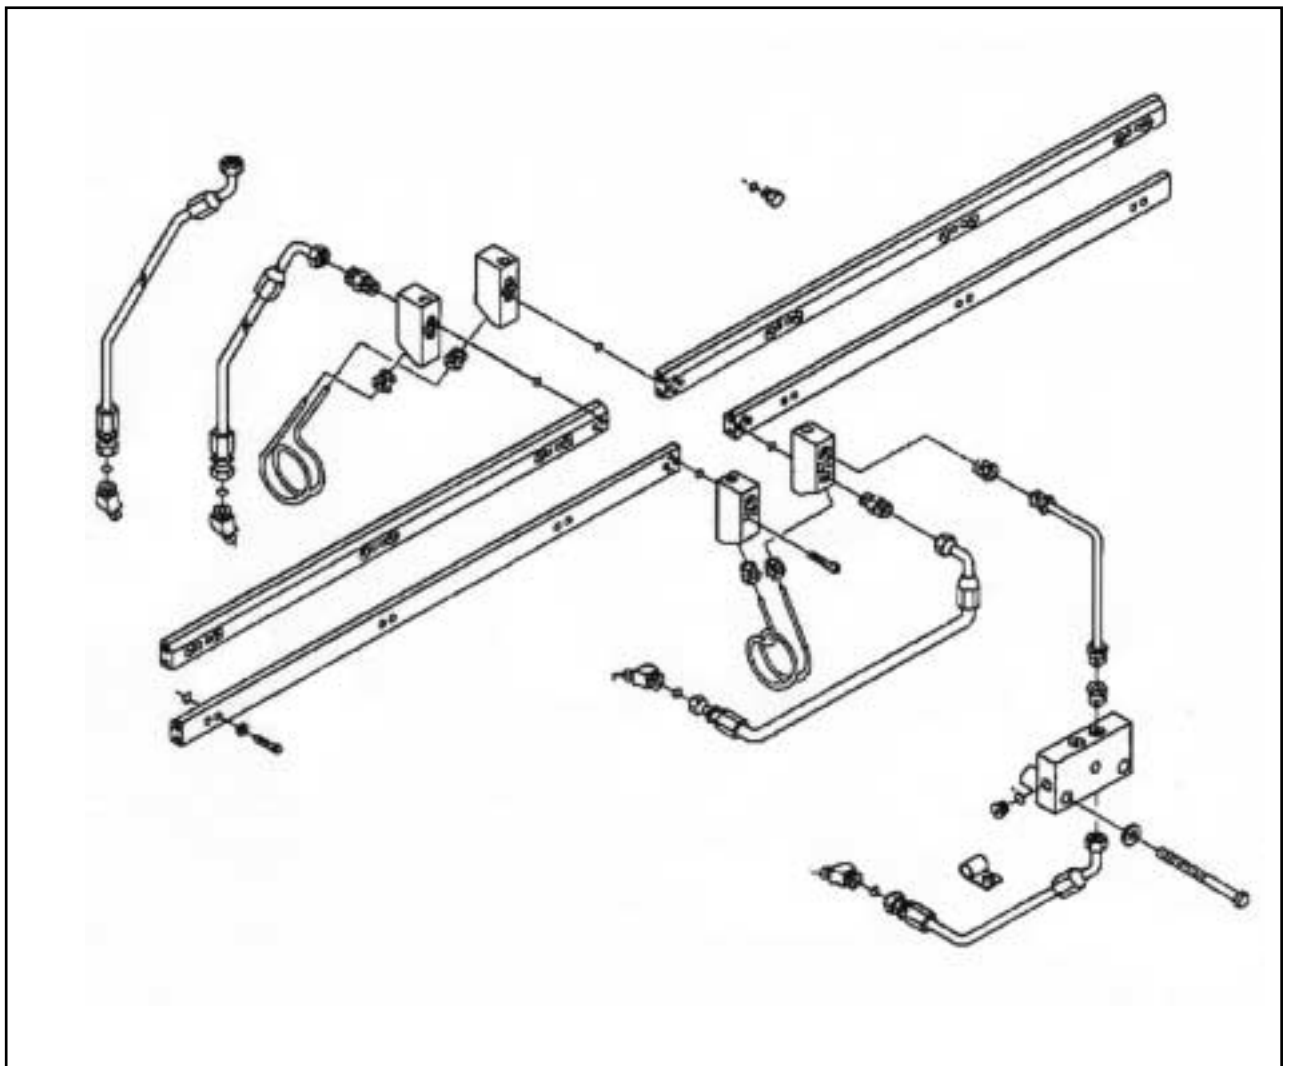
Figure 16

The design change involved replacement of the upper pig-tail with a further fuel manifold, and is shown in **Figure 16**. Cummins has stated that this was done to improve diagnostics on the engine.

Proposed fuel plumbing

The risk of fuel spillage and fire using this design is reduced, but not eliminated. Stena Line has requested that Cummins retrofit this new design to the 12 engines affected in the Stena fleet. This will be done as part of the next planned overhaul of each engine. However, Cummins has stated that it will not advise its customers to modify engines which do not already bear the improved design. This is an unsatisfactory situation, and one which Cummins ought to reconsider.

Further, at the request of Stena Line, Cummins Diesel will make a gauge to facilitate an in-situ check of pig-tail pipes, to ensure that they are pushed as far as possible into the fuel blocks. It is not the intention of Cummins Diesel to supply this gauge to its agents, fitters or customers, other than Stena Line. It will not be illustrated in its workshop manual or parts catalogue.
