Report of an investigation  
of an injury sustained during  
the firing of cannon on  
***sv Grand Turk***  
while alongside at Portsmouth  
on 24 August 2001

Marine Accident Investigation Branch  
First Floor, Carlton House  
Carlton Place  
Southampton  
SO15 2DZ

**Report No 15/2002**  
**April 2002**

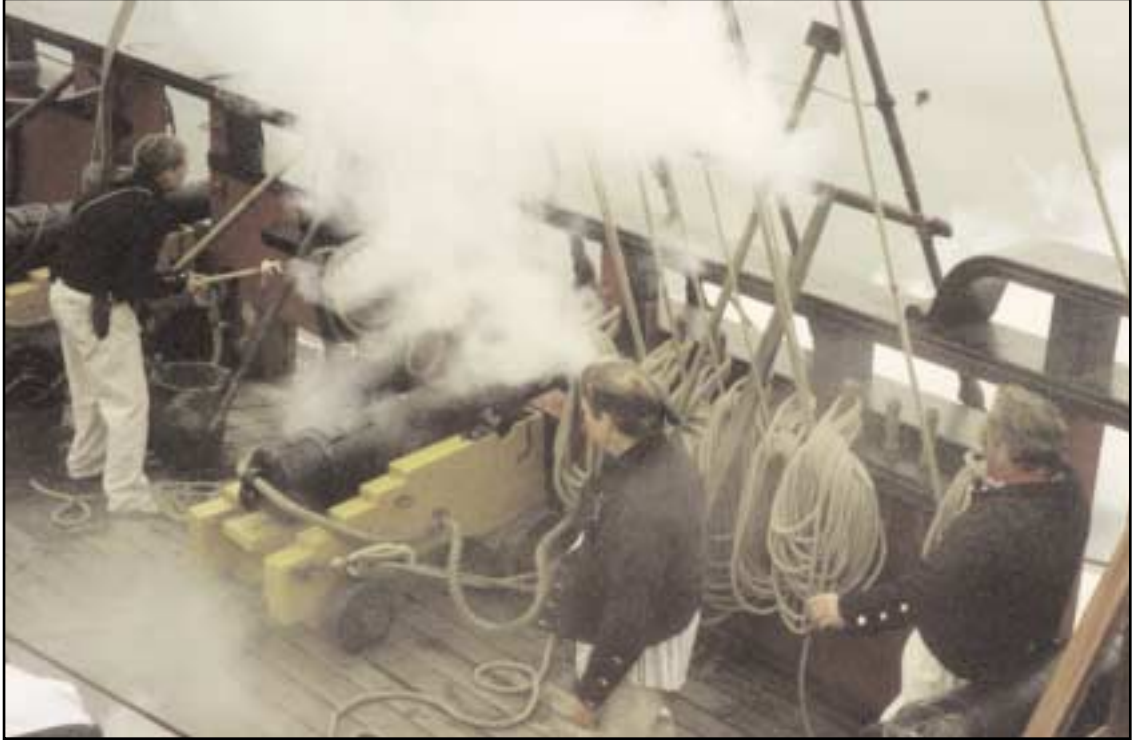
Figure 1

On Wednesday 22 August, at 1330, *Grand Turk* again sailed into the Solent to the Nab Tower where, in conjunction with the Royal Navy, a cannon broadside was fired to welcome the American warship, *USS Winston Churchill* (**Figure 1**). With the first mate in charge, assisted by the gun team that had been in action the previous day, all six 9lb cannons and the three signal guns were fired. Later that day, the vessel moved from Gosport to her IFOS berth in Portsmouth.

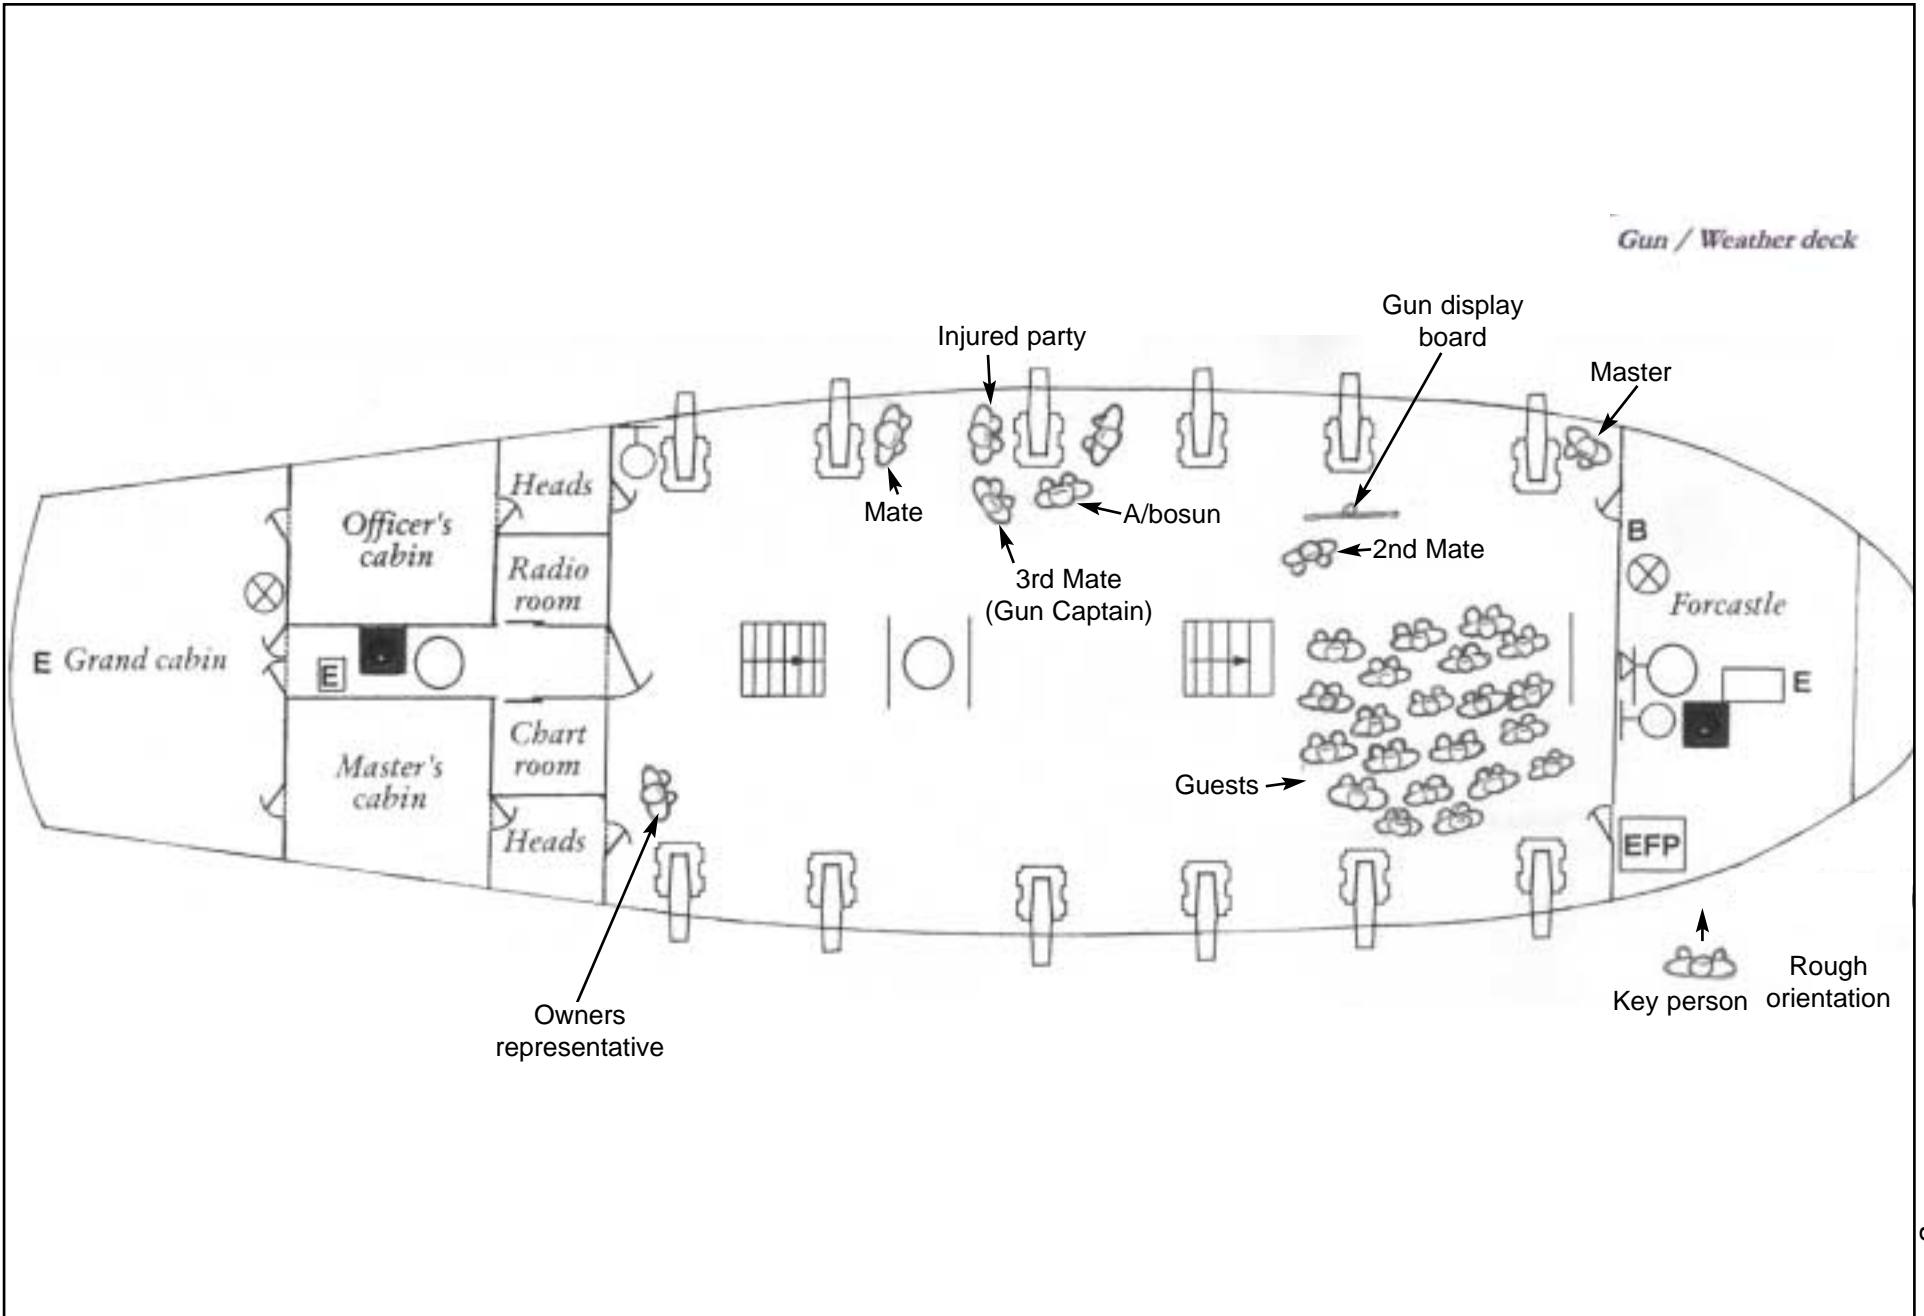
Figure 2

- 1.3.5 On Friday 24 August, with *Grand Turk* tied up alongside the north wall of HM Dockyard, Portsmouth, the vessel’s charterers, *BAE Systems* and their guests, boarded the vessel to join in the International Festival of the Sea festivities. By about 1145, all six 9lb cannons on the port, or seaward side, of *Grand Turk* had been loaded and wadded but not primed. The demonstration gun team was in position and dressed in period costume (**Figure 2**).

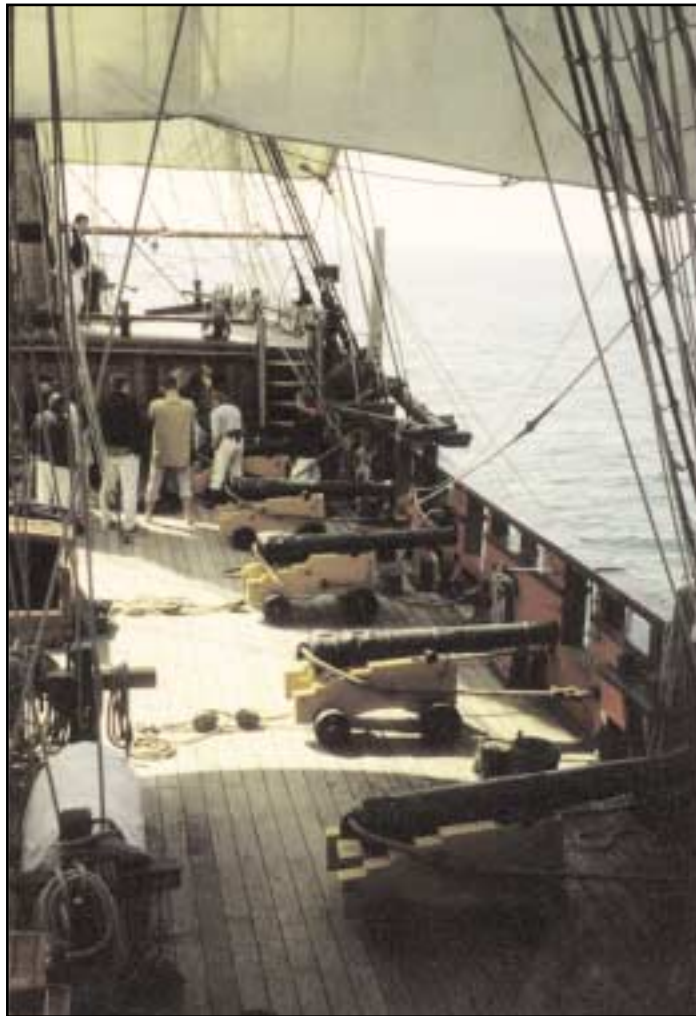
Figure 3

The guests were standing in a group on the forward starboard side of the main deck, with the second mate standing in front of them with the gun display board (**Figures 3 & 4**). The board showed a cut away section of a cannon on which the various actions of loading, priming and reloading could be seen. It was the second mate’s duty to explain to the guests what happens during cannon firing, and to answer questions regarding the demonstration.

Forward starboard side of *Grand Turk's* main deck

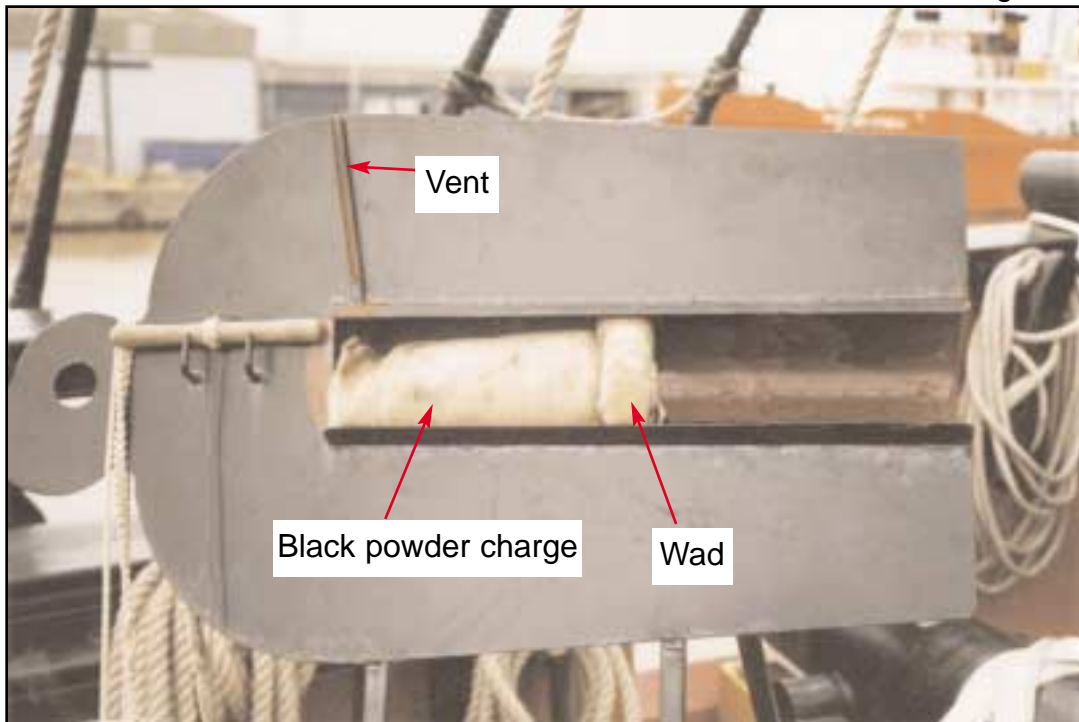
Figure 4

Cut away model of cannon
