Report on the investigation of
the flooding and loss of the fishing vessel

Aurelia (BF15)

13 August 2001

**Report No 40/2002
December 2002**

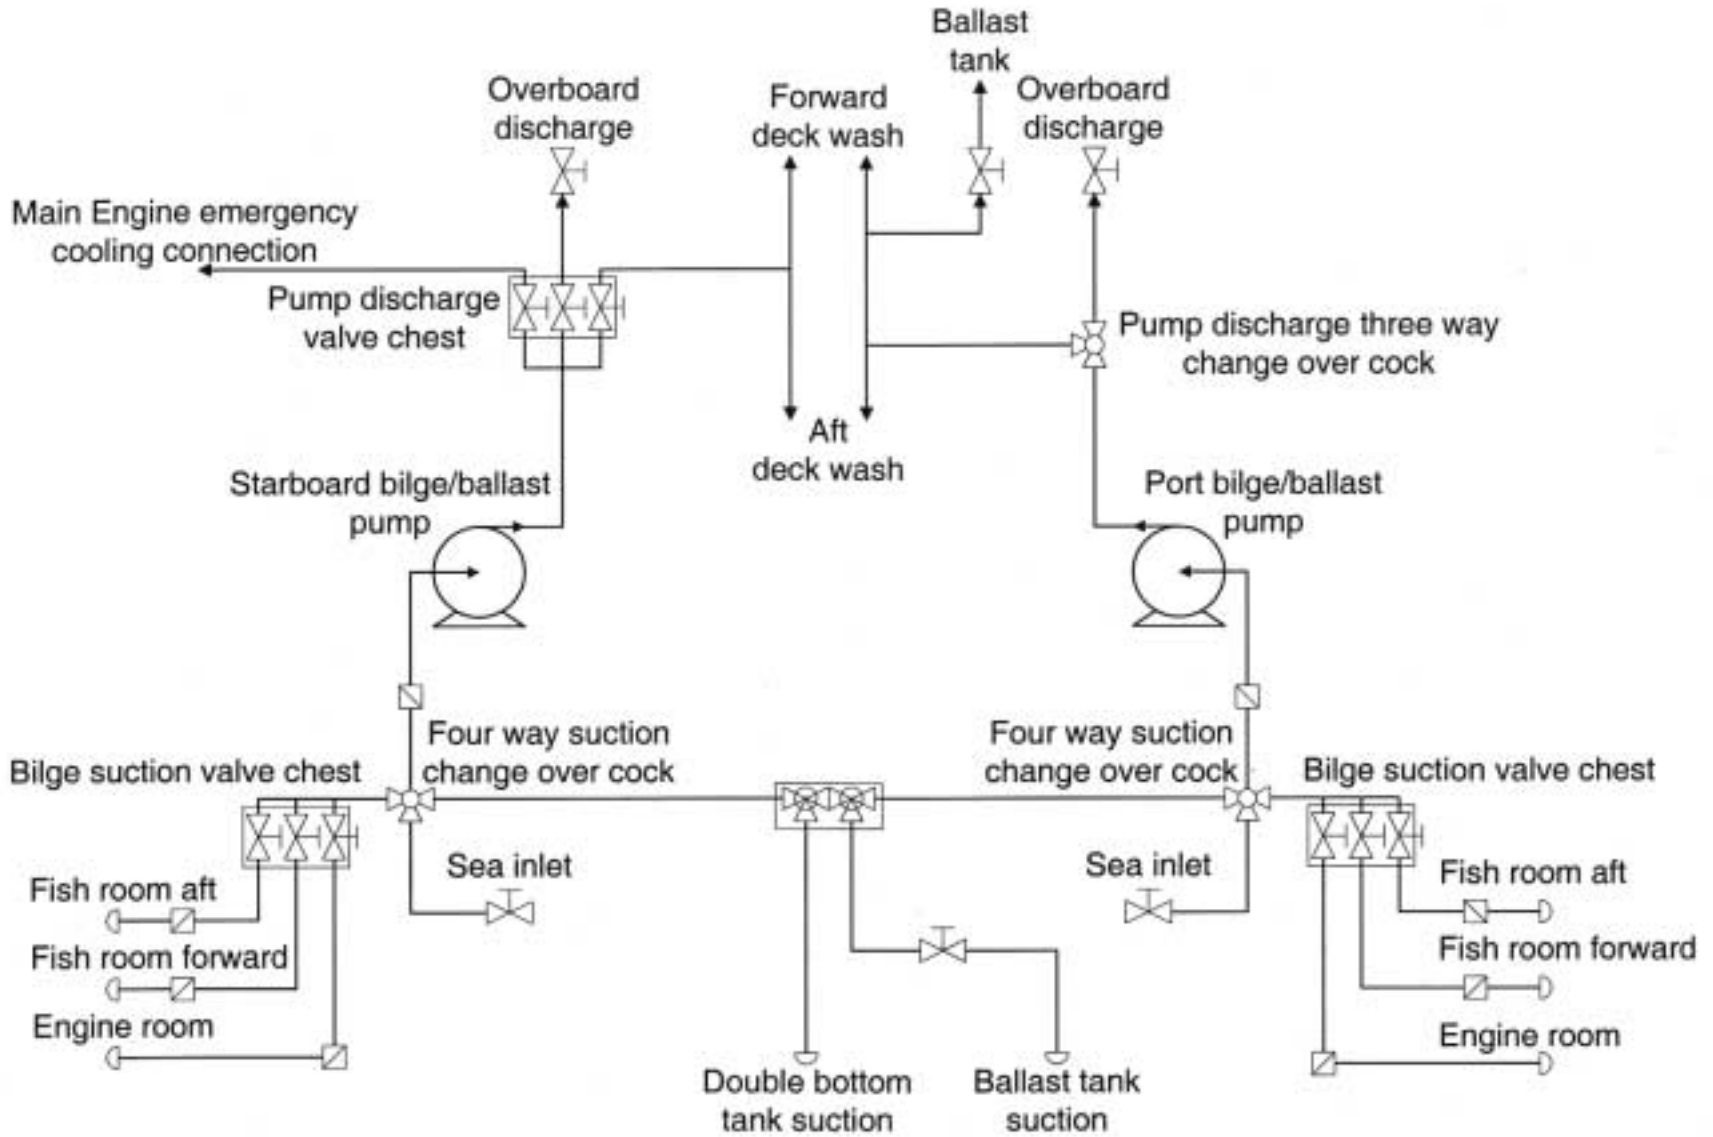
Bilge and ballast system schematic

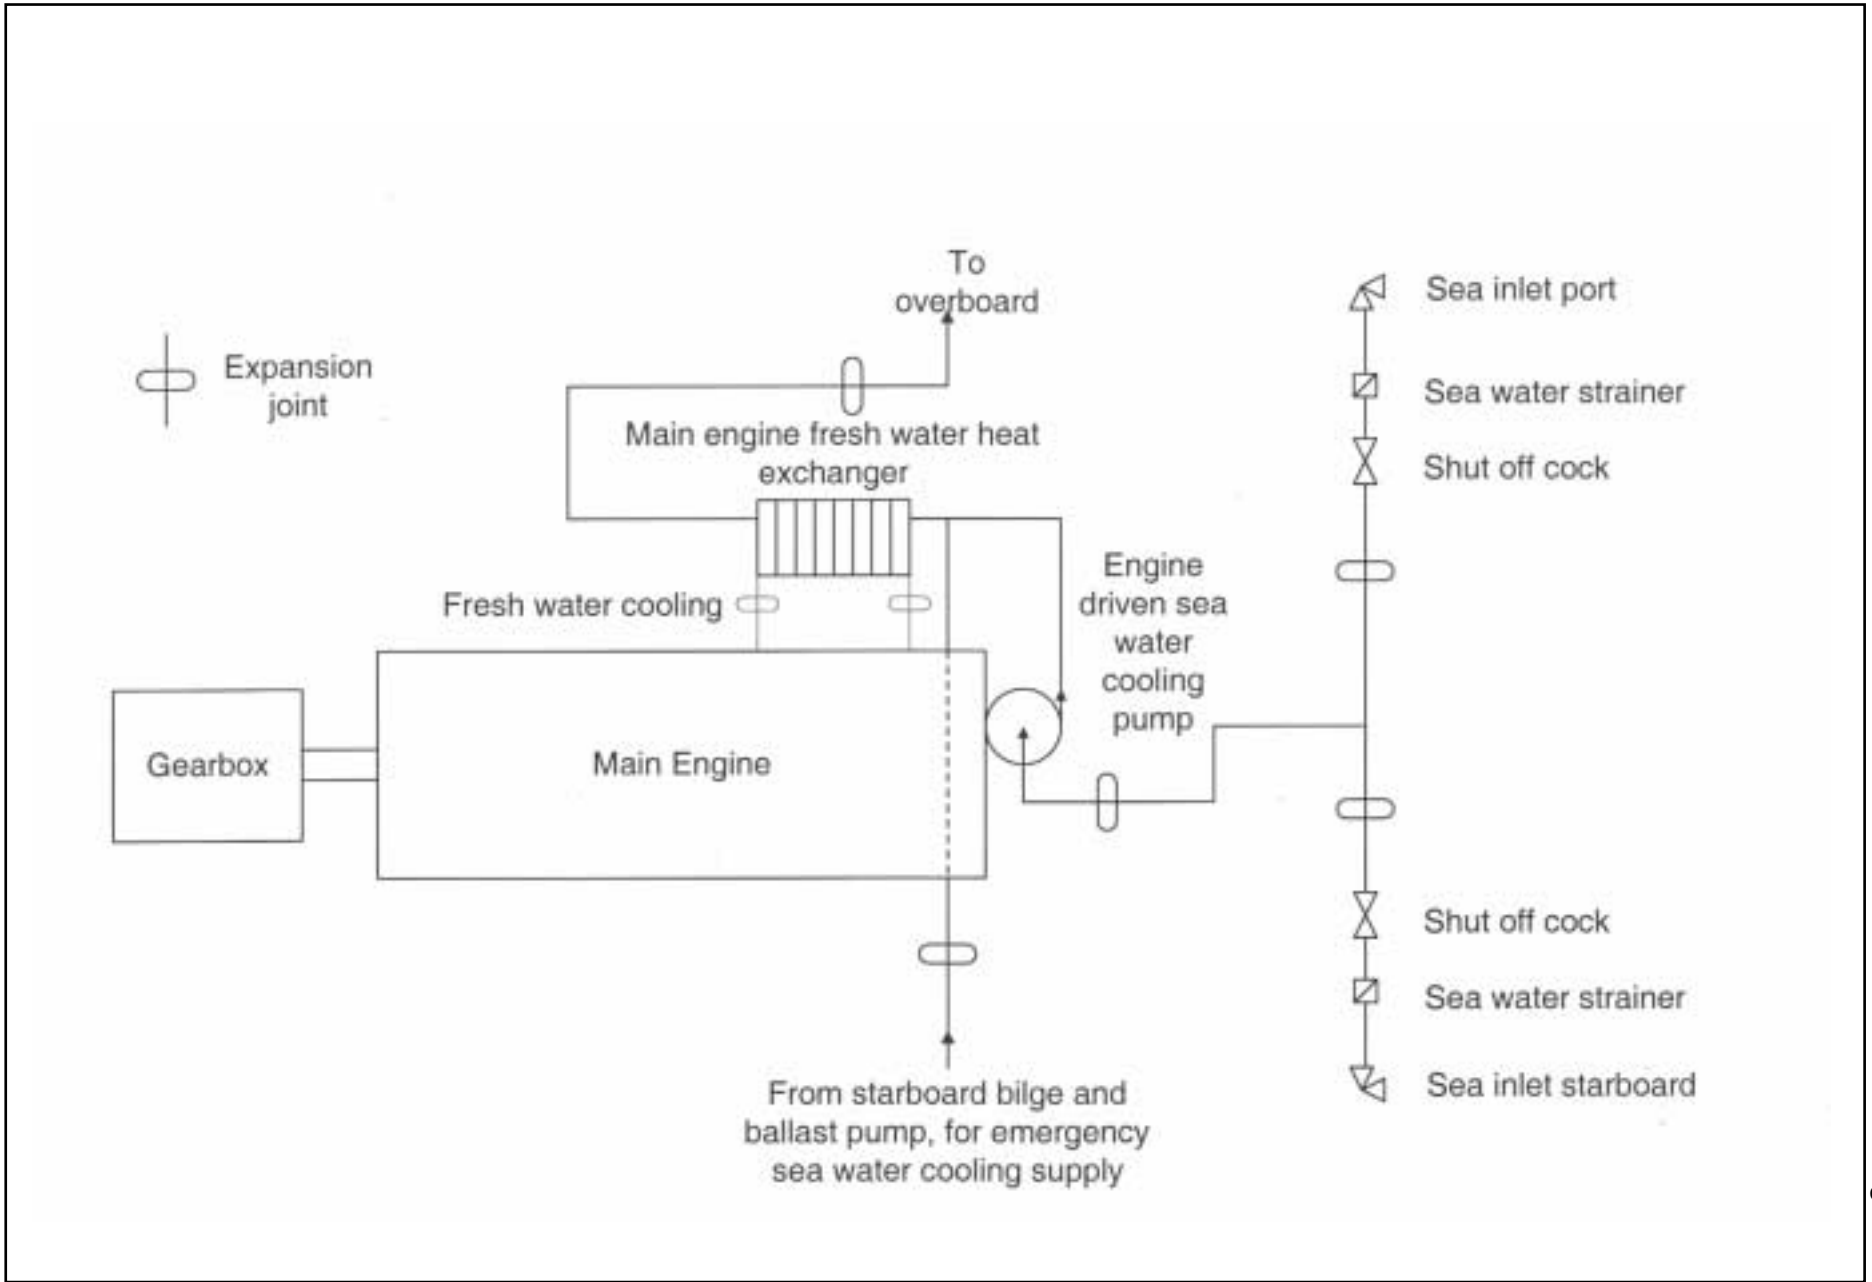
Figure 11

The sea water cooling pipework for the main engine was 75mm diameter aluminium brass (BS2871 CZ110), a copper alloy (76 - 78% copper) which is resistant to corrosion in sea water. The “Main Engine Sea Water Cooling System Schematic” in **Figure 11**, shows the layout of this system.

Main engine sea water cooling system schematic
