Report on the investigation of
an accident which caused major injury
to an engineer officer on board

Royal Princess

4 August 2001

**Report No 34/2002
November 2002**

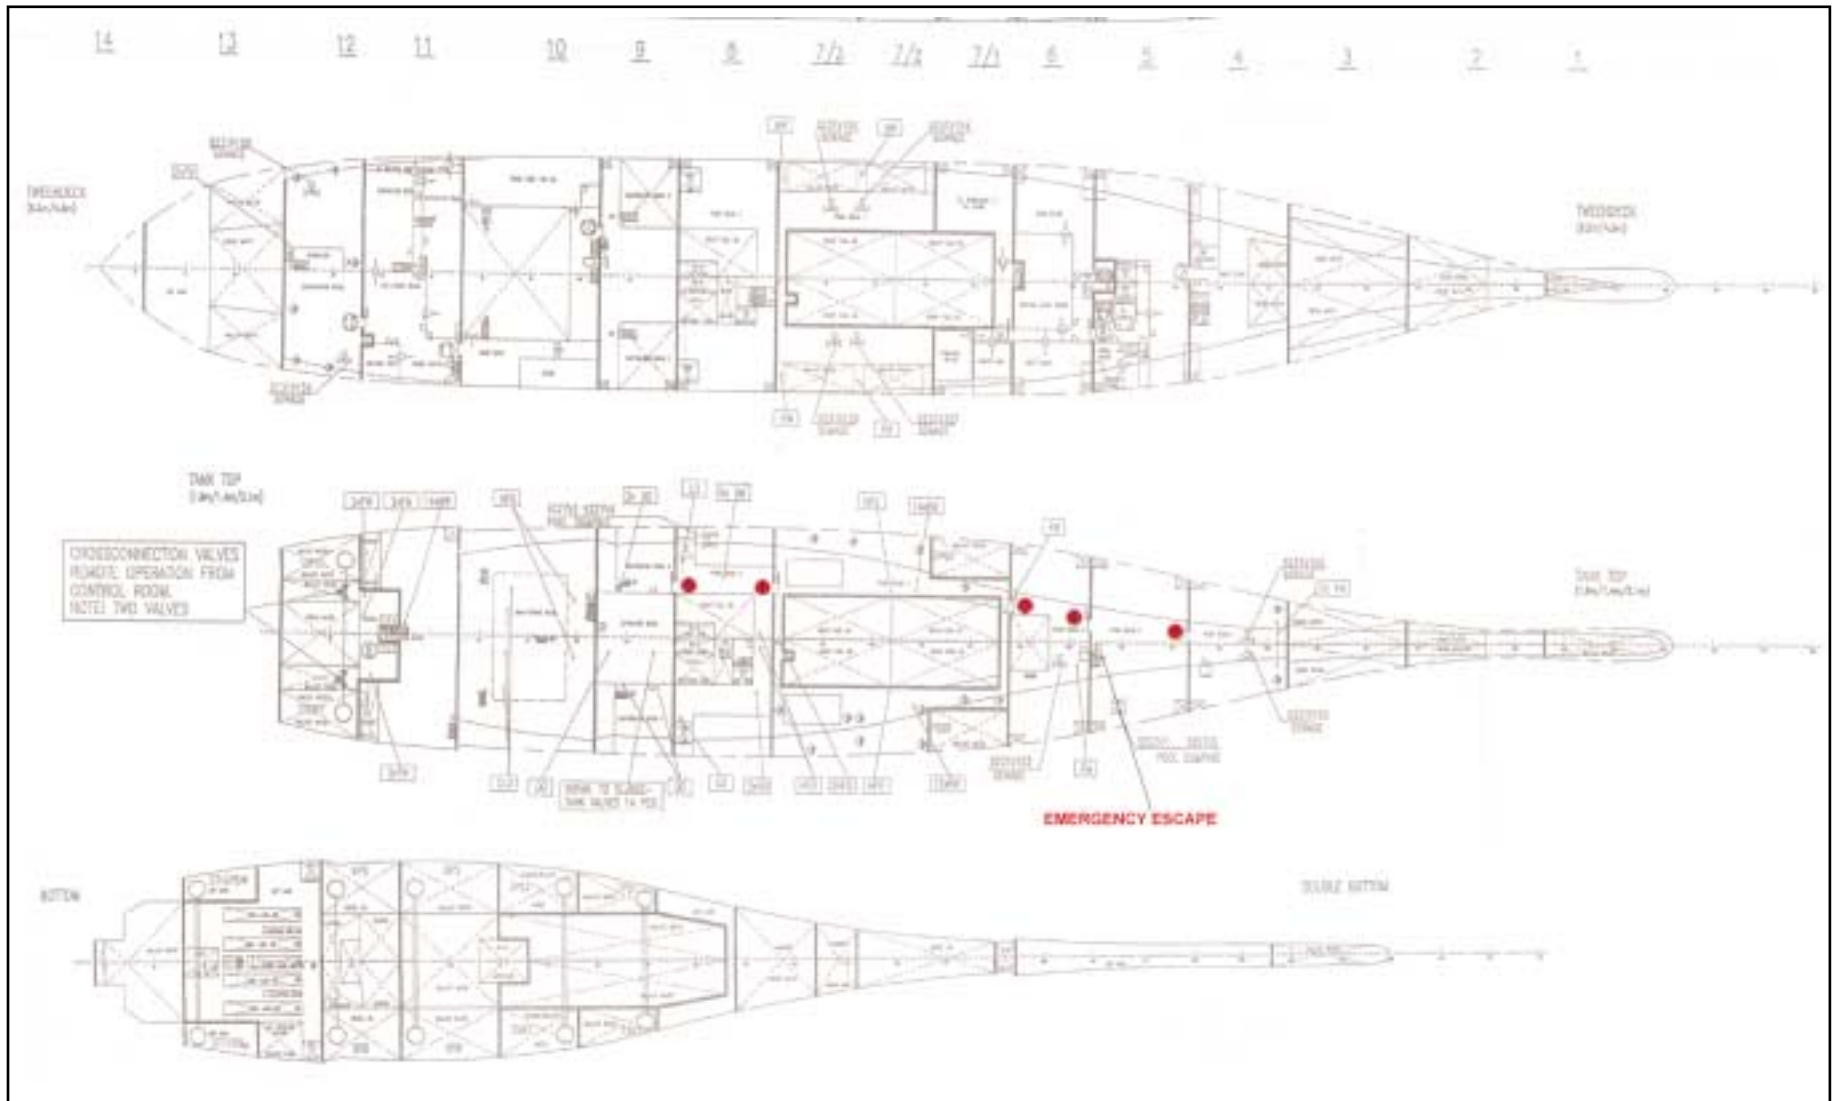
At about 0105, the 3EO attempted to pass through watertight door No 2 (**see photograph 1**). He operated the controls to start the door opening and, when it had opened sufficiently to allow him to pass through, he locked the operating lever in the 'close' position. As the door was closing, he began to step through, but his boilersuit became snagged, or something else caused him to hesitate and momentarily delay or abort his progress through the doorway.

Despite his trying frantically to reverse the movement of the door, it closed on his upper left arm and crushed it. With difficulty, he managed to open the door and free his arm.

All the watertight doors were of steel construction and operated by sliding horizontally under hydraulic power (**see photograph 1**). In an emergency, the doors could be closed from the bridge or from one of five control positions on Deck 1.

The accident occurred at No 2 watertight door, situated between No 2 and No 3 pump rooms in the forward auxiliary machinery spaces. It was a steel, horizontally sliding door, of Type C which closed from port to starboard (**see photograph 1**).
