Report on the investigation of  
the grounding and loss of  
the crabber

***Our Nicholas (SY811)***

near the entrance to Stornoway Harbour  
on 24 July 2001

**Report No 26/2002  
August 2002**

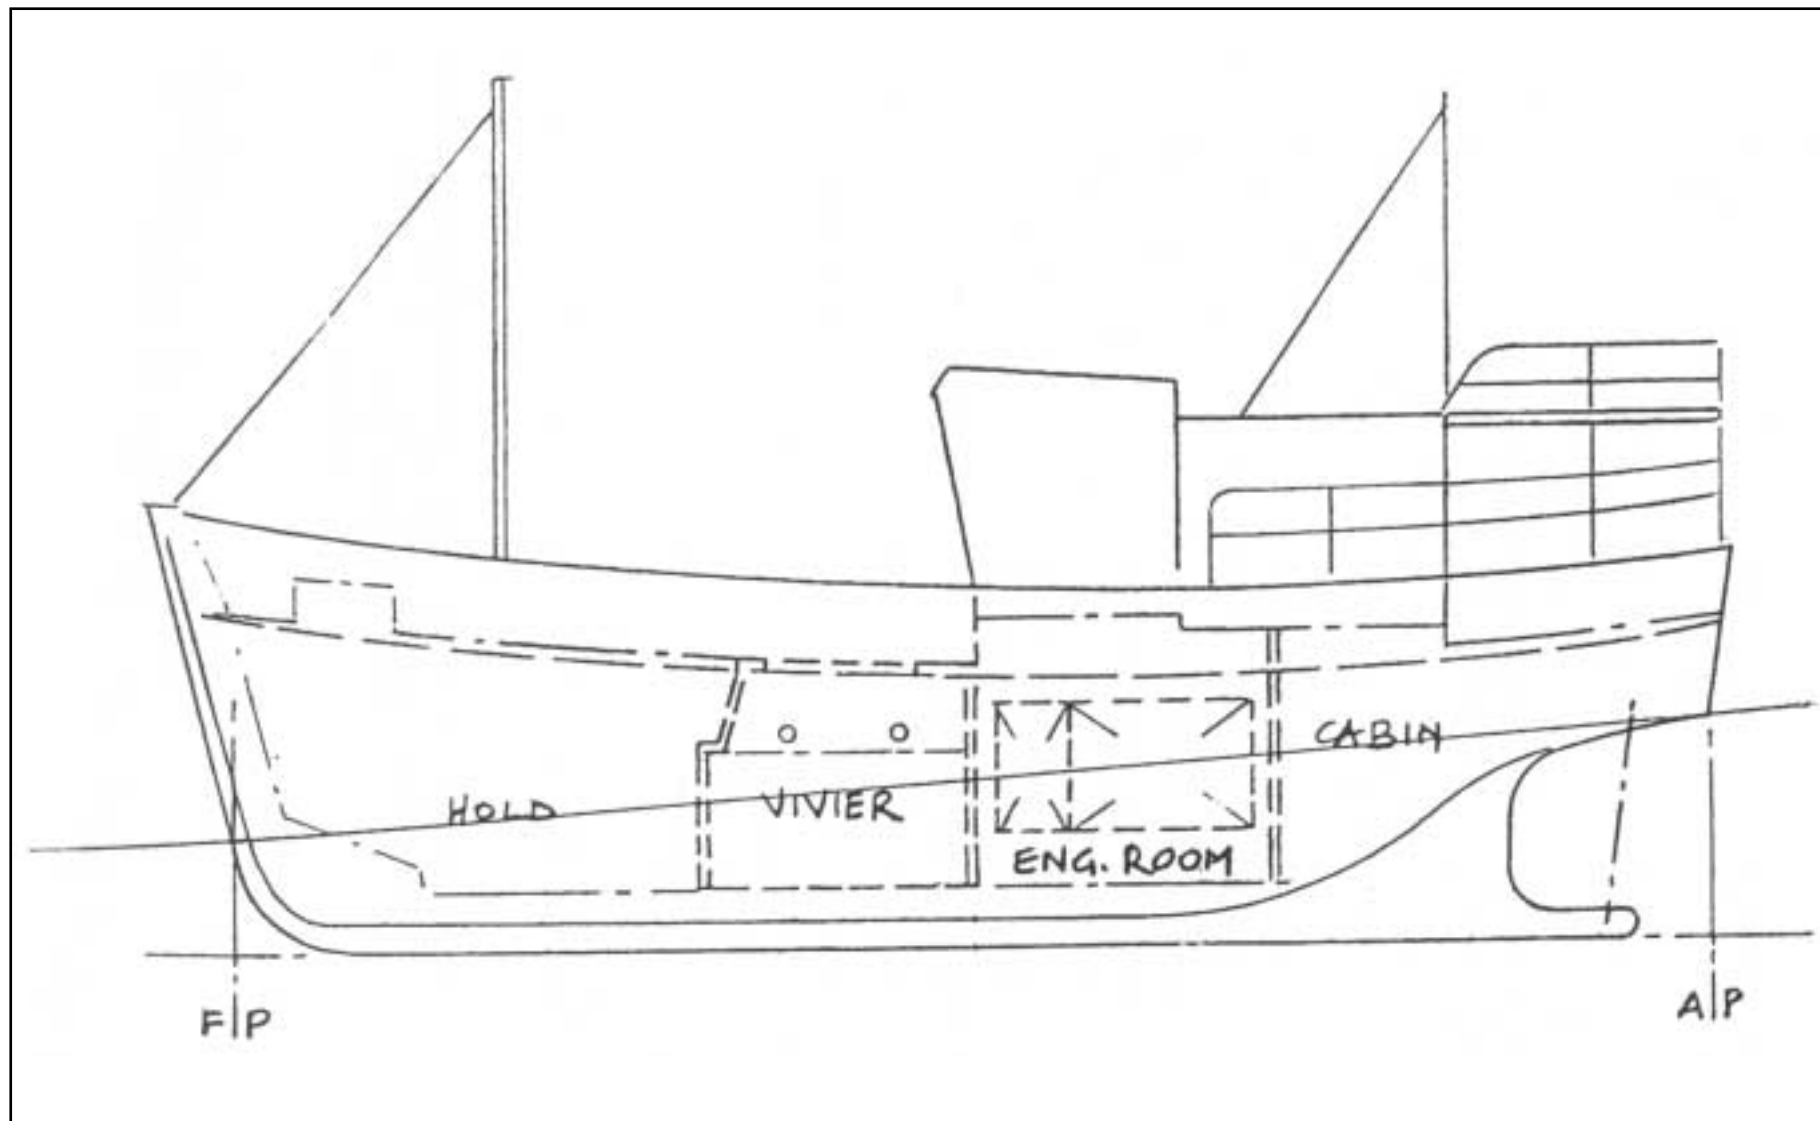
Diagram 1

Diagram of *Our Nicholas*

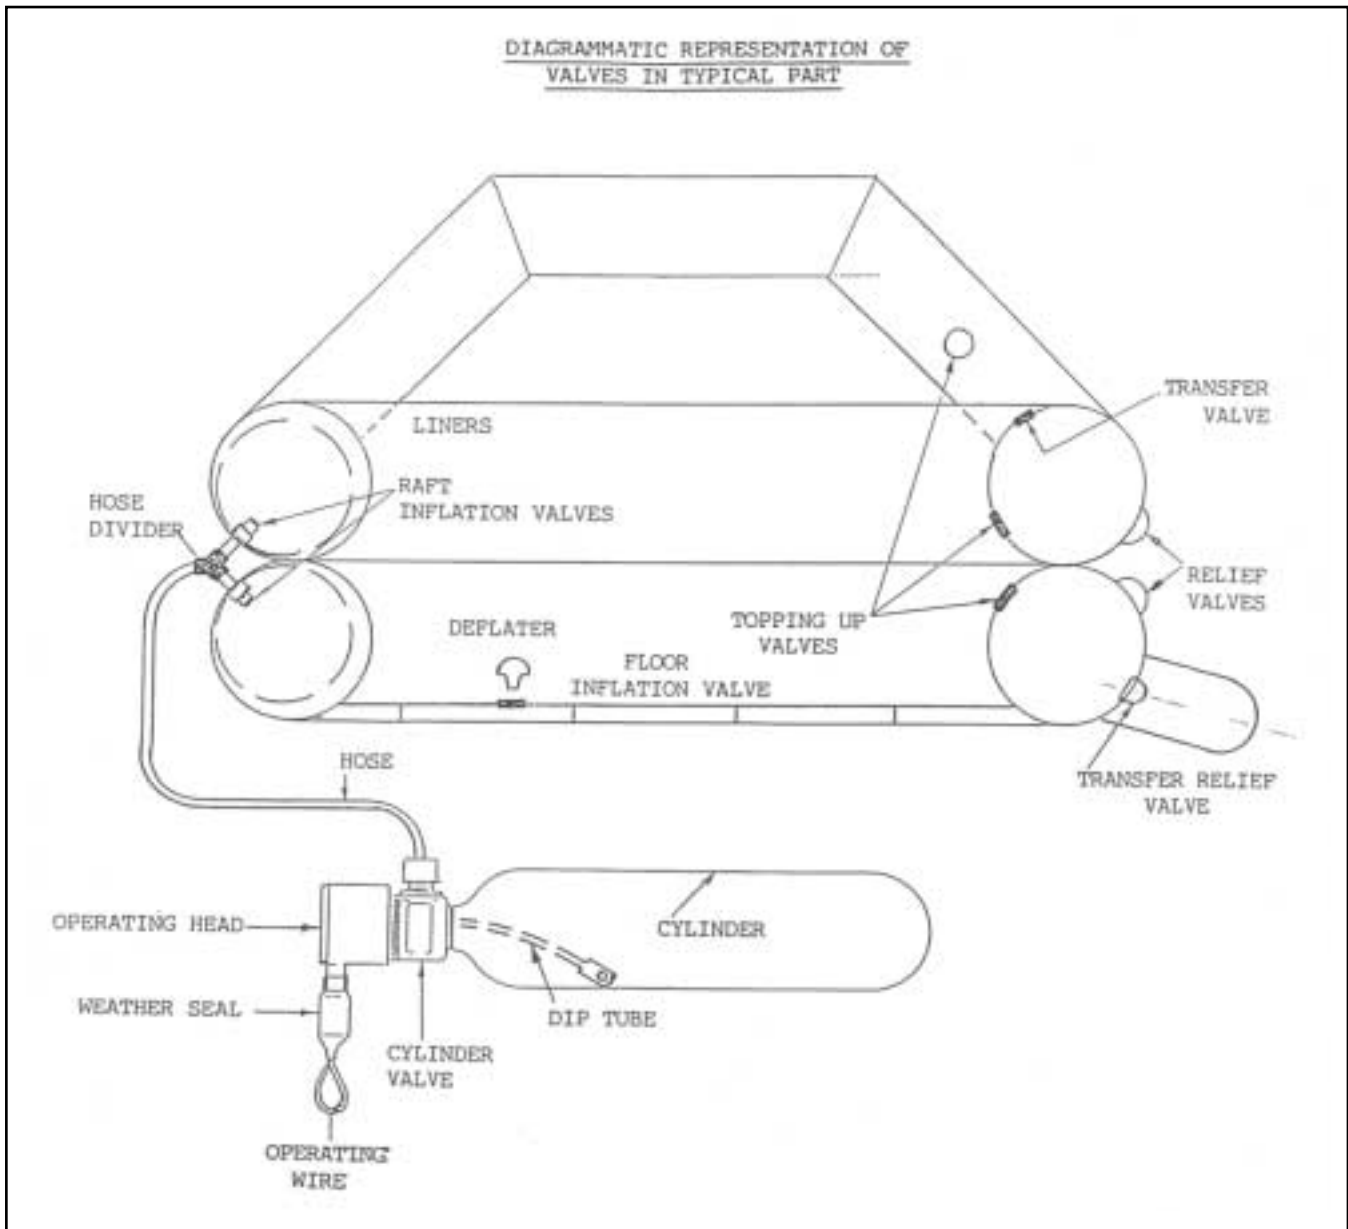
Diagram 2

The cylinder valve prevents the gas from escaping until required. To enable the CO<sub>2</sub> to inflate the type of liferaft on *Our Nicholas*, a system known as the “knife and cutter” is used. When activated, the knife pierces the diaphragm and allows the gas to escape from the cylinder to the gas hose. The diaphragm also acts as a bursting disc if and when the cylinder pressure rises towards its test pressure. The operating head used a stored energy system by means of a spring, which drove the knife rapidly and over a controlled distance into the diaphragm (**see Diagram 2**).

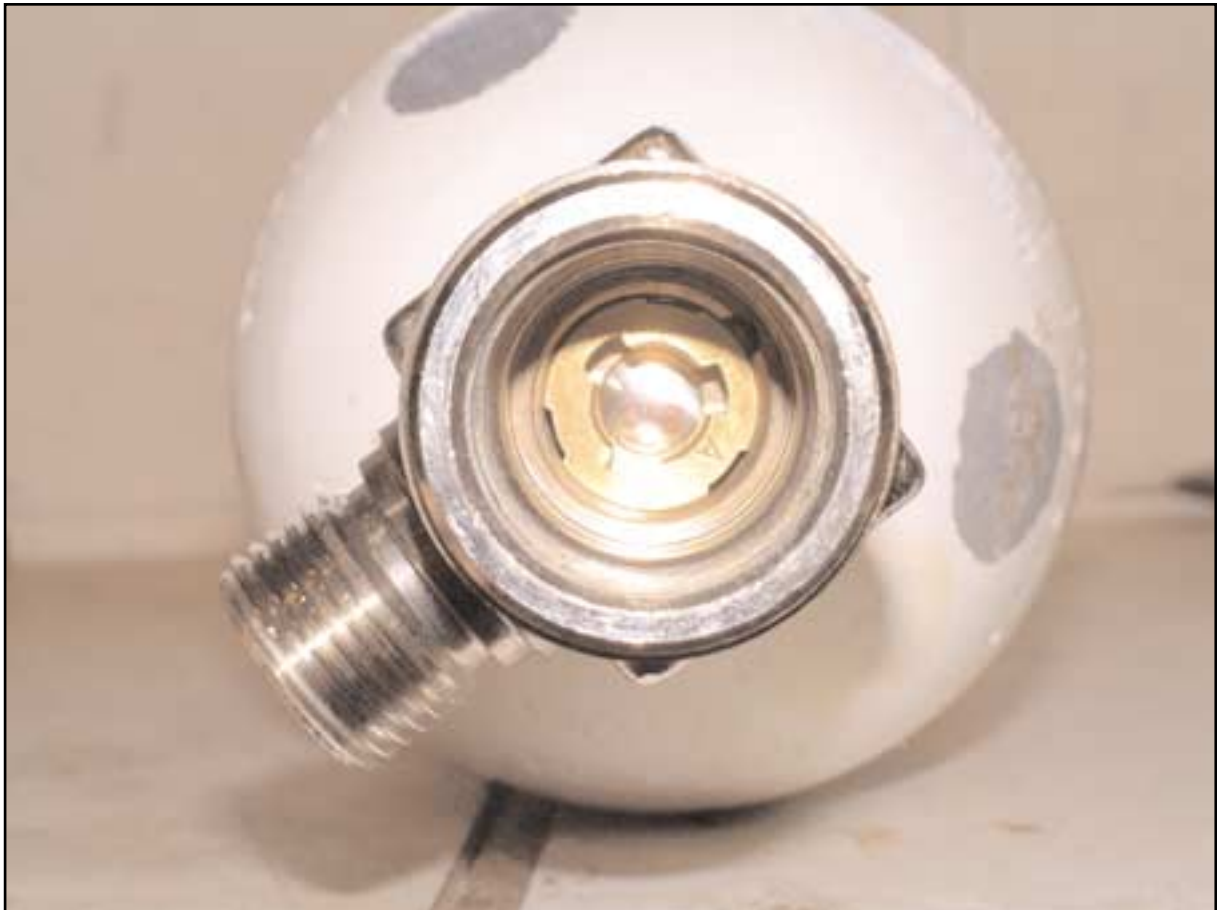
Photograph 6

When either the cylinder is refilled, or at the annual weighing, and the diaphragm is in place, the knife way and the release knife is screwed into the cylinder head with the special tool (**see Photograph 6**). If, as suggested in 1 above, the knife way had been over-tightened, the release knife might have scratched the diaphragm allowing gas to be released. However, the insertion tool only allows the knife way to be screwed in to a point where the tool butts up to the end of the cylinder.

Photograph showing the various parts of the gas release mechanism
