Report on the investigation of the loss of

***Vertrauen (BF 450)***

19 July 2001

**Report No 29/2002  
August 2002**

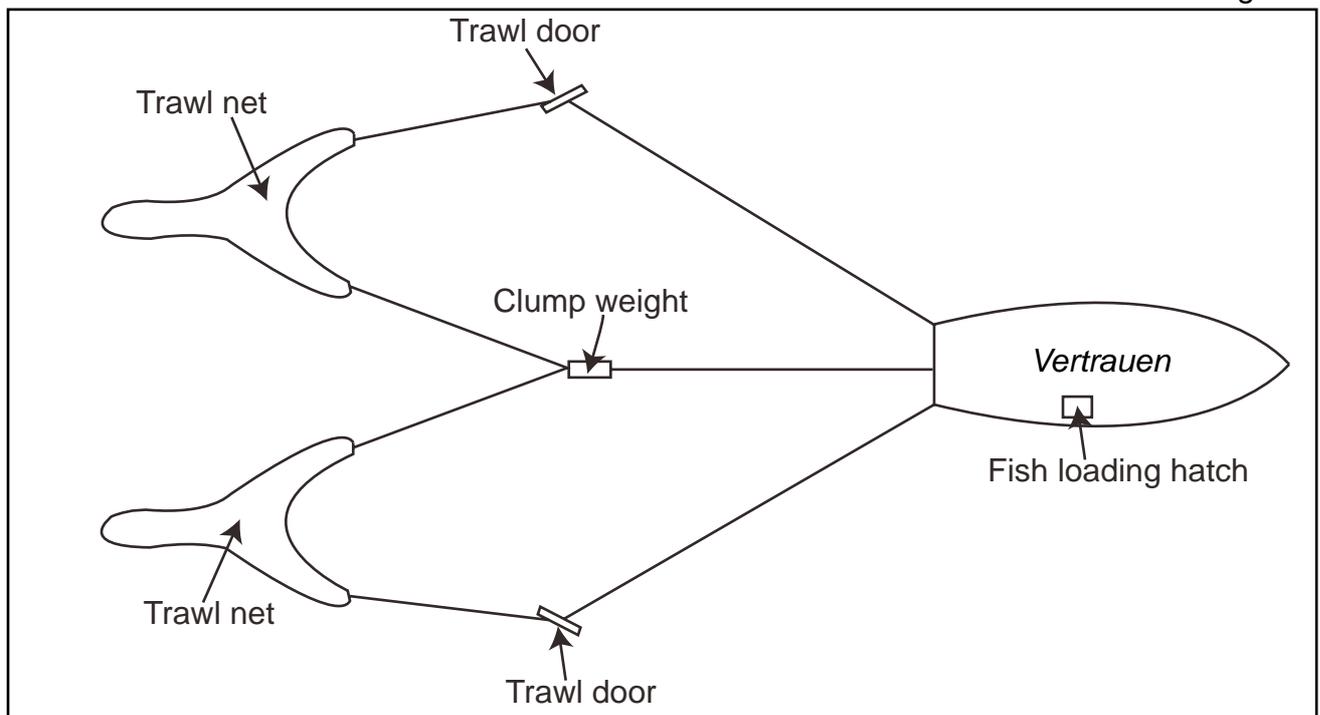
Figure 8

*Vertrauen* used a twin trawl deployed from the stern (**Figure 8**). A bottom trawl was used, and prawns were the main catch on her final fishing trip. The trawls were stowed on net drums located on the aft deck. When the net was on board, it was handled mainly using a crane, on the end of which was a rotating drum, referred to as the power block. The net was deployed over the side using the power block. Once the net was streamed aft, it was controlled by the winch, to which were attached the two trawl warps. The trawl was usually towed for about five or six hours. When the tow was finished, the gear was hauled using the winch. When the gear was on the surface, the power block was used to move the starboard trawl from aft to the starboard beam. The gilson was then attached to the cod end, and the catch was lifted by hauling the gilson through a
