Report on the investigation of the loss of

Constant Faith

on 30 June 2001

**Report No 21/2002
June 2002**

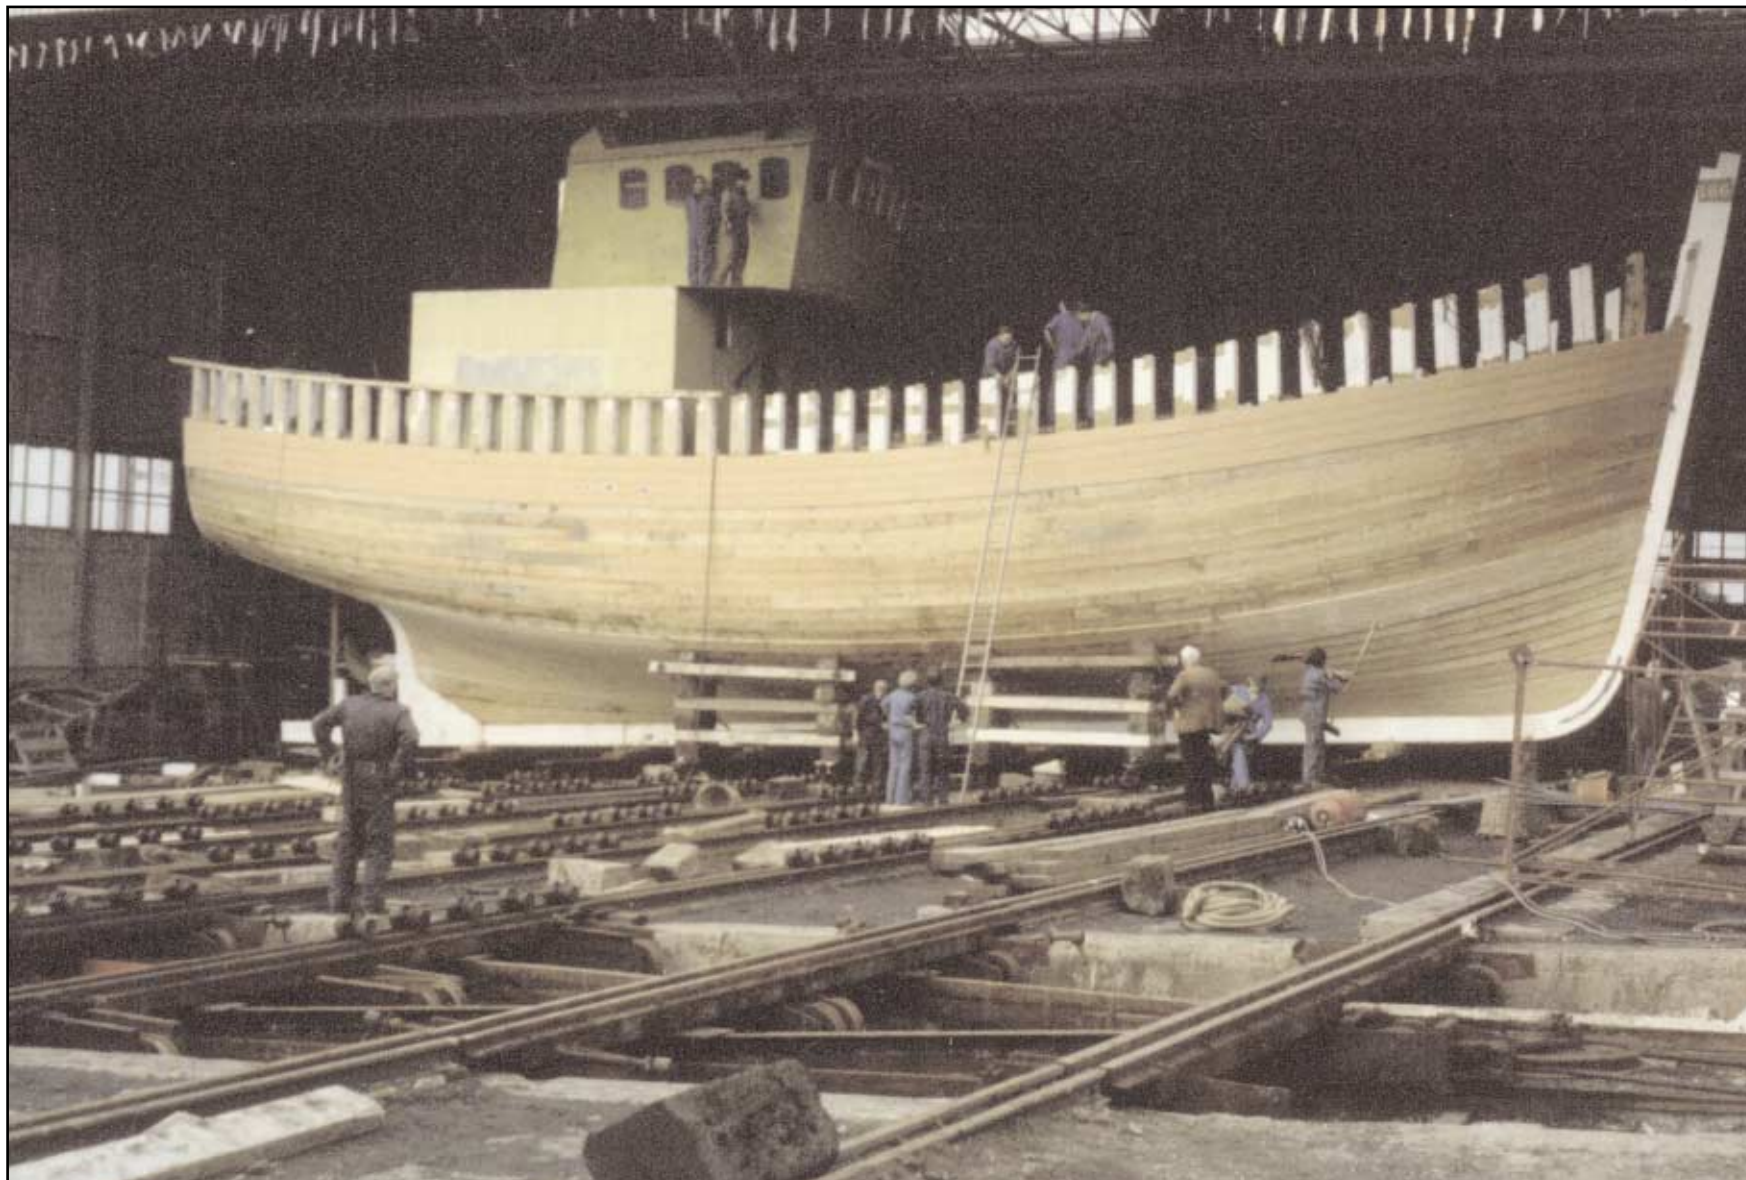
Constant Faith showing wooden construction

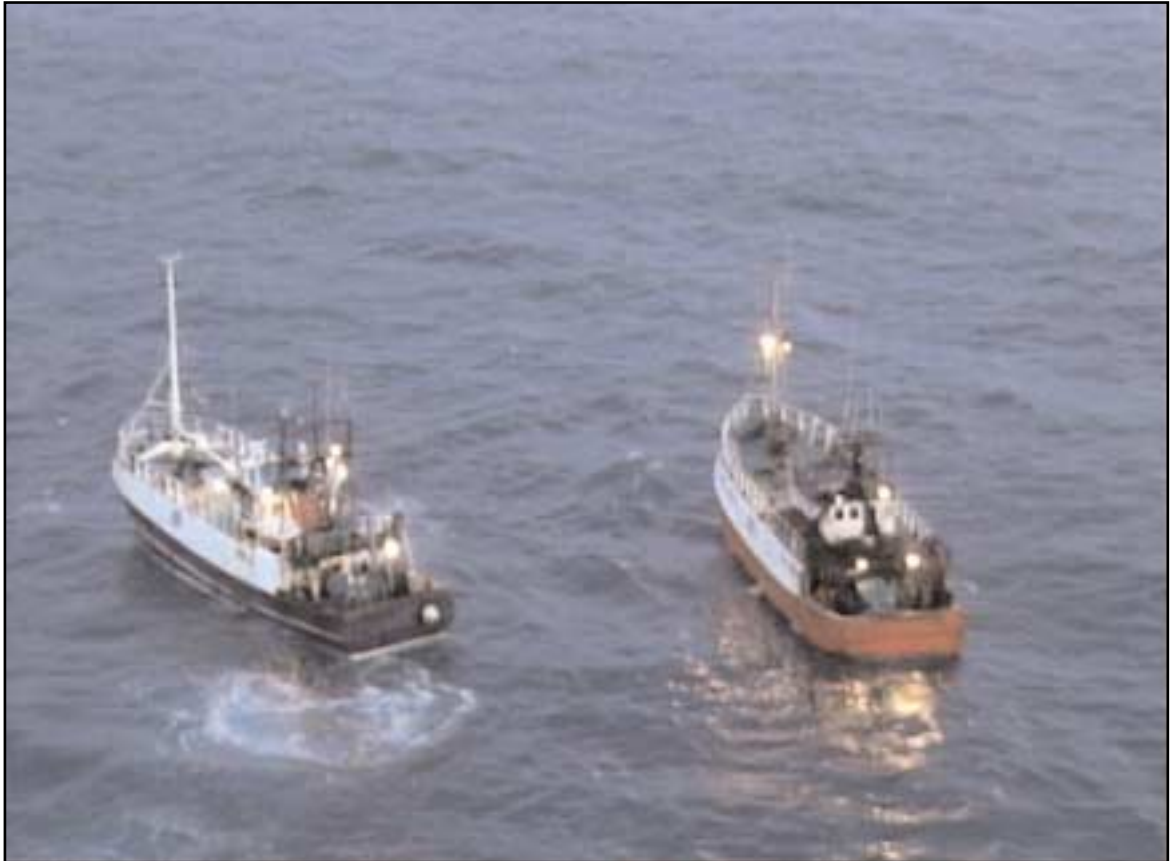
Figure 12

0238. *Constant Faith*, with her skipper and mate still on board, is shown in **Figures 10 and 11**. The tonnage valve and freeing port on the starboard side are above the waterline. **Figures 12 to 14** show *Conquest* manoeuvring in and taking off the skipper and mate. *Conquest* is shown manoeuvring away in **Figure 15**. All the figures show that the sea was fairly calm.
