Report on the investigation of
the grounding of
fv Primrose
on the Island of Rhum
on 15 June 2001

Report No 13/2002
April 2002

On 15 June 2001, the MAIB was informed that the stern trawler *Primrose* had grounded on the Isle of Rhum. An investigation started that day.

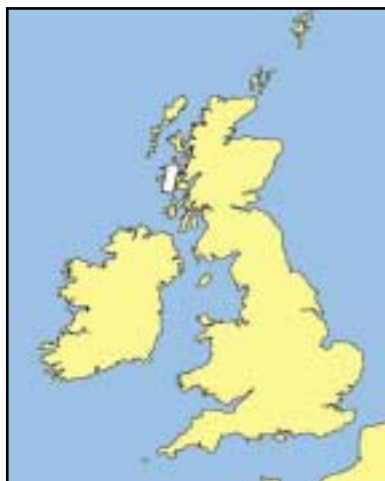
The vessel was refloated at high water later that day, with the assistance of Mallaig lifeboat. There was superficial hull damage, and water damage to the accommodation and engine room. No injuries or pollution were sustained as a result of the grounding. *Primrose* was later repaired and re-entered service.
