Report on the investigation of
the collision between
Thelisis and Our Sarah Jayne
in the
Thames Estuary
20 June 2001

Marine Accident Investigation Branch
First Floor
Carlton House
Carlton Place
Southampton
United Kingdom
SO15 2DZ

**Report No 9/2002
February 2002**

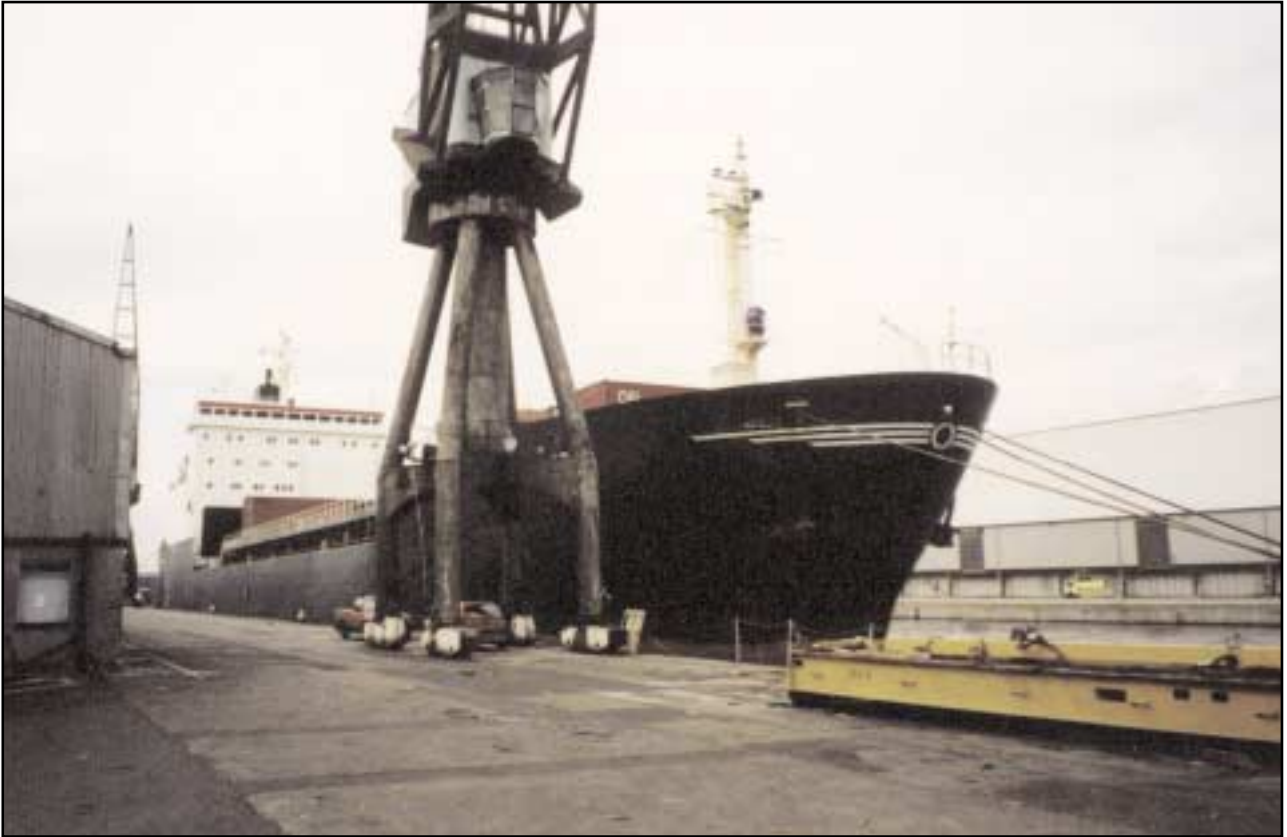
Figure 1

Thelisis

Thelisis, built of steel in 1979, was a conventional ro-ro cargo vessel. Her design incorporated two decks above the waterline with a stern ramp. The bridge, which ran the full width of the vessel, was positioned aft, above the superstructure and accommodation (**Figure 1**).

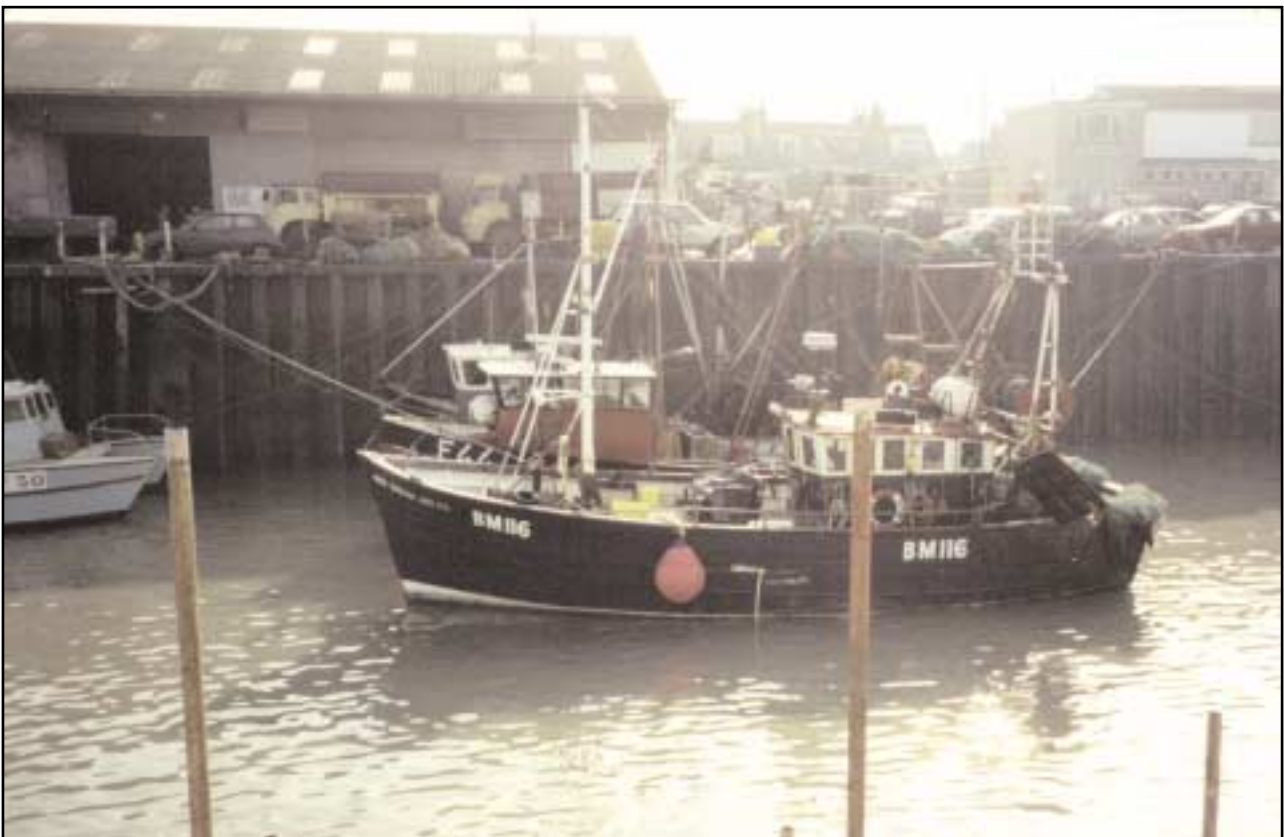
Figure 2

Our Sarah Jayne

Our Sarah Jayne was built of wood in 1973. Her design incorporated one deck above the waterline. Above deck, the wheelhouse was positioned aft. A trawl winch was situated forward of the wheelhouse. Aft of the wheelhouse was a net drum mounted on a stern gantry (**Figure 2**).

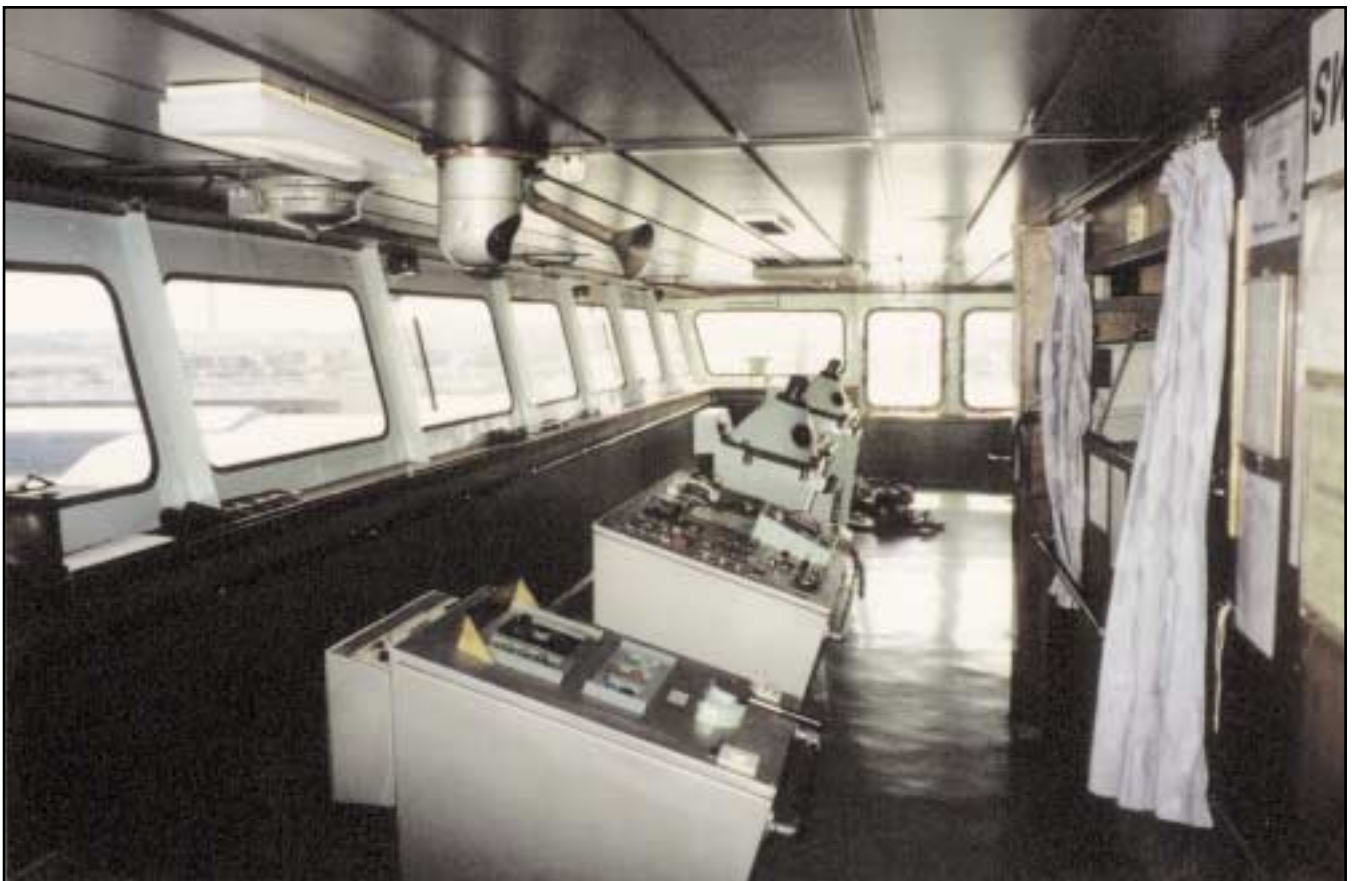
Figure 3

The helm position was situated centrally at the forward end of the bridge, with tiller controls on the extreme port and starboard sides. The main engine controls were strategically placed in an operating console to starboard of the helm position (**Figure 3**).

Bridge of *Thelisis*
