Report on the investigation of the
collision between
Hampoel and Atlantic Mermaid
in the Dover Strait
on 7 June 2001

Marine Accident Investigation Branch
First Floor
Carlton House
Carlton Place
Southampton
United Kingdom
SO15 2DZ

Report No 12/2002
March 2002

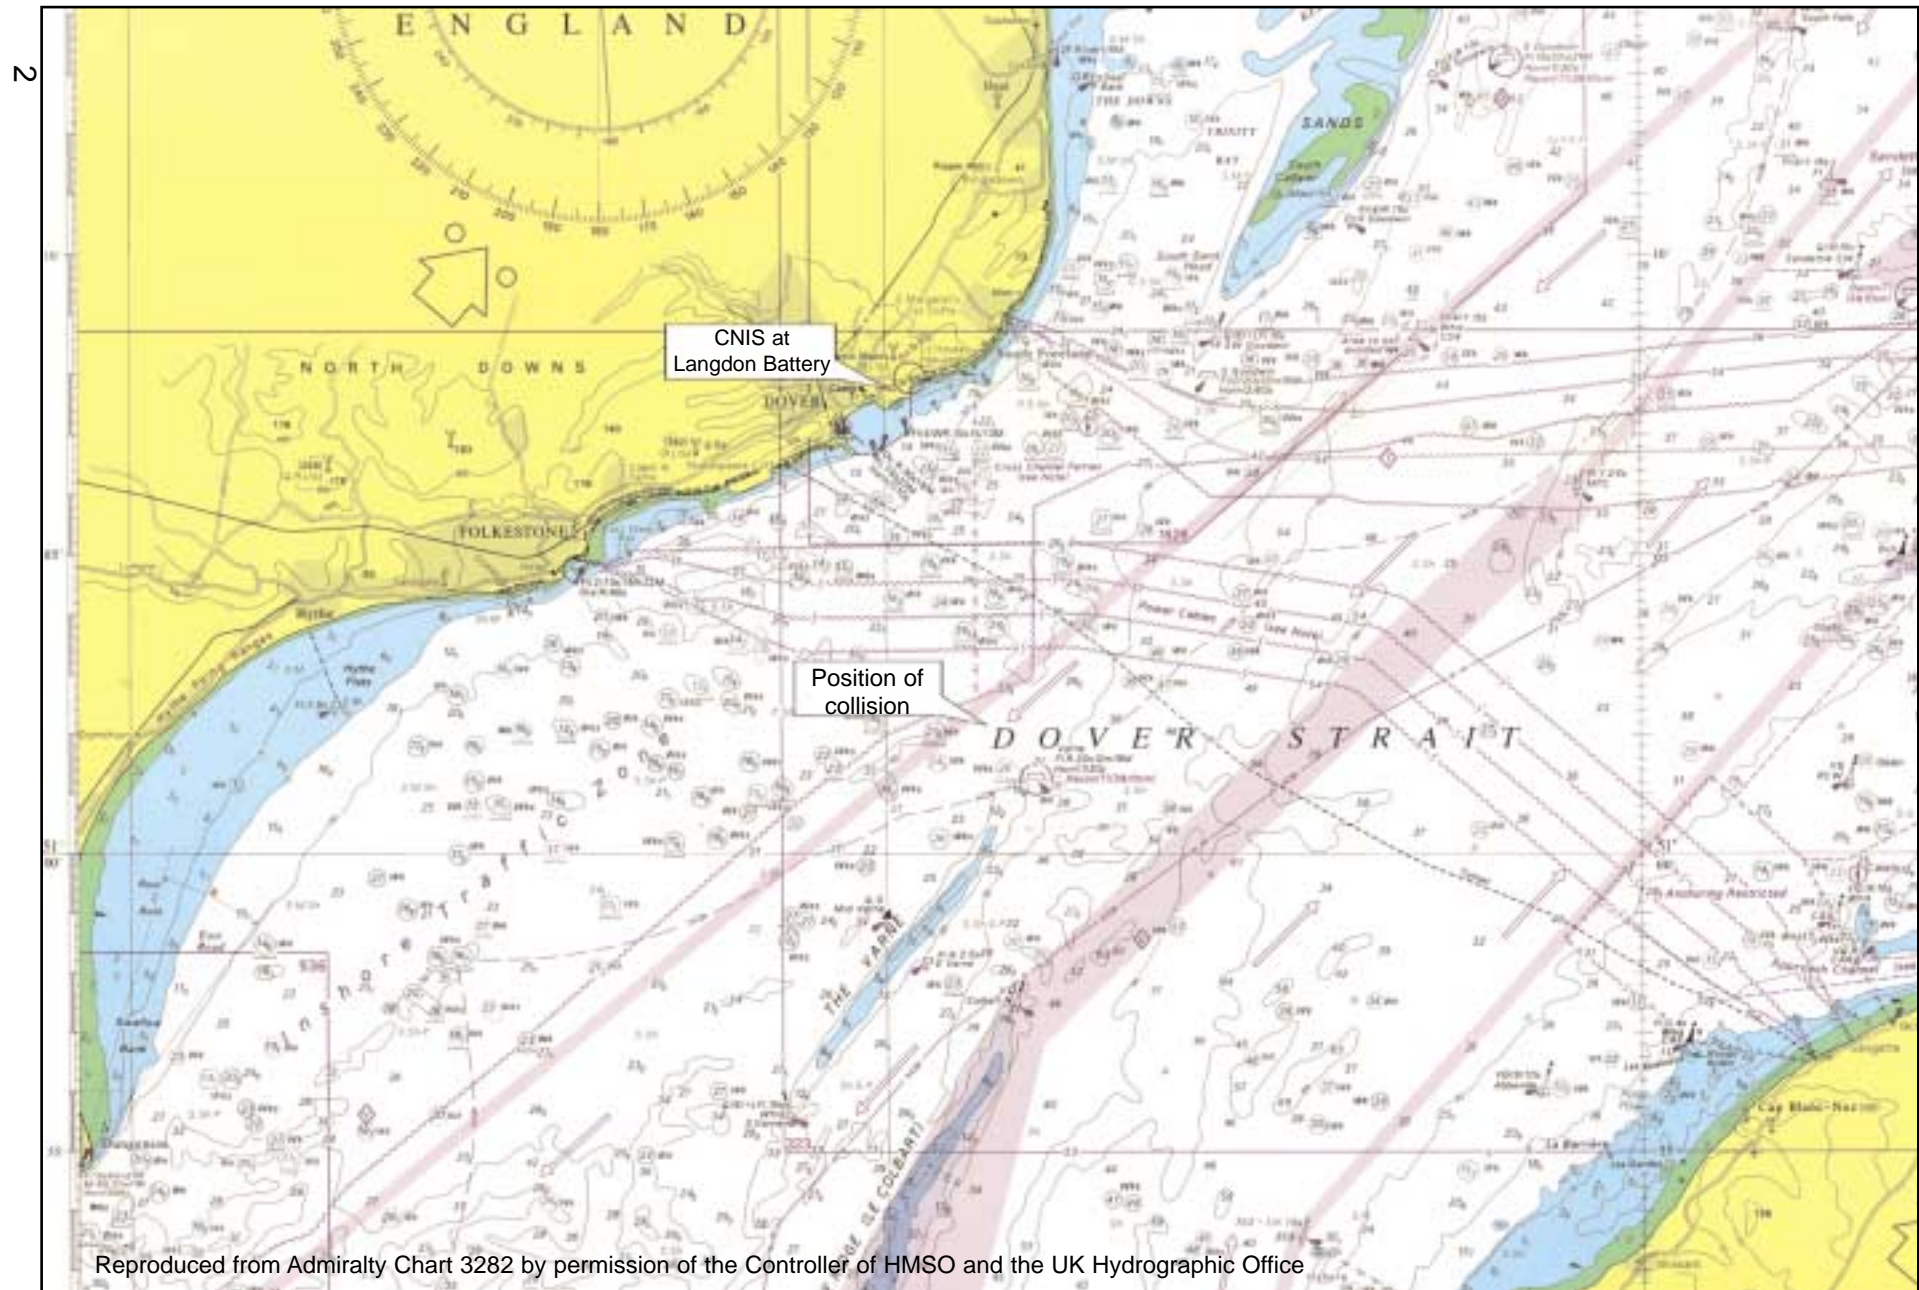
Figure 1

At 0153 UTC on 7 June 2001, the Panamanian-registered refrigerated cargo vessel *Atlantic Mermaid*, collided with the Cypriot-registered general cargo vessel *Hampoel*, off the Varne in the south-west bound lane of the Dover Strait traffic separation scheme (TSS) (**Figure 1**). An MAIB investigation began that day.

Chart extract showing Dover Strait and position of collision

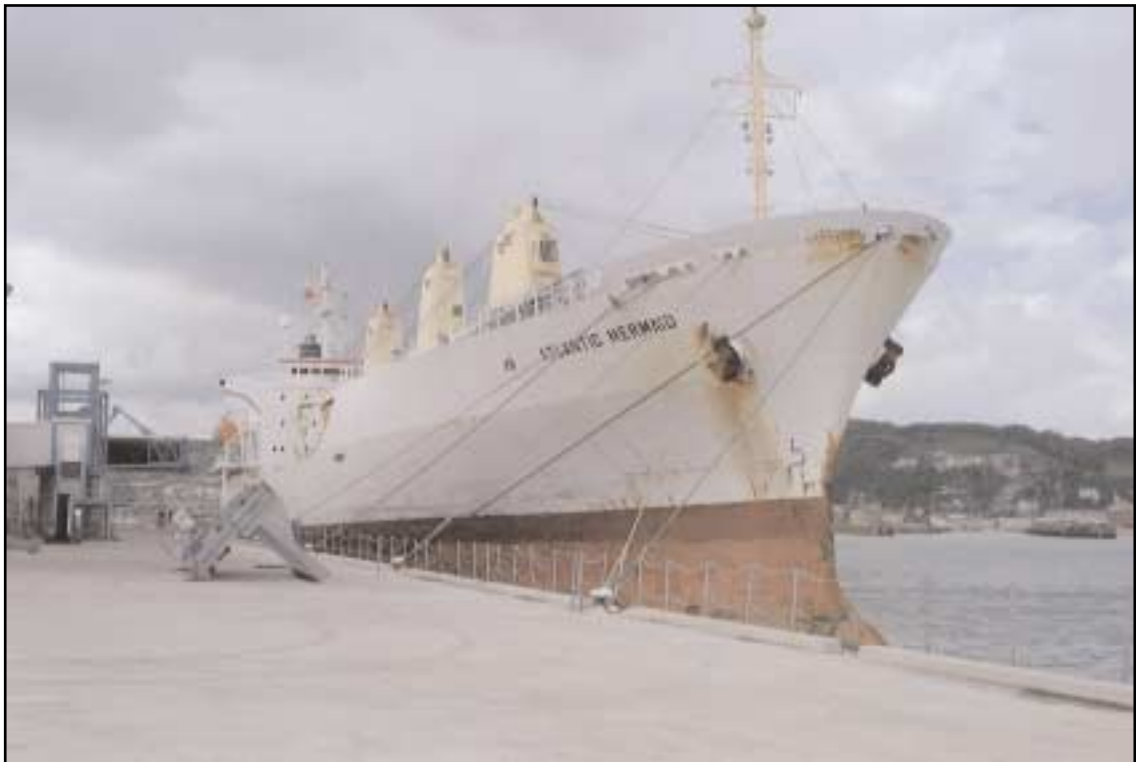
Figure 6

Atlantic Mermaid

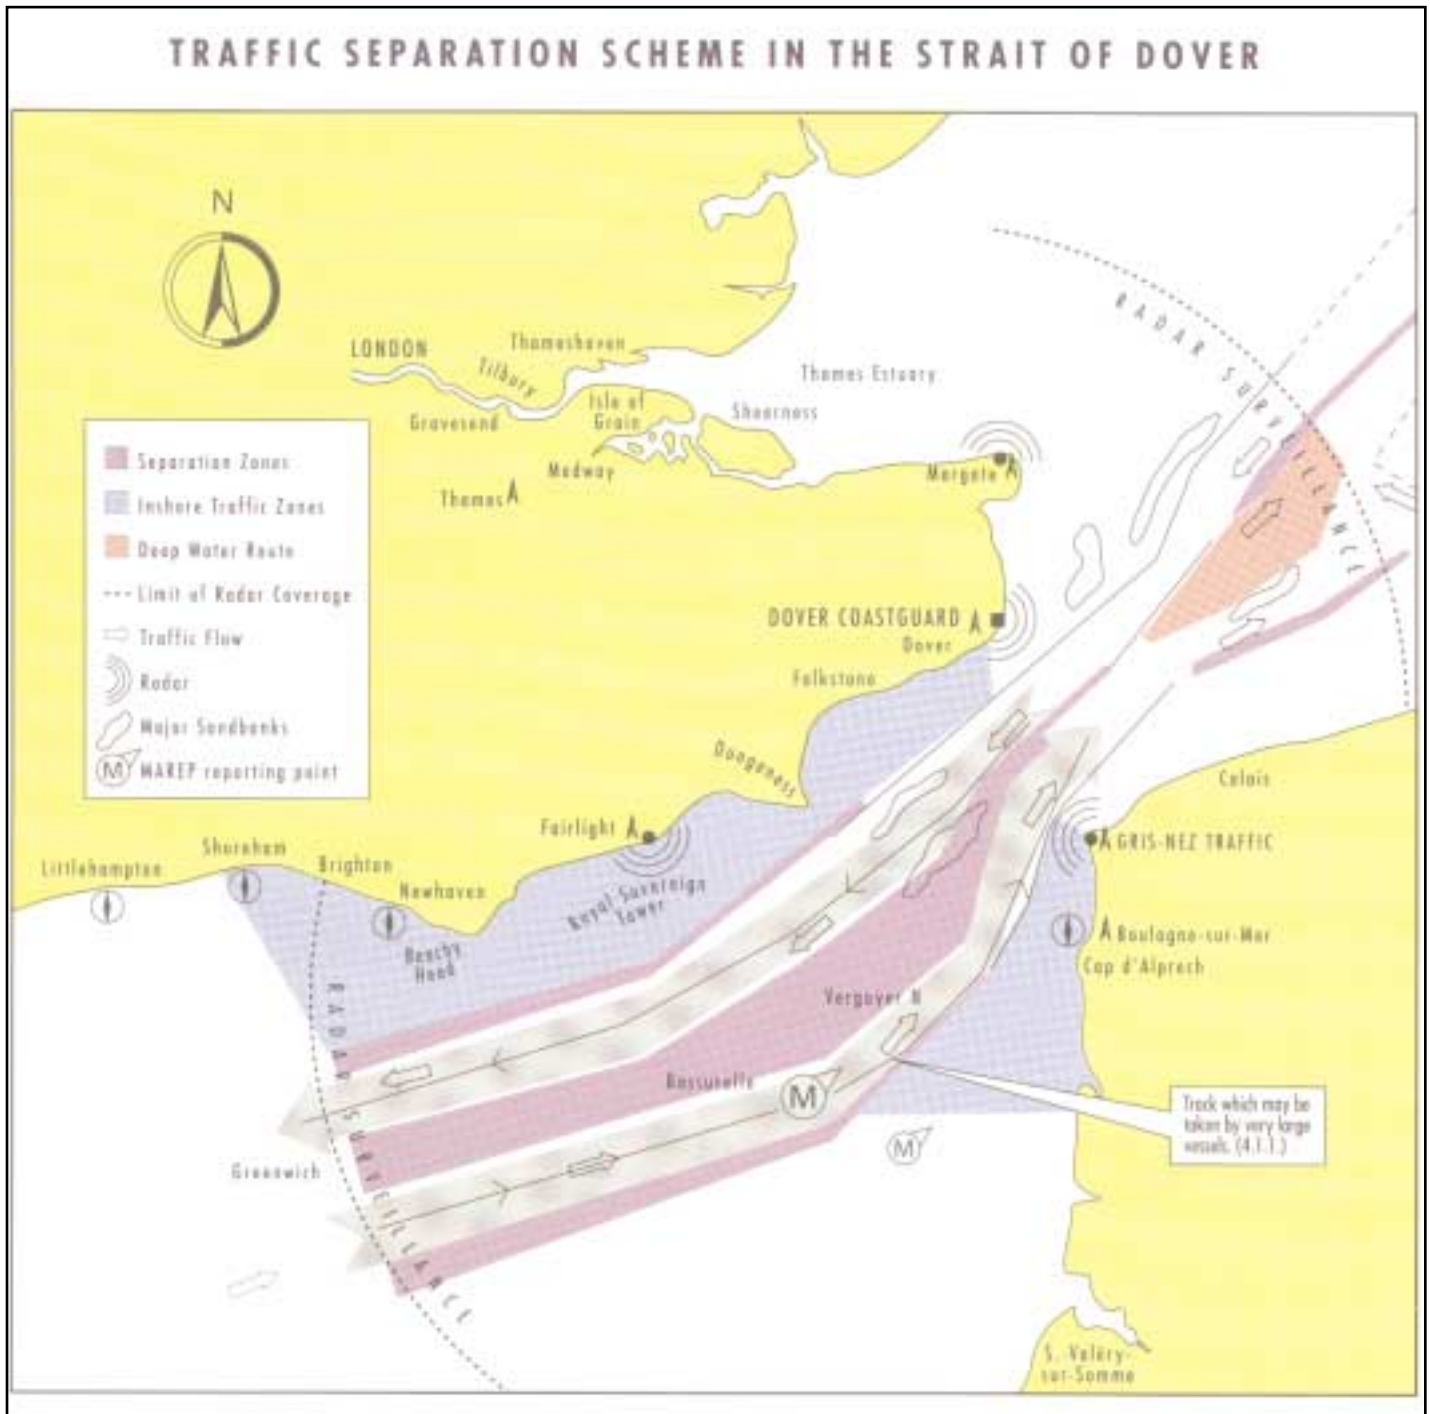
The Dover Strait and its approaches is one of the busiest waterways in the world, and it poses severe safety problems to ships because of the density of traffic and the proximity of navigational hazards. In 1977, the traffic separation scheme (TSS) in the Dover Strait and adjacent waters, became compulsory **(see Figures 8 & 9)**.

This collision was the third in 9 months involving vessels using the south-west lane of the TSS and proceeding in the same direction.

All three collisions occurred within a 7-mile stretch of water close to the Varne. All six vessels were heading south-westerly and involved a slower vessel being struck from astern by an overtaking vessel. The MCA successfully prosecuted two of the three overtaking vessels.

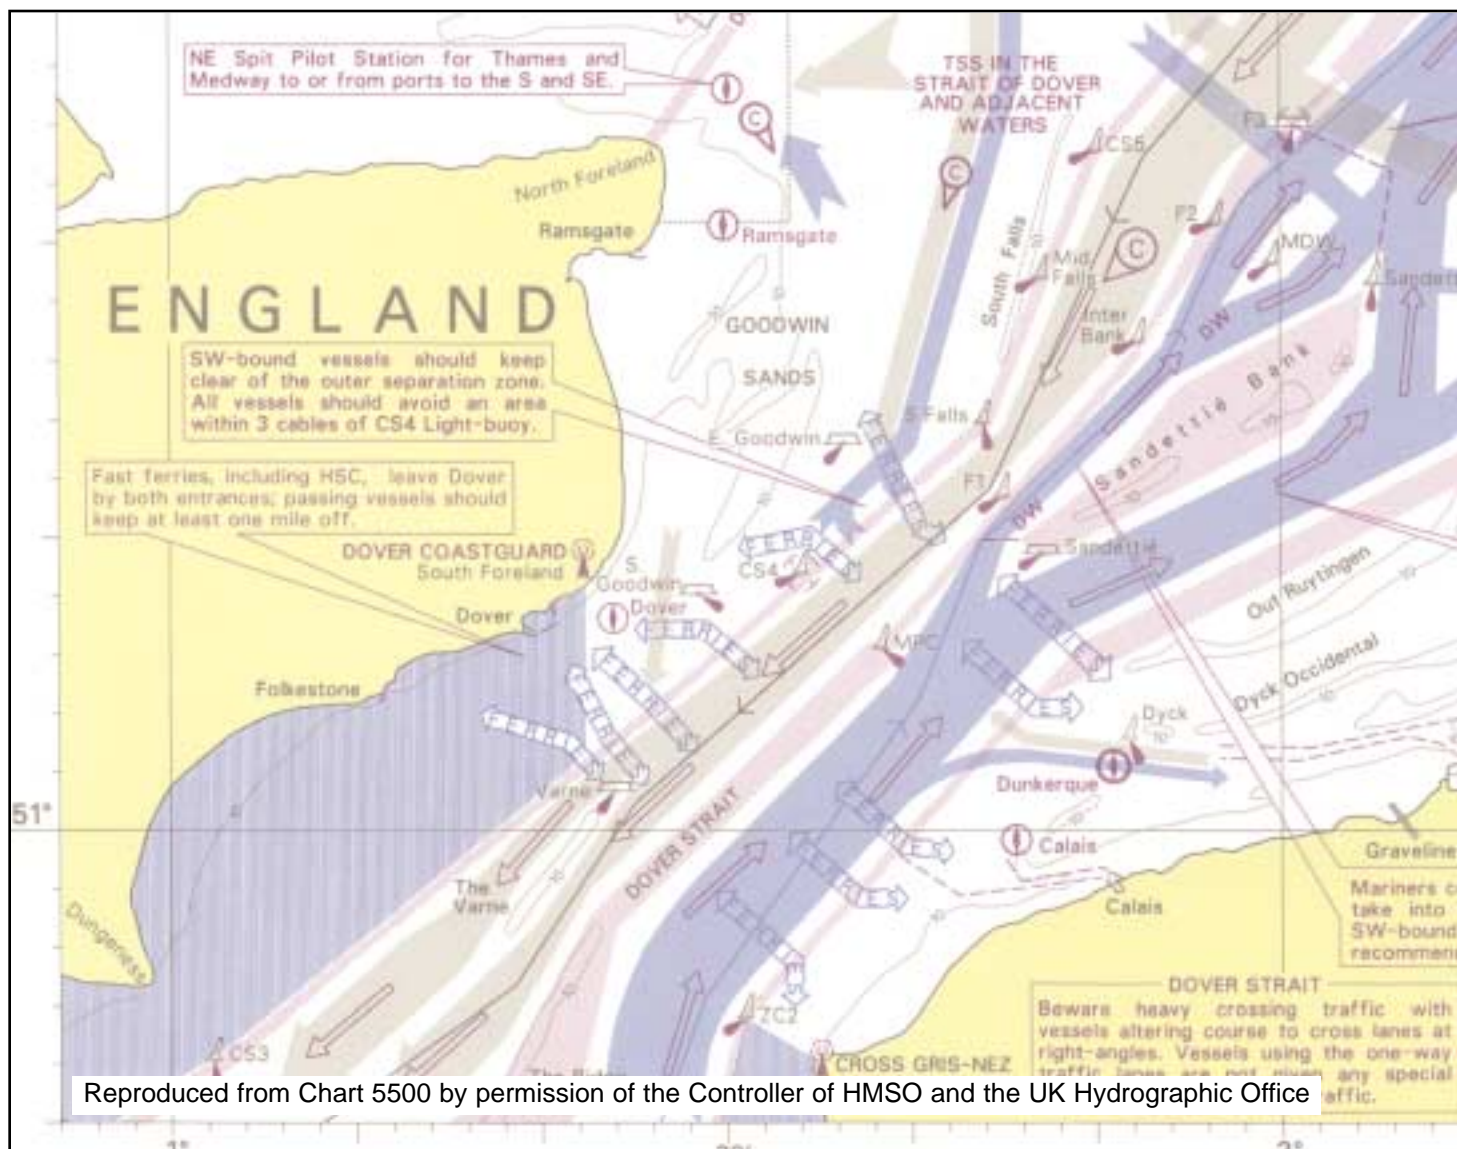
Extract of chart 5500
