Report on the investigation of
the collision between the chain ferry

Bramble Bush Bay

XOD class yachts

**Report No 20/2002
June 2002**

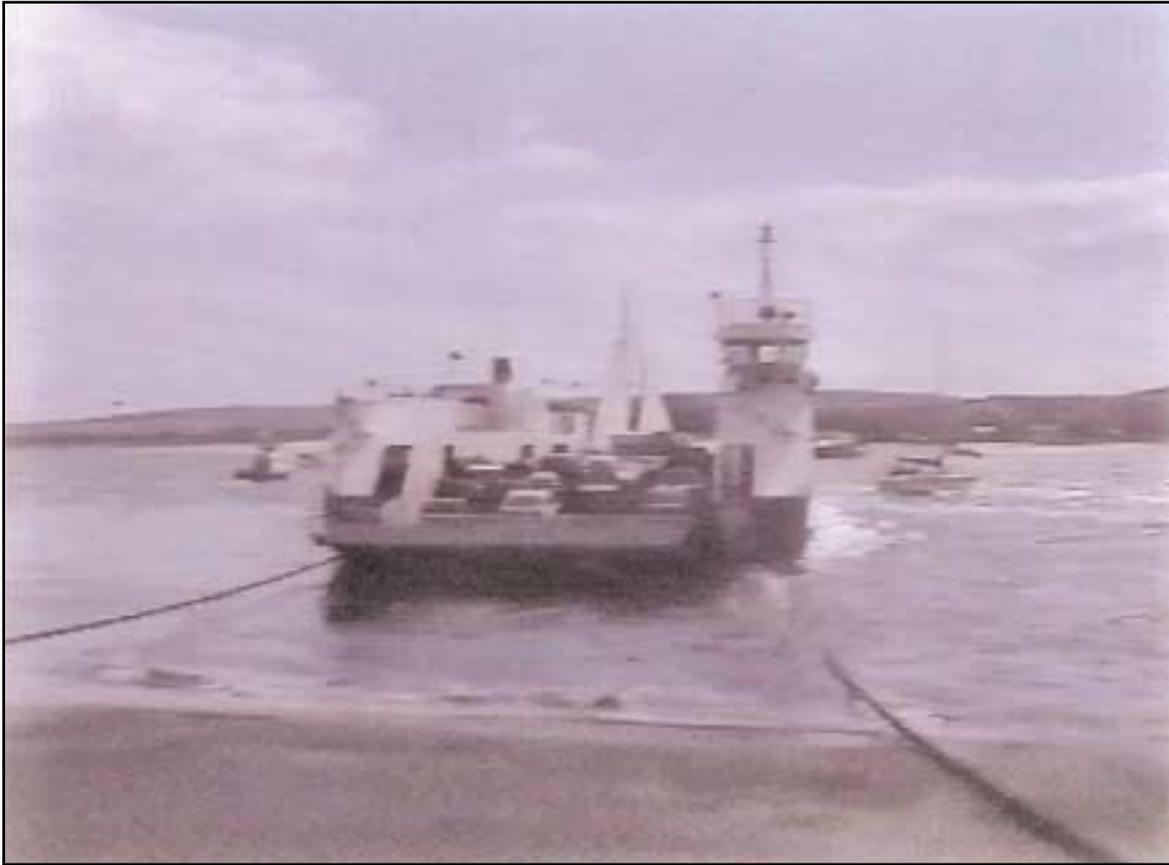
Photograph 3

The skipper began his shift on board the chain ferry *Bramble Bush Bay* at about 1355, and found that the yacht traffic between the havens was very heavy (**see Photographs 3 and 4**). He saw that there were sailing dinghies of various classes racing out towards the Swash Channel. He made his first crossing to South Haven Point, with several yachts passing close to the ferry. The ferry arrived on the south side and, being aware that *Condor Vitesse* had passed the Bar buoy at 1405, the skipper informed Poole Harbour Port Control that he would wait on the north side until she had passed. The ferry crossed to the north side, arriving at about 1408. At about 1415, *Condor Vitesse* cleared the chains, and the skipper moved *Bramble Bush Bay* off the slipway at slow speed. He could see a line of yachts approaching from North Haven beacon. The first three were ahead of the rest of the fleet, and they appeared to be heading for the middle of the channel to pass ahead of the chain ferry. The skipper moved the chain ferry slowly ahead so that she could pass between the first three and the rest of the fleet.

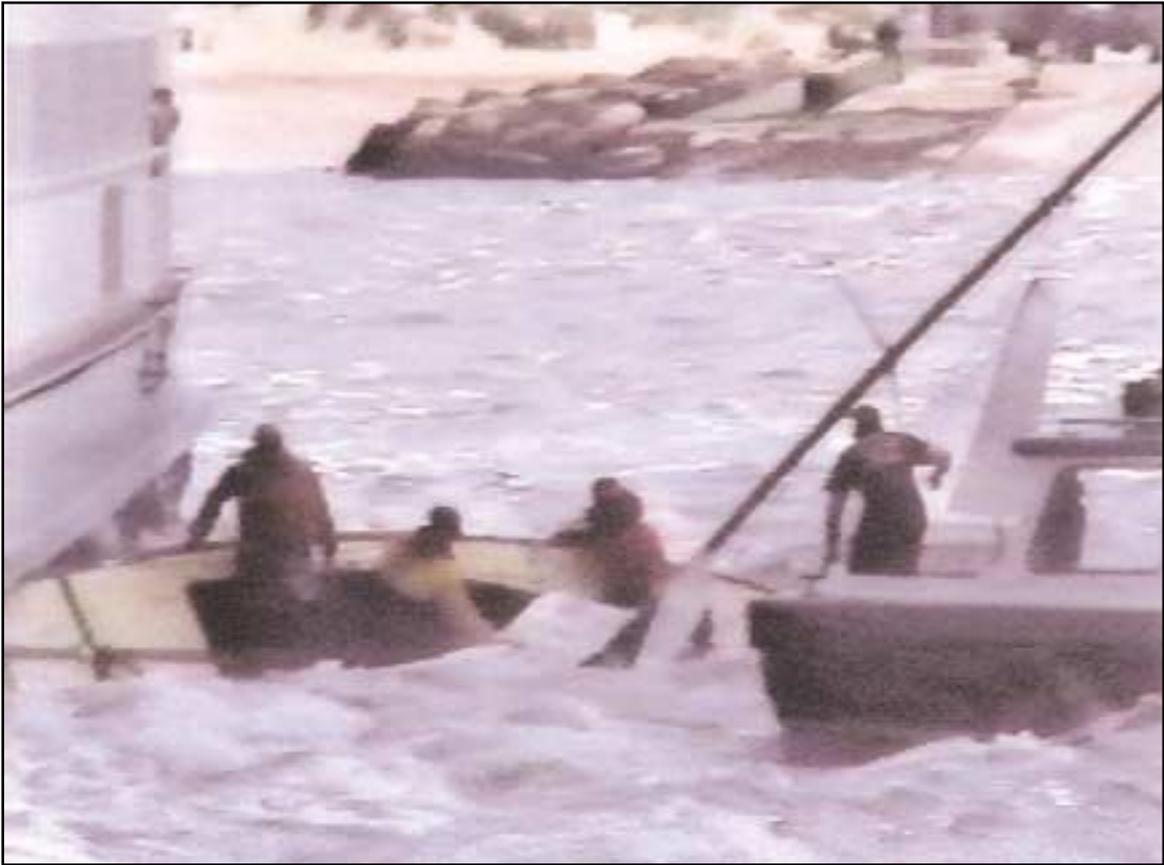
Photograph 5

Photographs 3-10 are images from a video recording taken at the time of the incident
