Report on the investigation
of shift of cargo containers,
involving dangerous goods on

Dutch Navigator

25 - 26 April 2001

**Report No 37/2002
November 2002**

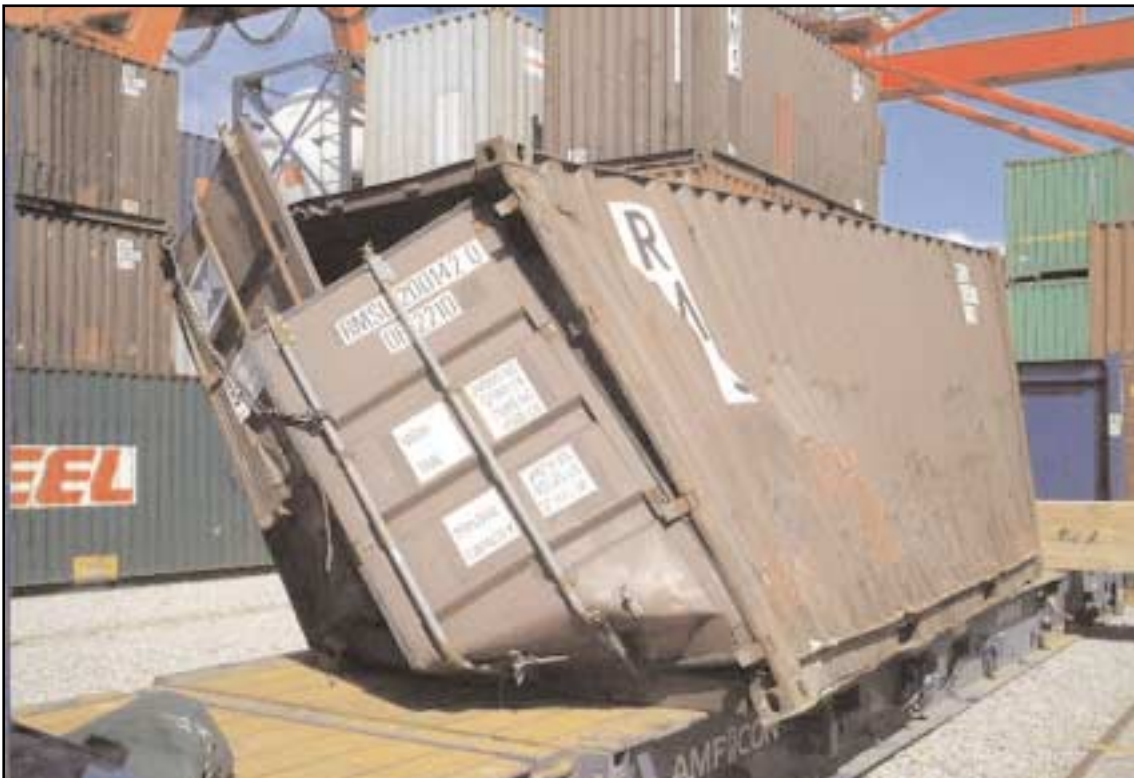
Figure 6

Box containers from Bay 1

The seven box containers, although damaged sufficiently to cause concern to their shippers, were seen as of limited significance to this incident, and the primary task was to make safe the two tanks containing dangerous goods. As none of the box containers held dangerous goods, this is an understandable approach and one that is generally adopted throughout this report.

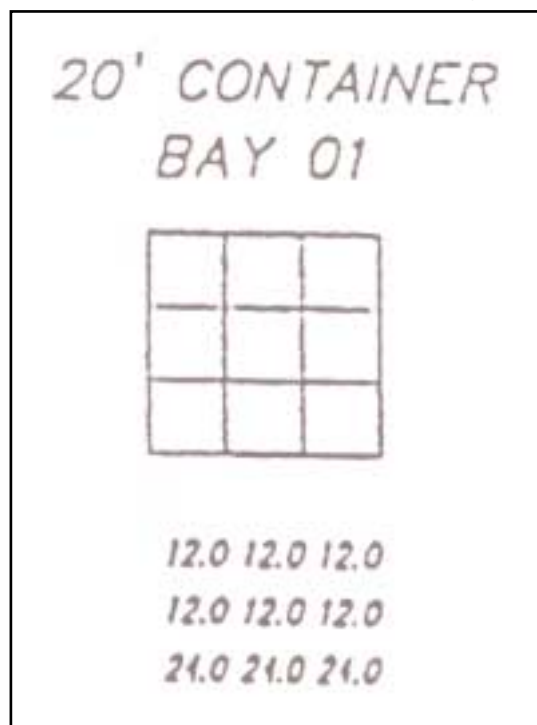
Figure 7

The limiting container weight distributions within stacks and bays and securing arrangements are also presented in graphic form. For Bay 1, the foremost, containers in the bottom tier are limited to 24t, all others in the bay to 12t (**Figures 7 & 8**).

Extract from cargo securing manual -
stack masses in Bay 1

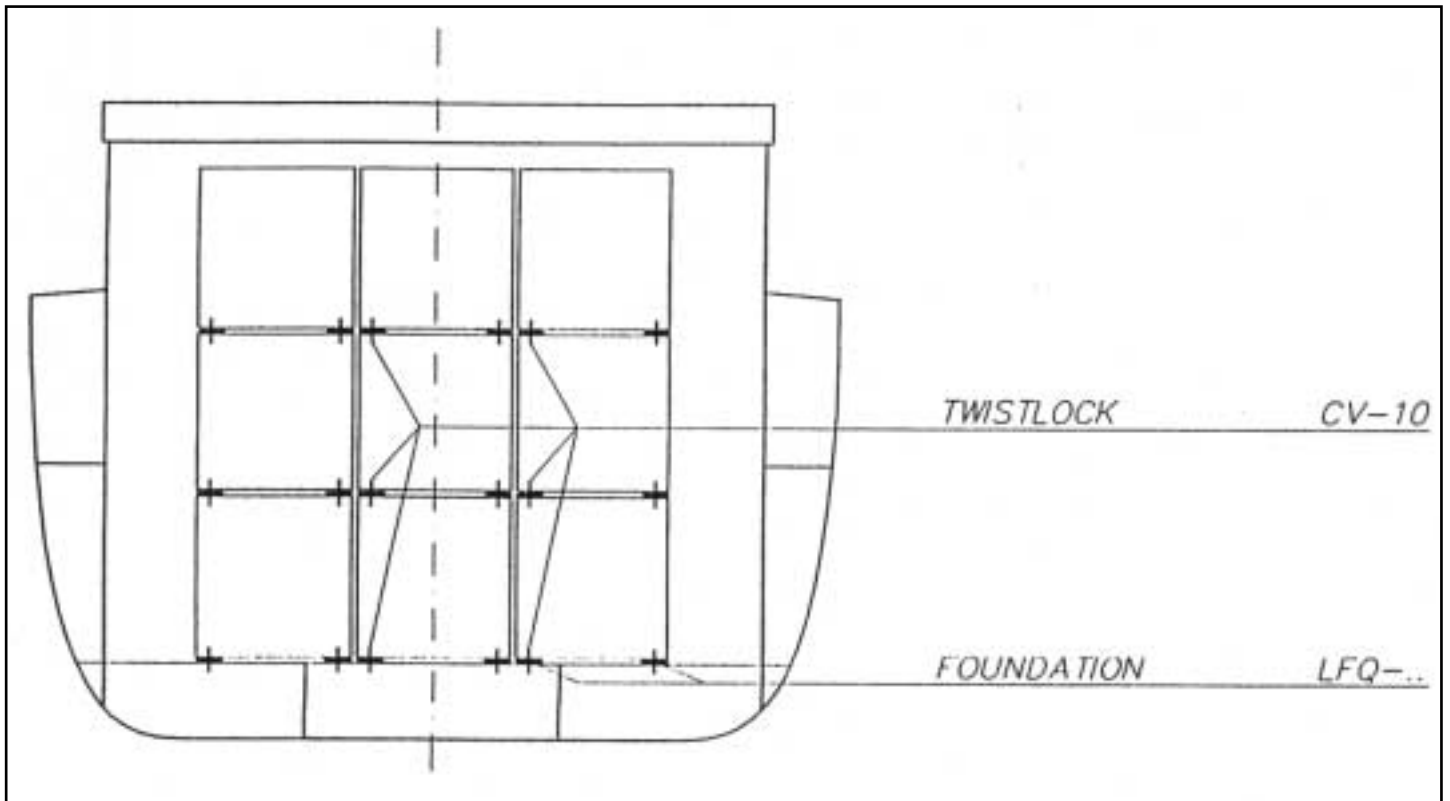
Extract from cargo securing manual - container securing arrangements, Bay 1

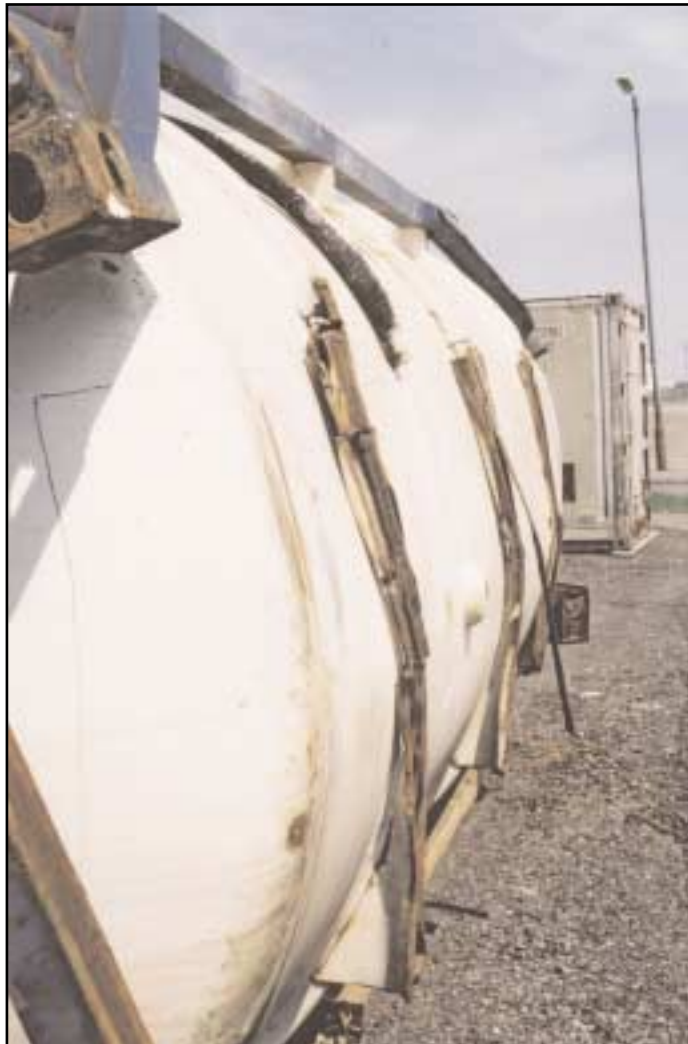
Figure 15

Damage to bottom of barrel
