Report on the investigation of the loss of

***Crimond II***

on 24 April 2001

**Report No 8/2002  
February 2002**

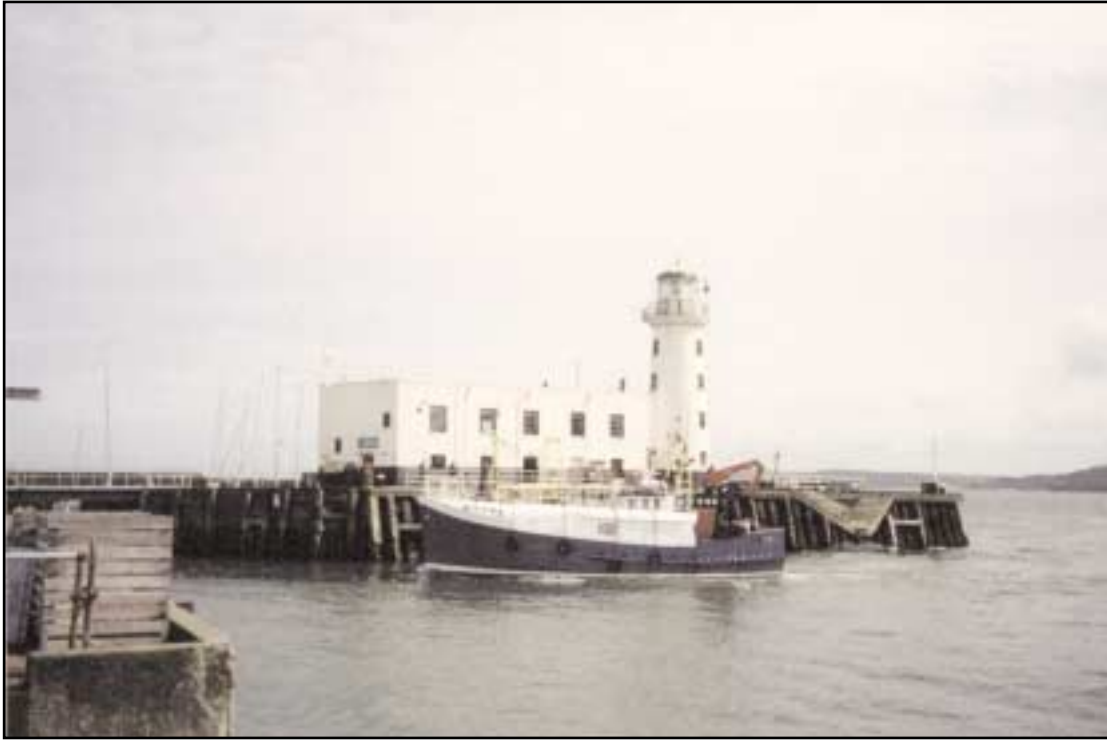
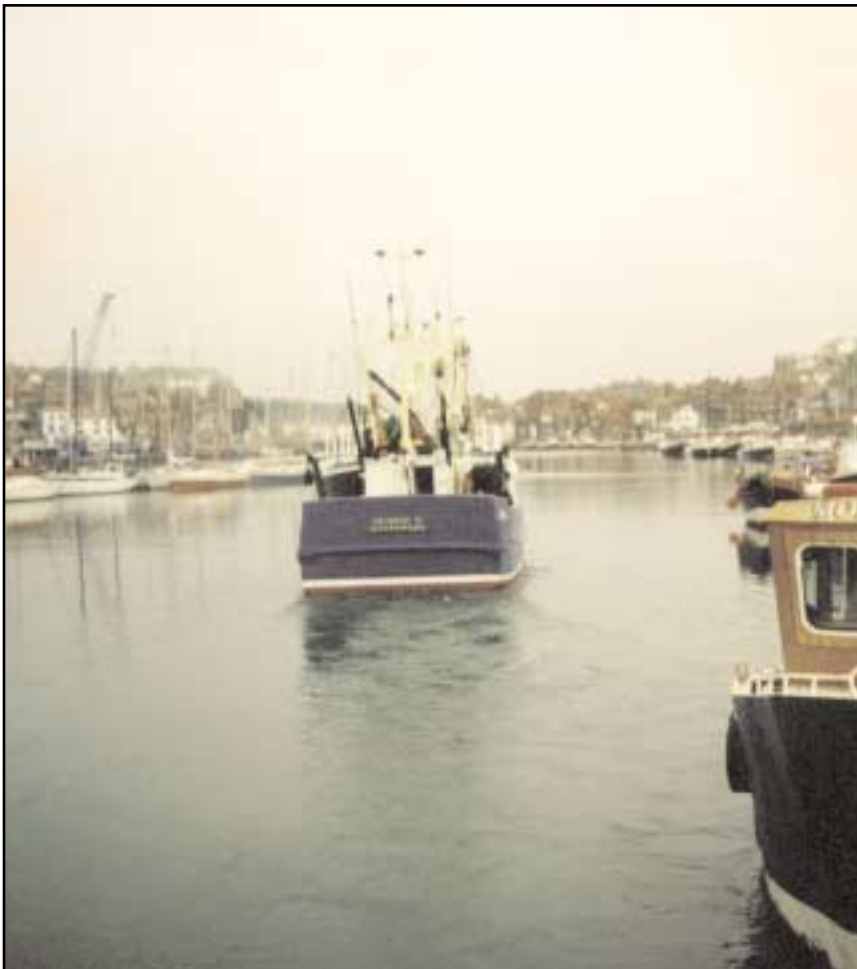
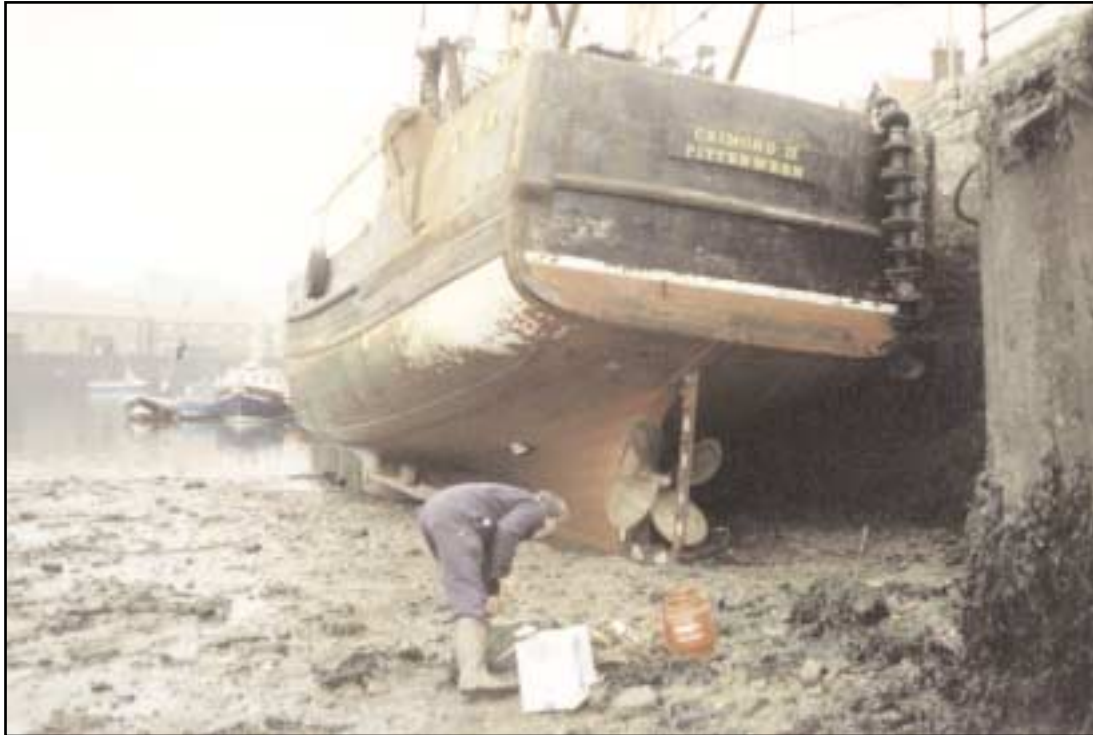
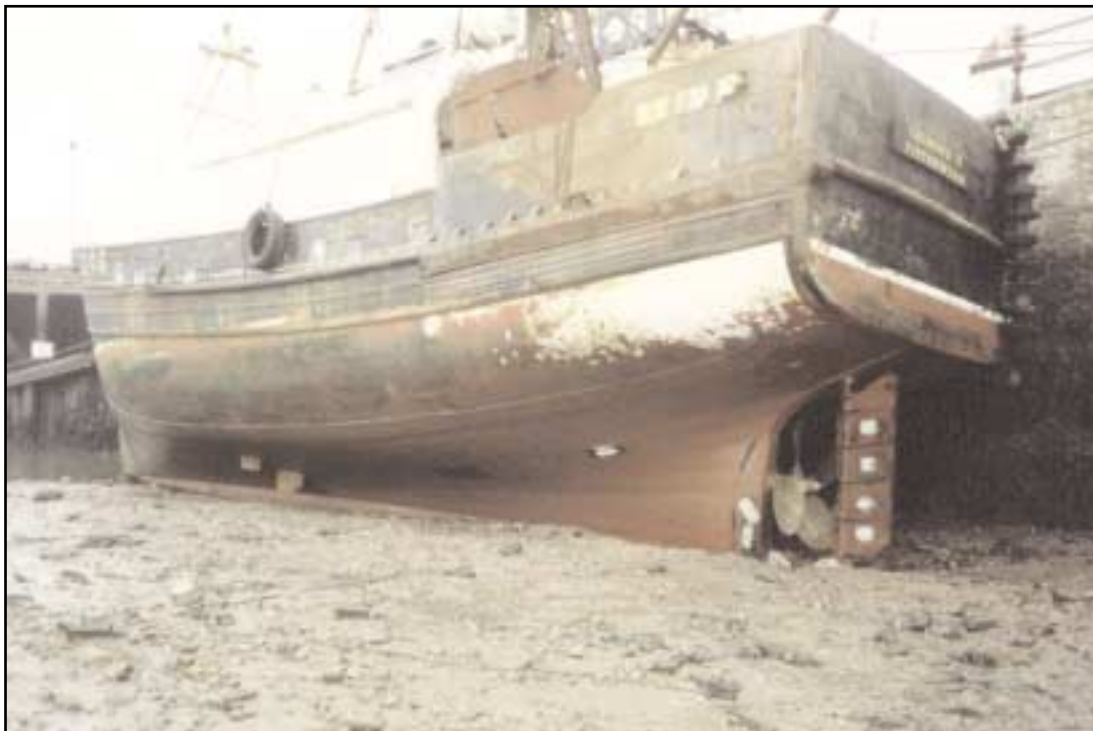
General views of *Crimond II* are shown in **(Figures 1, 2, 3 and 4)**. A general arrangement, before the fitting of the shelter, is shown in **(Figure 5)**.

*Crimond II* - General views

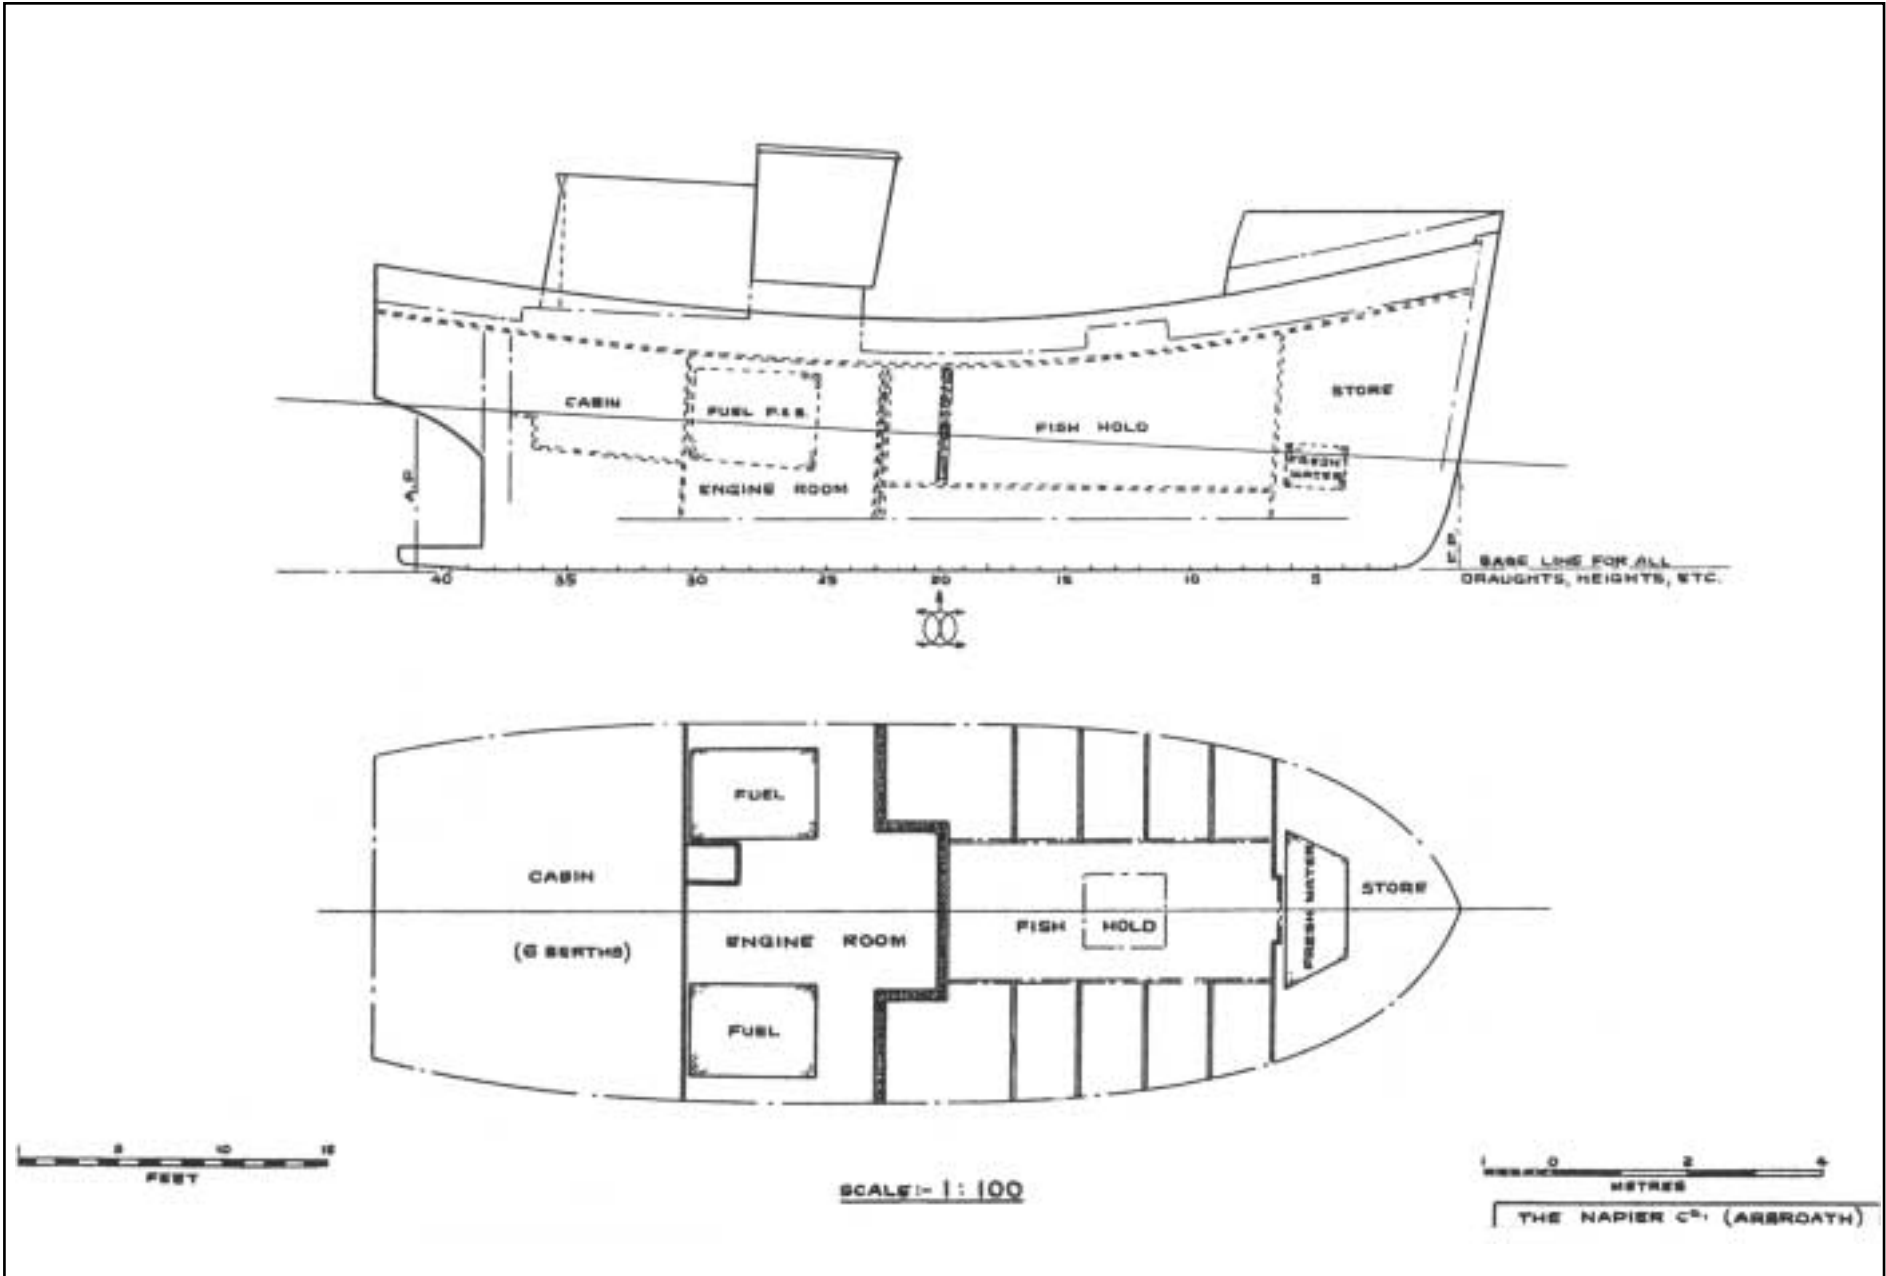
Figure 5

*Crimond II* - General arrangement before fitting of the shelter deck

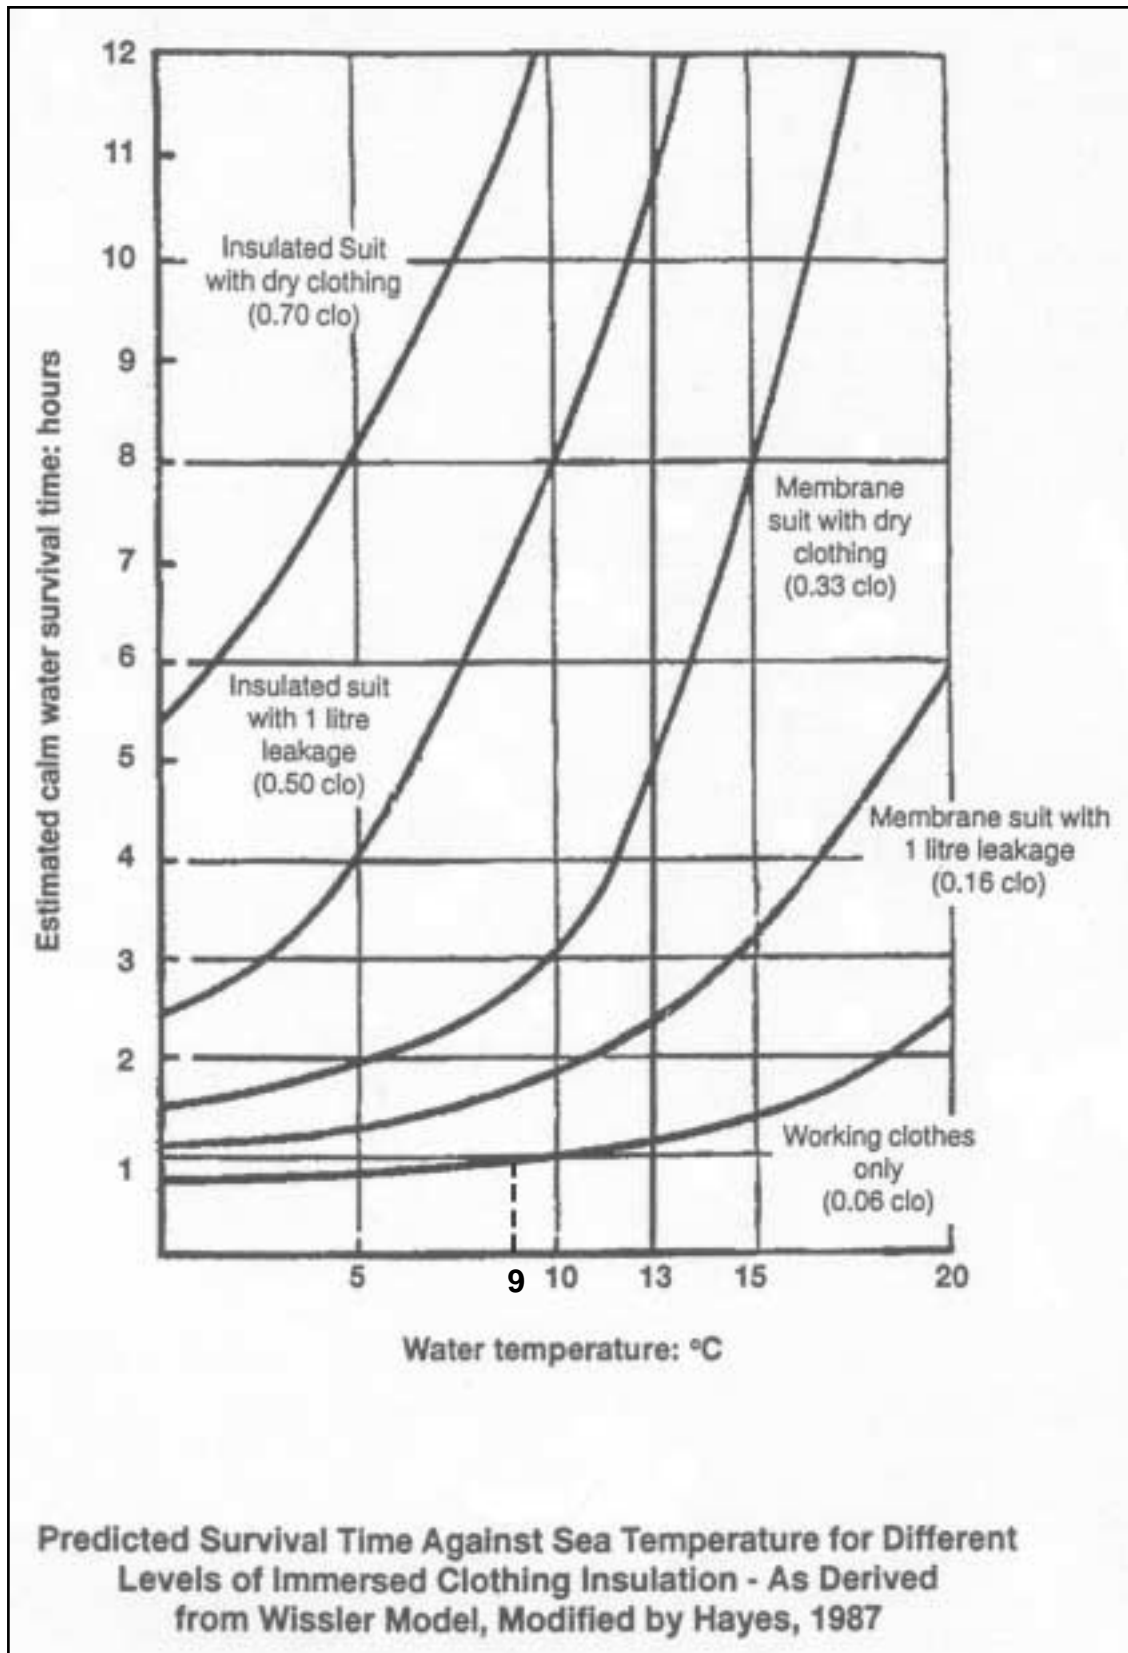
Figure 9

Estimated survival time versus water temperature is shown in **(Figure 9)**. The survival time in calm water at a temperature of 9°C, when working clothes are worn, is about 1 hour.

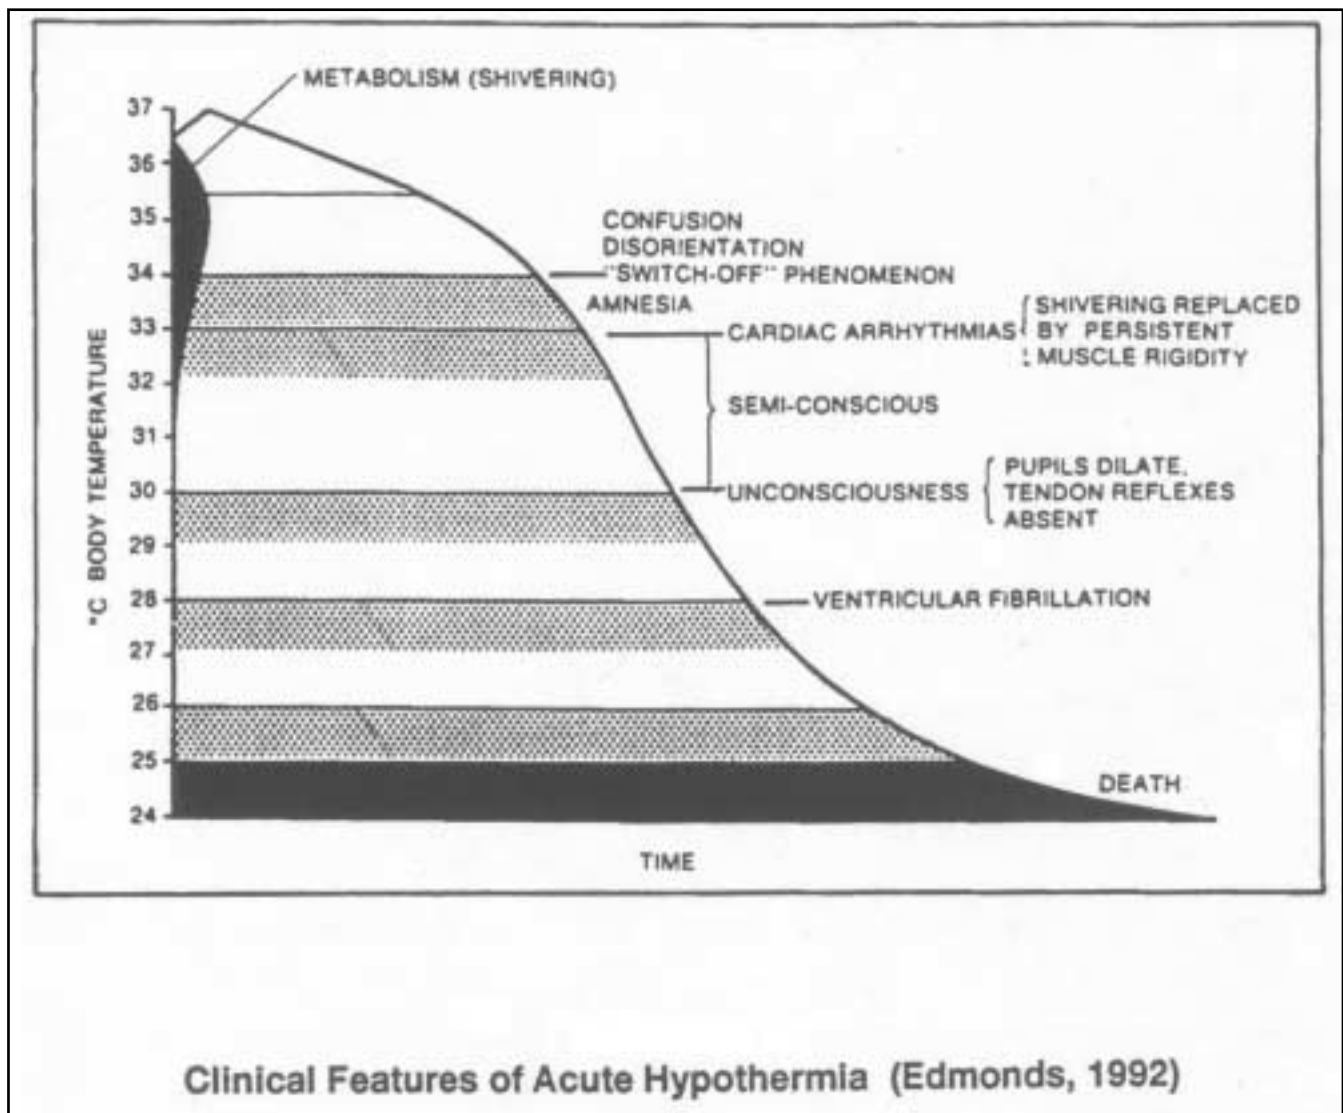
Figure 10

The effects of hypothermia are shown in **(Figure 10)**. The skipper's body temperature was reported to be 25°C when he reached hospital, but as he did not appear to lose consciousness, it might have been slightly higher than this.
