Report on the investigation of
the collision between
Gudermes
and
Saint Jacques II
in the Dover Strait
on 23 April 2001

Marine Accident Investigation Branch
First Floor
Carlton House
Carlton Place
Southampton
United Kingdom
SO15 2DZ

Report No 5/2002
February 2002

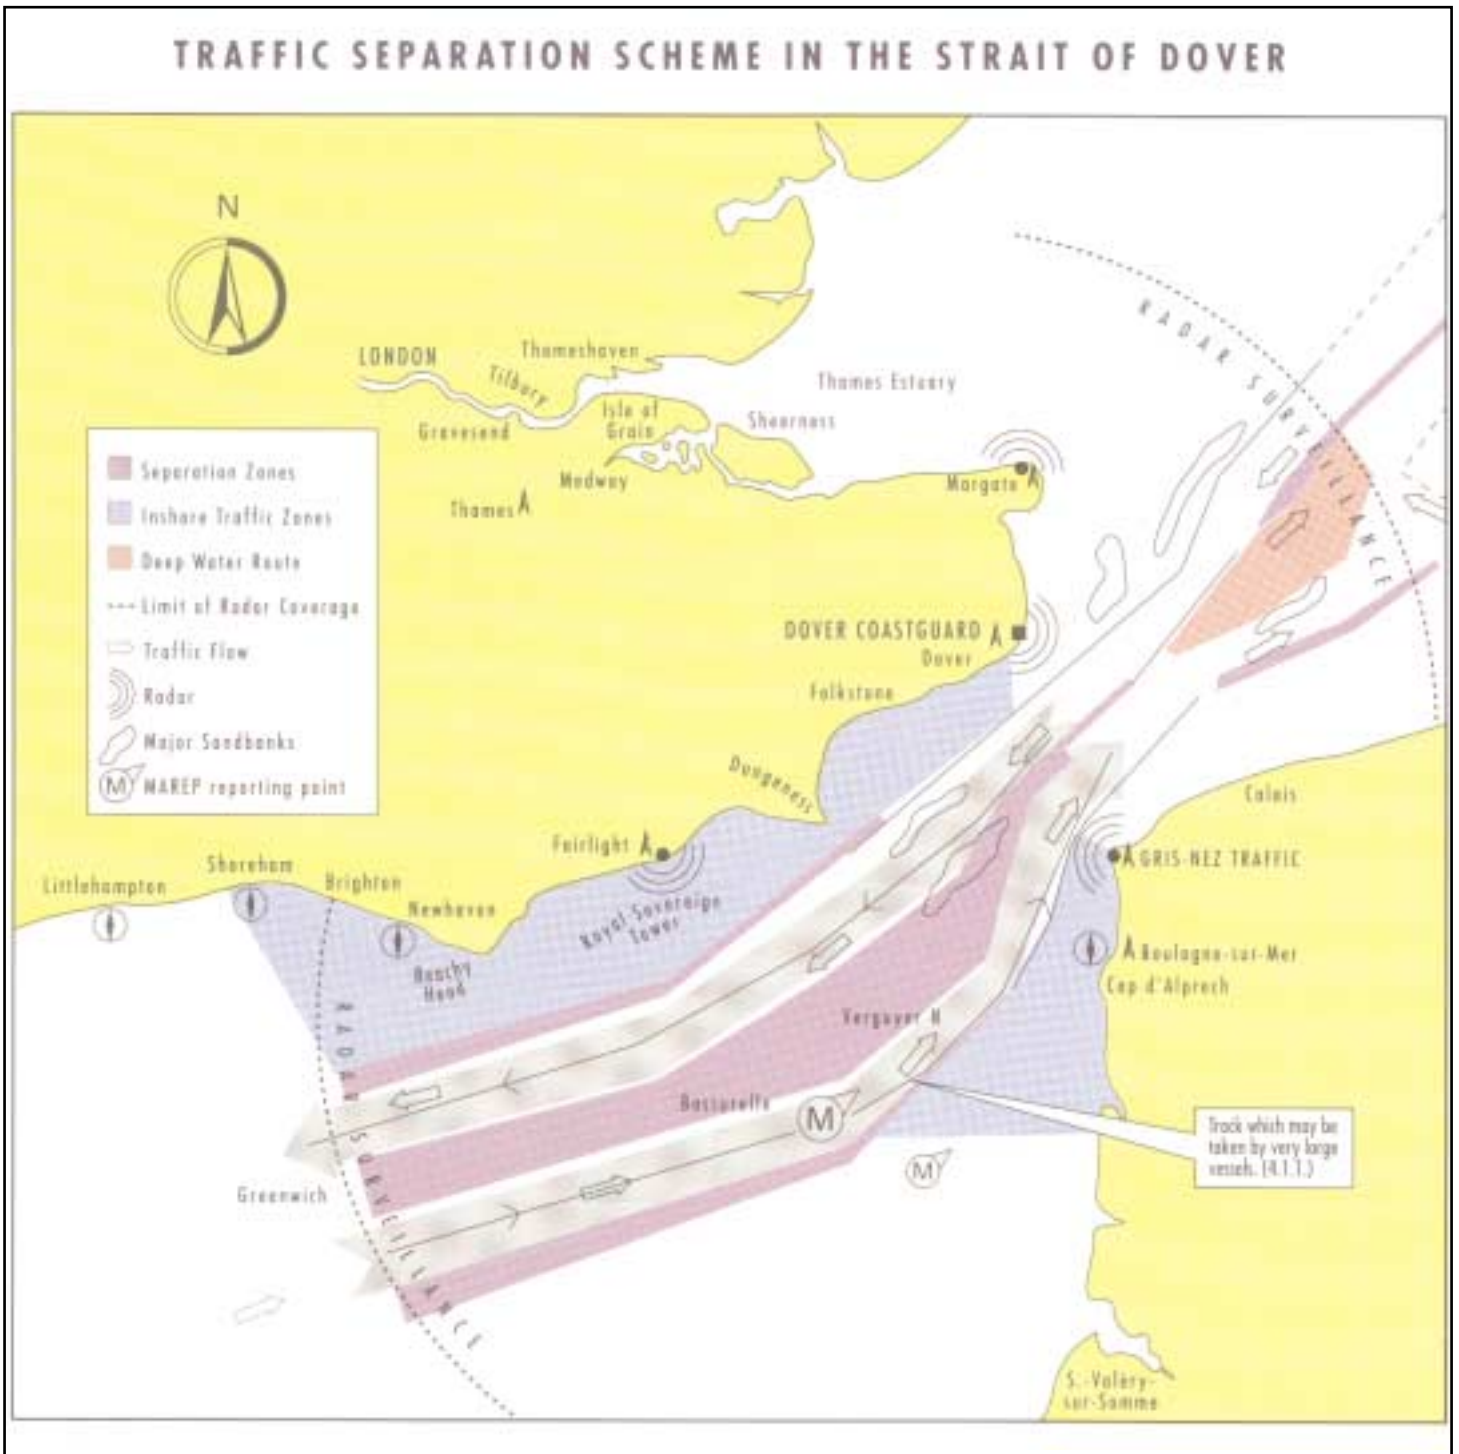
| | Page |
|--|---|
| Figure 7 Traffic separation scheme in the Strait of Dover | |

CNIS provides a 24-hour radio safety service by scheduled broadcasts or, on request, to individual vessels on passage through the Dover Strait. The area covered by the service and radar coverage of the area is shown at **Figure 7**. Continuous radar coverage is achieved via radar aerials sited at Margate, Dover, and Hastings. These aerials feed into the MRCC Dover which is also equipped with VHF DF sensing equipment, and monitors and records a selection of VHF channels, including 11 and 16.
