Report on the investigation  
of broaching of fast rescue boat  
while being launched from  
***Commodore Clipper***  
on 18 February 2001

Marine Accident Investigation Branch  
First Floor Carlton House  
Carlton Place  
Southampton  
SO15 2DZ

**Report No 19/2002**  
**June 2002**

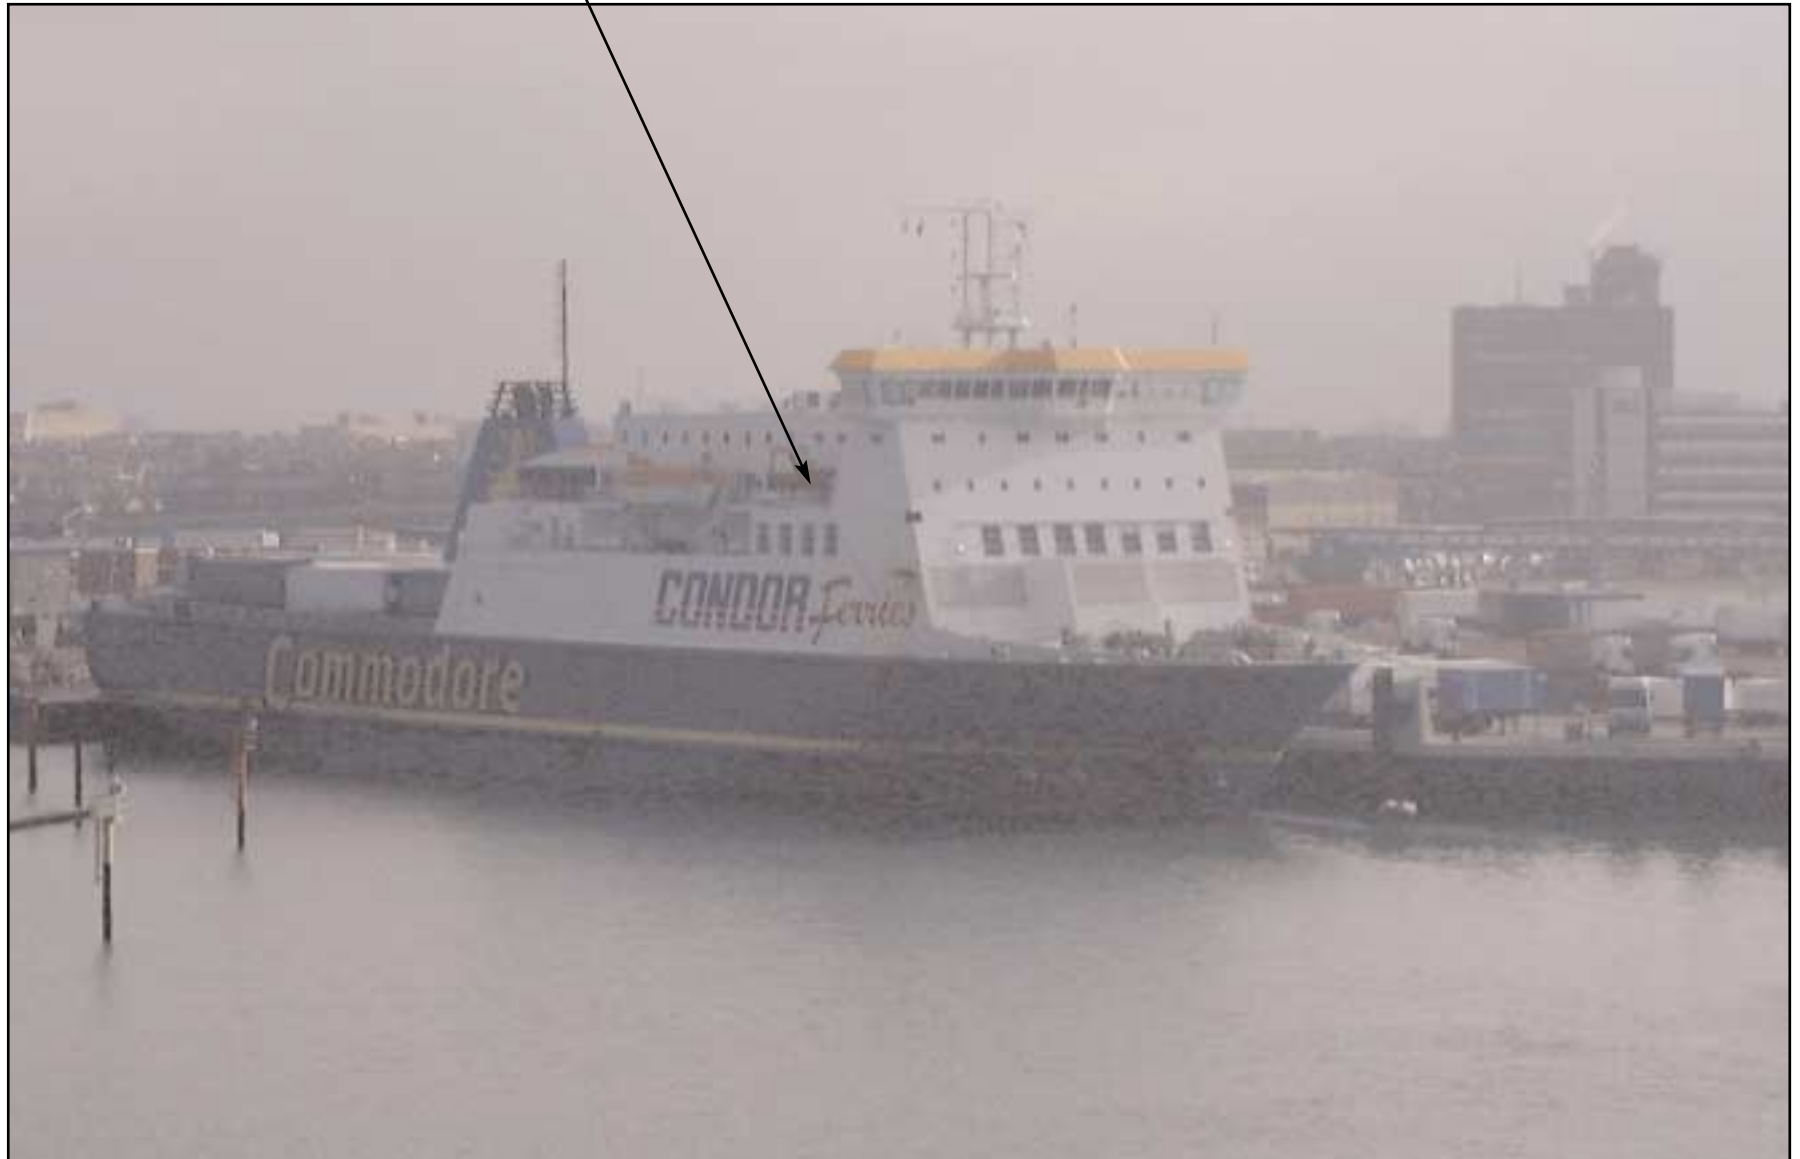
Figure 1

Fast rescue boat

*Commodore Clipper* is fitted with a Type FRB 600 S, 6.1metre, GRP fast rescue boat manufactured by Ernst Hatecke, Germany. This is mounted on a davit on the starboard side of the vessel, on the boat deck, two decks below the wheelhouse, about 24metres above the waterline (**Figure 1**).
